Service Bulletin

Bulletin No.: 17-NA-271

Subject: Clicking Noise from Front Wheels While Turning at Slow Speeds

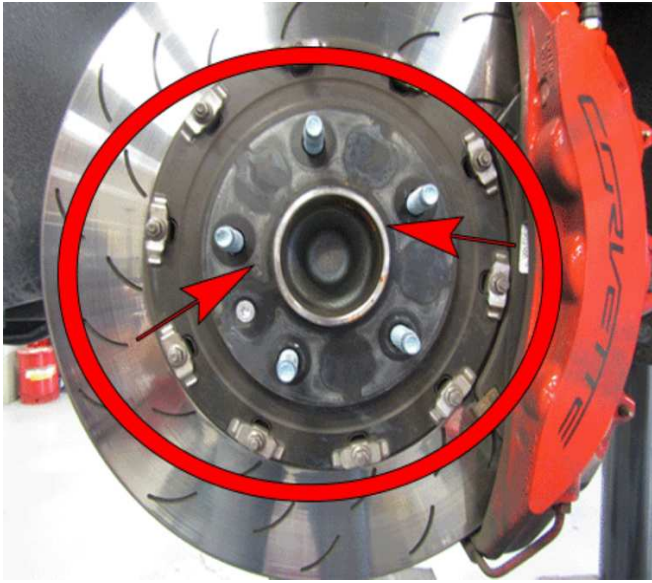
5152800

- Clean the wheel mounting surface of the brake rotors, or sometimes referred to as the brake rotor top hats, as follows:

- Using 3M red Scotch-Brite 7447 pad or equivalent with approved brake cleaner (ex. Part number 19370705 (U.S.), 88901247 (Canada)), wipe the wheel mounting surface of the rotor (brake rotor top hat) and the wheel pilot at the center of the rotor, removing any residual grey or black material that has accumulated on the rotors.

Note: All cleaning must be done by hand. **DO NOT** use pneumatic or power tools.
