Warranty Extension: B-612P Catalina Blue Pearl or Bright Kinetic Blue Pearl Paint

AFFECTED VEHICLES

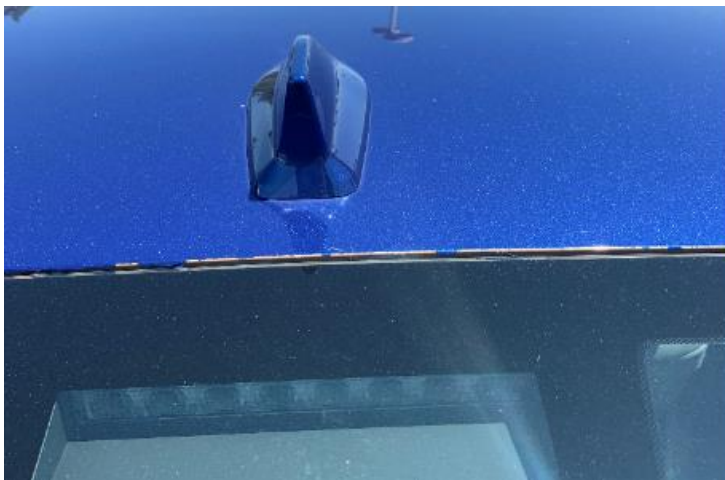
If there are any questions about vehicle coverage under this warranty extension, contact your DPSM.
