Subject: A/C Compressor Belt Replacement			
Field Change Program: Field Campaign	FCP Number: 485	Revision: A	Date: 09/17/2020
Coach Section: 16- Heating & A/C	P/N: 08-27-1357		Type: Product Integrity

1.0 Description

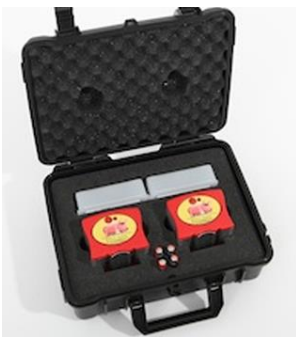
Belt alignment tool

Ratchet Strap

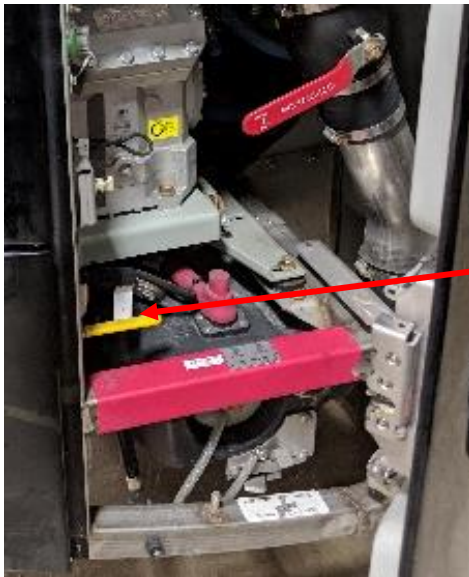
Rotate the lever
counterclockwise

Open the engine door using the latch behind the curbside service door.

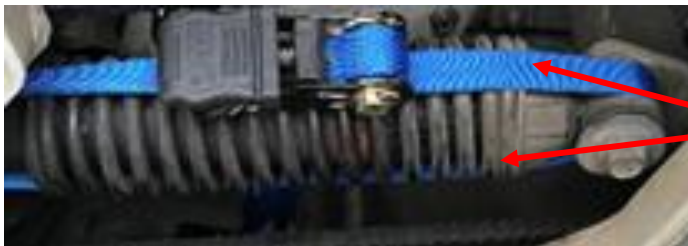
Remove and discard
the belt using ratchet
strap or MCI tensioner
compressor tool, P/N:
20-13-6675

Use a ratchet strap or MCI tensioner compressor tool, P/N: 20-13-6675, to clasp the AC belt tensioner. Remove and discard the A/C belt.

Spring is under compression and in tension.

To prevent personal injury, use caution while using ratchet.

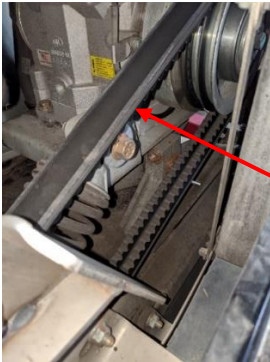
Remove and discard the belt

Remove and discard the double groove belt on the AC compressor.

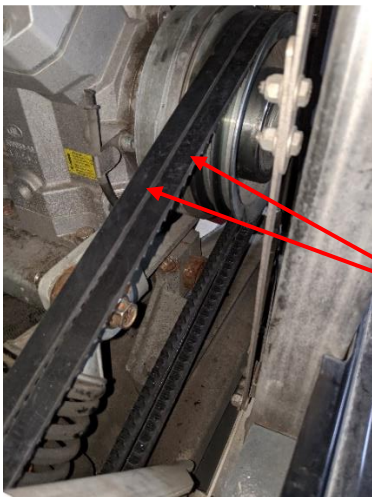
Install single groove matched belts, 08-27-1538

Install single groove matched belts, MCI P/N: 08-27-1538, as shown below.

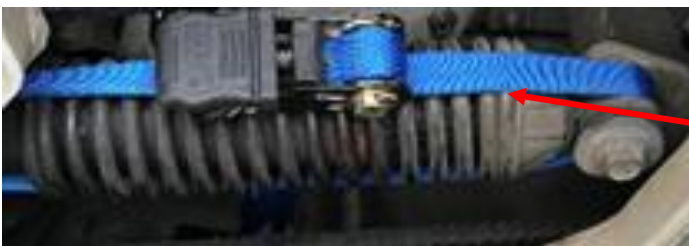
Remove the ratchet strap or MCI tensioner compressor tool, P/N: 20-13-6675

Remove the ratchet strap or MCI tensioner compressor tool, P/N: 20-13-6675, from the AC belt tensioner.

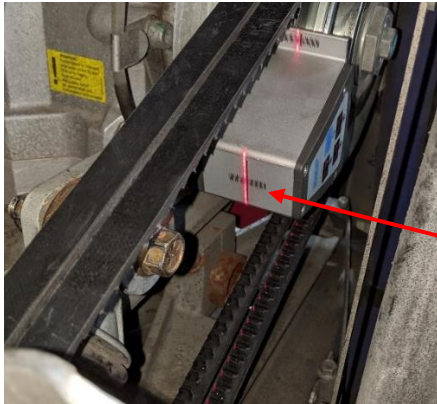
Laser line on the tool

Use the belt alignment tool to verify alignment of AC compressor pulley to the pulley on the crankshaft following the instructions in the maintenance manual section 16A-2.
