AfterSales BOL Technical Information

MAS002324 (BOL 20-12)

Engine coolant leaks from the cabin heater water delivery hose or the cabin heater water return hose

Models: M156, M157, M161 from MY18 up to and including MY20

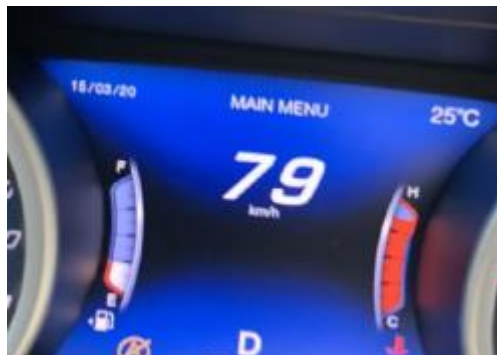
Figure 1

Issue: High engine coolant temperature indication on IPC (as figure 1) or engine coolant leak

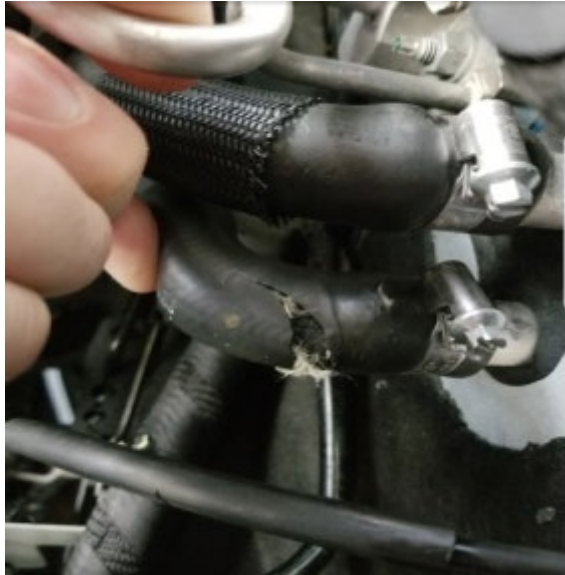
Figure 2

Cause: Engine coolant leaking from the cabin heater water delivery hose or the cabin heater water return hose

Action: Pressurize the engine coolant system to find the leak. If the cause of the leak is the cabin heater water delivery hose or the cabin heater water return hose (Figure 2), open a BOL as a “Support Request” and attach:

- DTC and parameters report from the ECM
- Photos of the leak and the hoses as they are installed in the car (as in figure 2)

Then proceed to remove the leaking hose. Avoid touching the inside of the hoses in order not to damage any of the components.

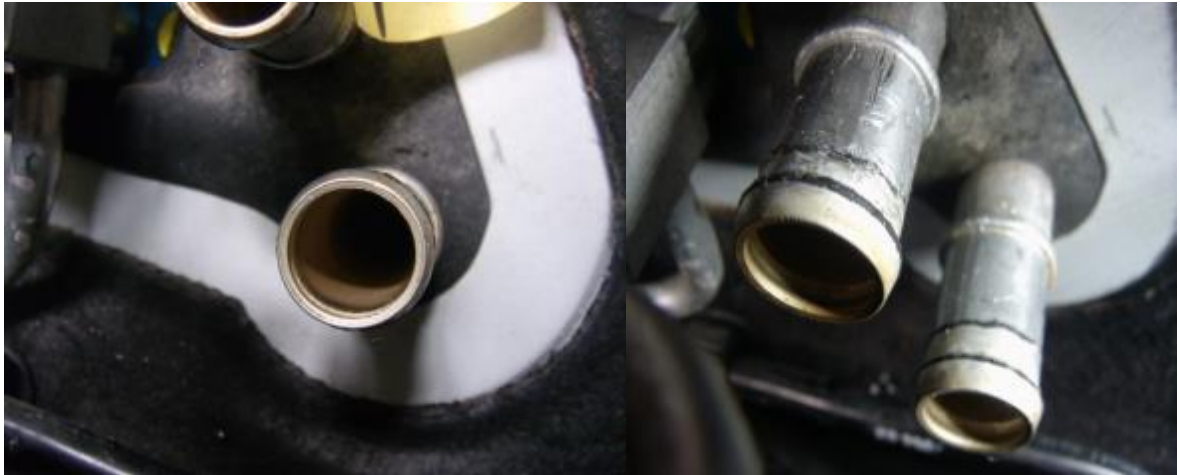
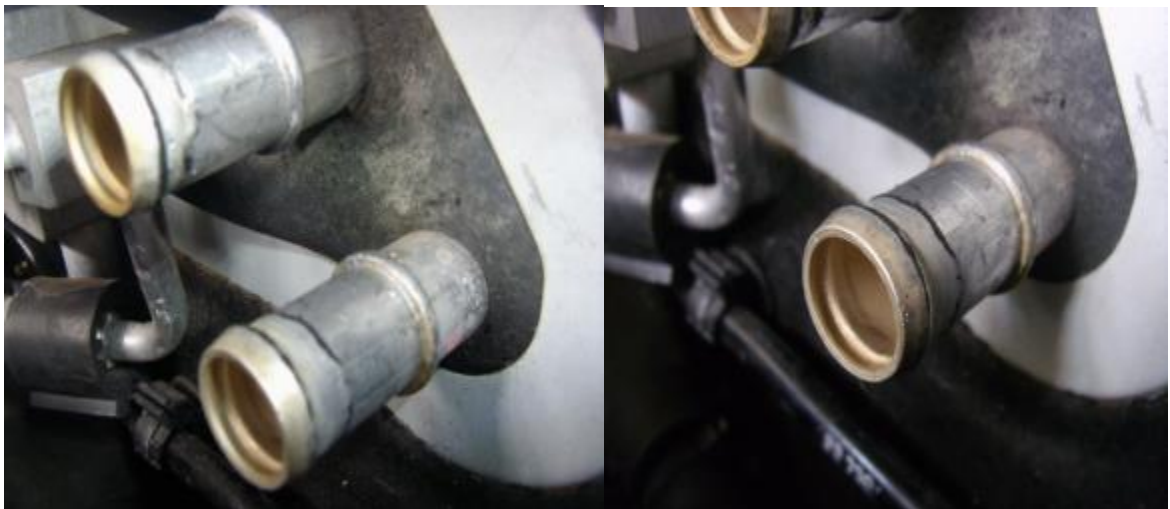
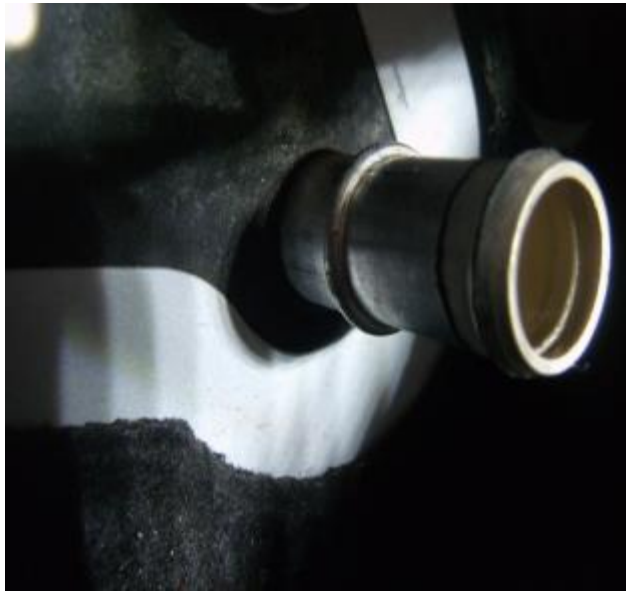
- Photos of flared end of the pipe on heater side (as figures 3,4 and 5)

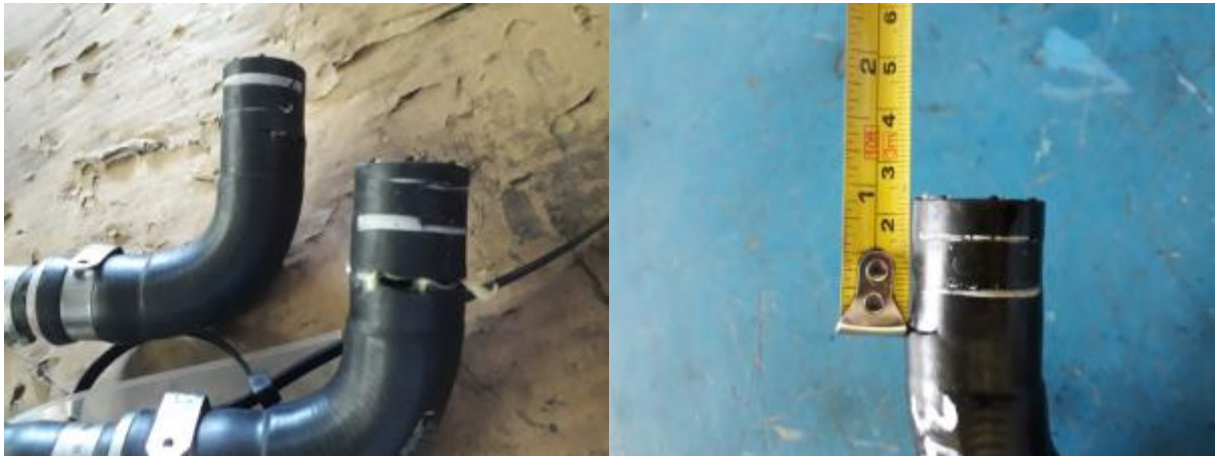
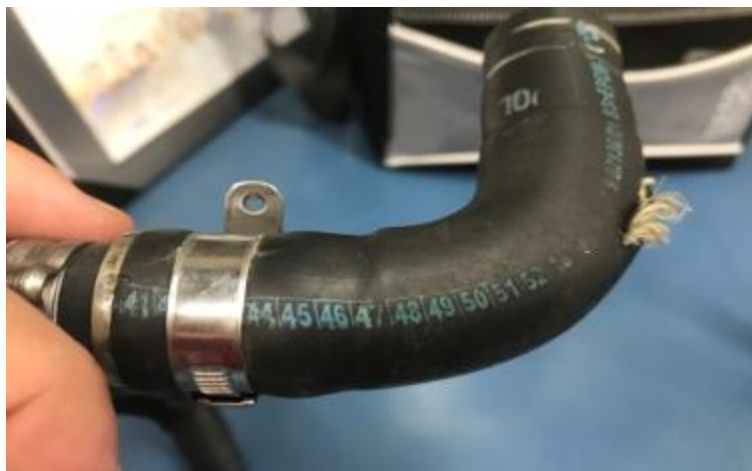
- photos of the hoses removed, with the detail of all damaged areas (as figures 6 and 7)

After the replacement of the damaged hose(s) and the securing clamp(s) on the cabin heater side, perform a road test to verify the performance of the engine cooling system.

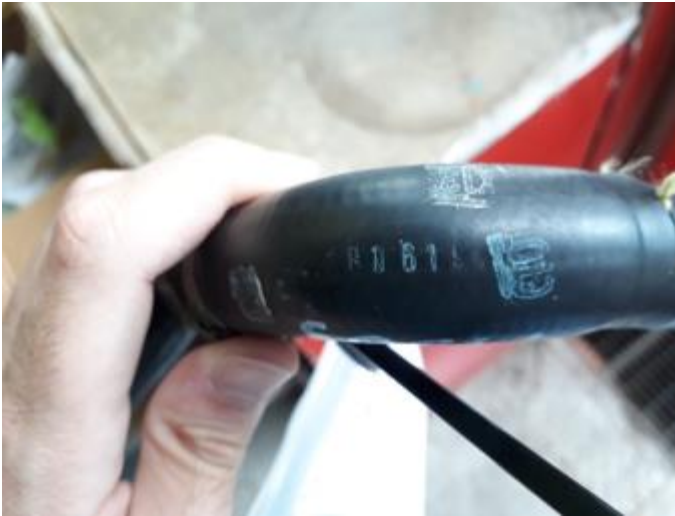
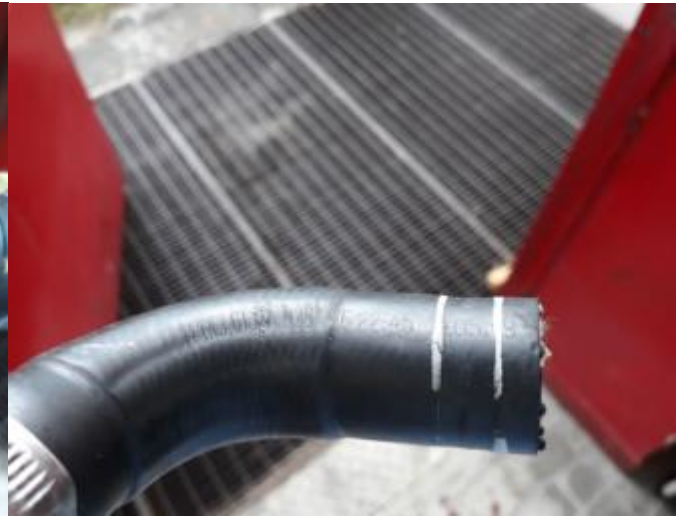
- photos of the markings on the cabin heater water delivery hose or the cabin heater water return hose (as figures 8 and 9)

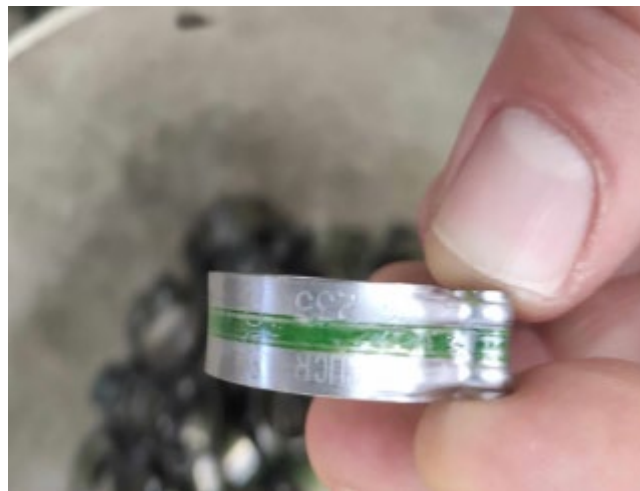
- photos of the securing clamps of the hoses on the cabin heater, with a clear indication of the markings on the clamps (as figure 10)

Figure 10: collar markings
