WORK DESCRIPTION FOR FIELD MEASURE

Code: 20P5891612

Replace exhaust gas cleaning information label

Model 463

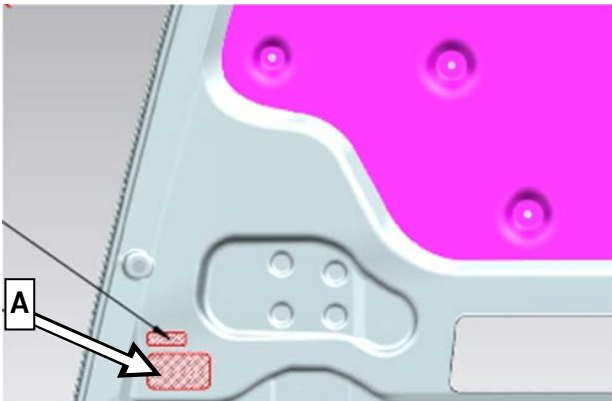
Figure 1

1. Open hood
2. Replace exhaust gas cleaning information label (A, Figure 1) on inside of hood.
 - i** In model 463 with engine **M176**, it **must** be part number **A 176 221 09 00** (B, Figure 2).
 - i** In model 463 with engine **M177**, it **must** be part number **A 177 221 17 00** (C, Figure 3).
 - i** If a correct information label has already been applied, no further work is necessary.

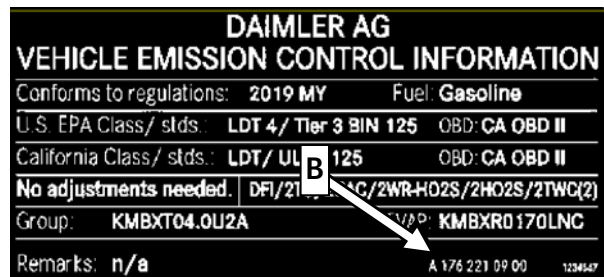
Figure 2, model 463 with engine M176 – A 176 221 09 00

Quantity	Designation	Part no.
As required (1)	Exhaust gas cleaning information label for model 463 with M176	A 176 221 09 00
As required (1)	Exhaust gas cleaning information label for model 463 with M177	A 177 221 17 00

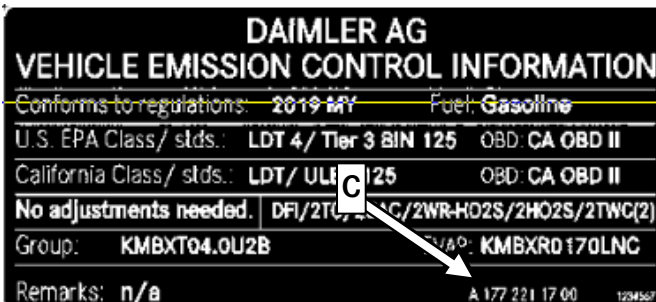
Figure 3, model 463 with engine M177 – A 177 221 17 00
