Mercedes-Benz

Campaign No. V-RC-2020090005, September 2020

SUBJECT: **Model 907 (Sprinter), Model Year 2019**  
**Fuel Delivery Module**

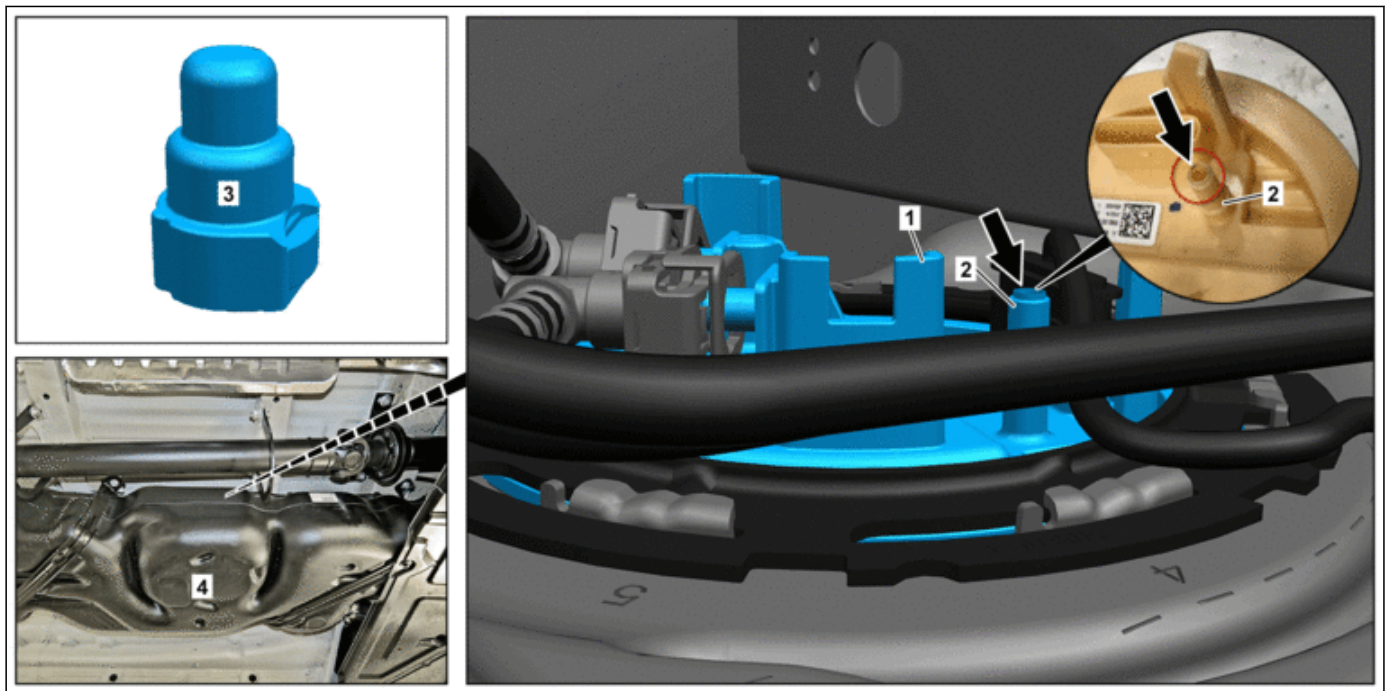
D47.20-A016-79

| 1 | Fuel delivery unit | 3 | Plug-in connector |
| 2 | Connection fitting | 4 | Fuel tank |

<b>Clean</b>		
3	Clean connection fitting (2) of fuel delivery unit (1).	Assembly cleaner	<a href="#">BR00.45-Z-1028-04A</a>

<b>Install</b>		
4	Seal connection fitting (2).	<p>

Attach connector coupling (3) to connection fitting (2). Ensure that connector coupling (3) engages correctly.</p> <p>

Connection fitting (2) can also be accessed without lowering the fuel tank. If necessary, use a mirror to help.</p>

<b>Clean</b>		
5	Clean fuel tank (3) from outside.	If fuel has leaked out of connection fitting (2). Assembly cleaner	<a href="#">BR00.45-Z-1028-04A</a>
6	Lower vehicle.
