STAR ONLINE PUBLICATION

Case Number: S1923000018 Rev A

Symptom/Vehicle Issue: Water Leak From Front Or Rear Of Sky Slider Open Top

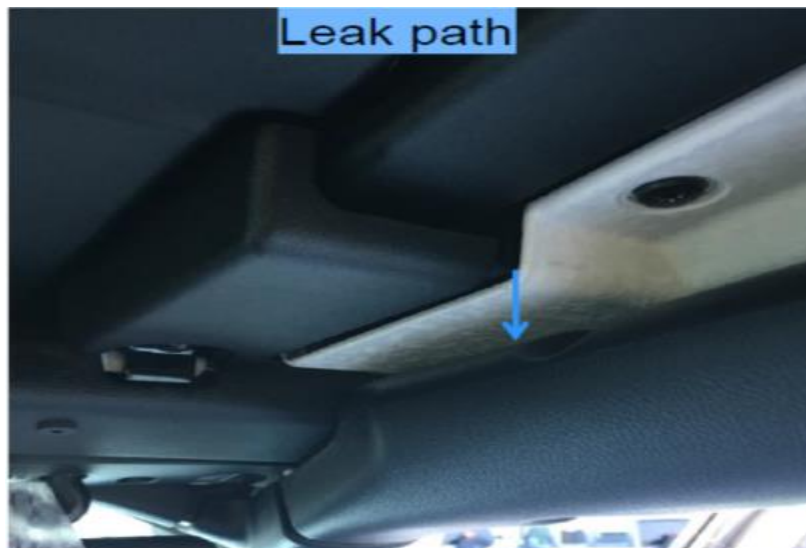
Discussion: A leak coming from the far corners (front or rear) of a Sky Slider could be the result of water leaking under the side seals. The side seals are sealed to the body with butyl. If the butyl is not “bedded” or sticking to both the seal and the body or if there is a skip/void in the butyl water could go under the seal and come in to the Jeep.

Fig 1 water leak path

To repair a front or rear corner leak see the below steps.

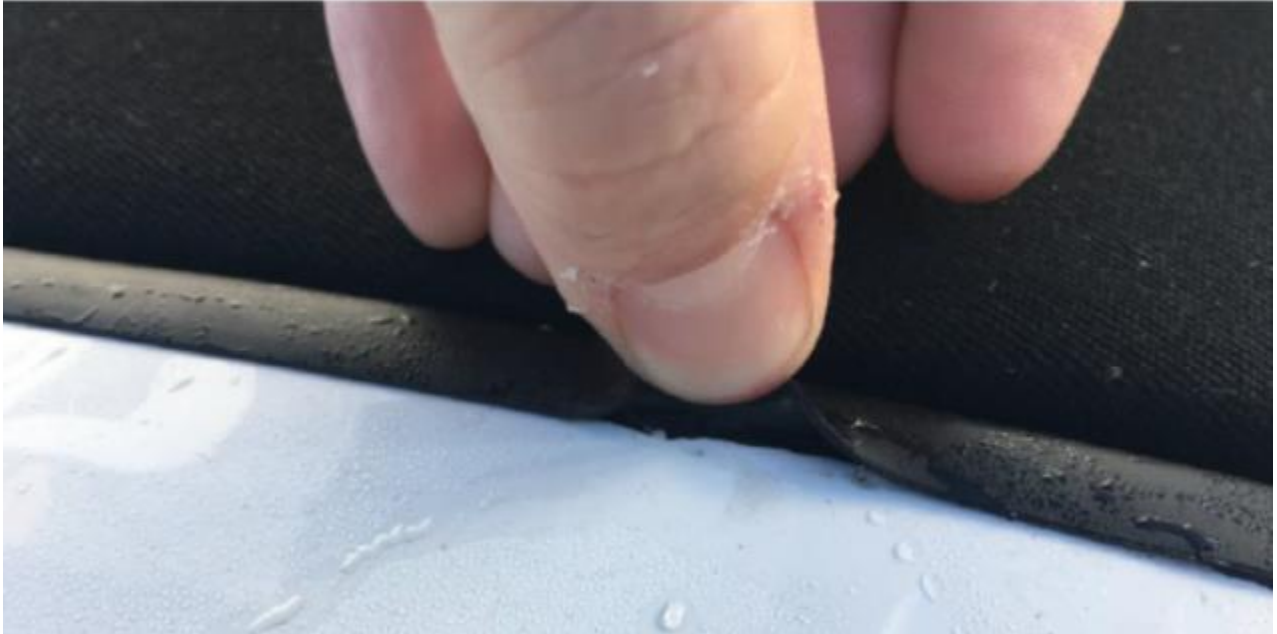
Fig 3 inspect for butyl void(s).

2. Roll the edge of the seal carefully up and inspect for voids in the butyl (fig 3). If any gaps are found, insert a small rope of butyl under the seal. Wet out (bed) the butyl using process in step 1.

3. Perform another water leak test.
