Service Bulletin

Bulletin No.: 18-NA-118

Subject: Diagnostic Tip for Malfunction Indicator Lamp (MIL) Illuminated - DTC P0101, P0171, P0172, P0300 and/or P1101 Set

Brand:	Model:	Model Year:		VIN:		Engine:	Transmission:
		from	to	from	to		
Chevrolet	Cruze (Gen II - VIN B)	2016	2019	—	—	1.4L (LE2)	—
Holden	Astra BL	2017

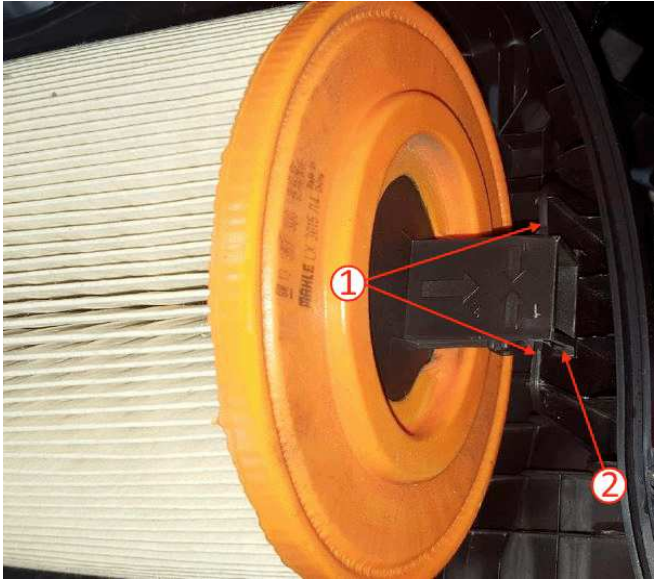
</div> <p style="text-align: right; font-size: small;">5040304</p> <p>This condition may be caused by the air cleaner element bracket (2) not properly installed onto the mount (1), causing the bracket and/or mount to become warped over time.</p>

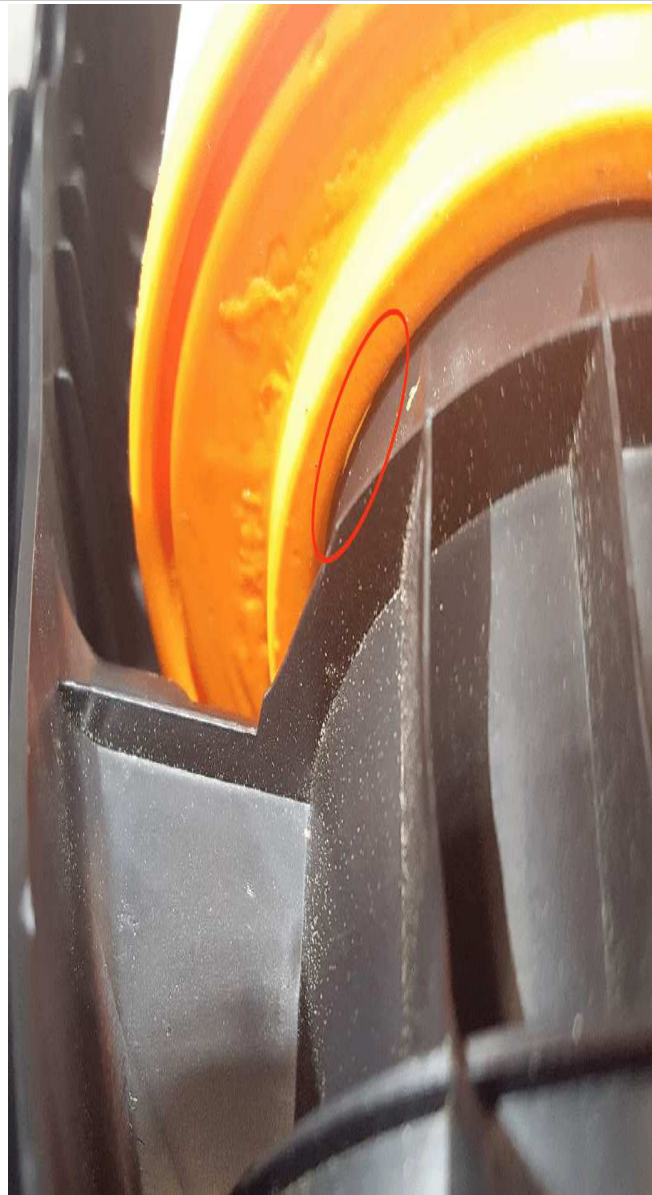
5039419

An improperly installed bracket may cause the air cleaner element to warp, be misaligned and/or improperly seal onto the air cleaner housing inlet duct, creating gaps as shown above.

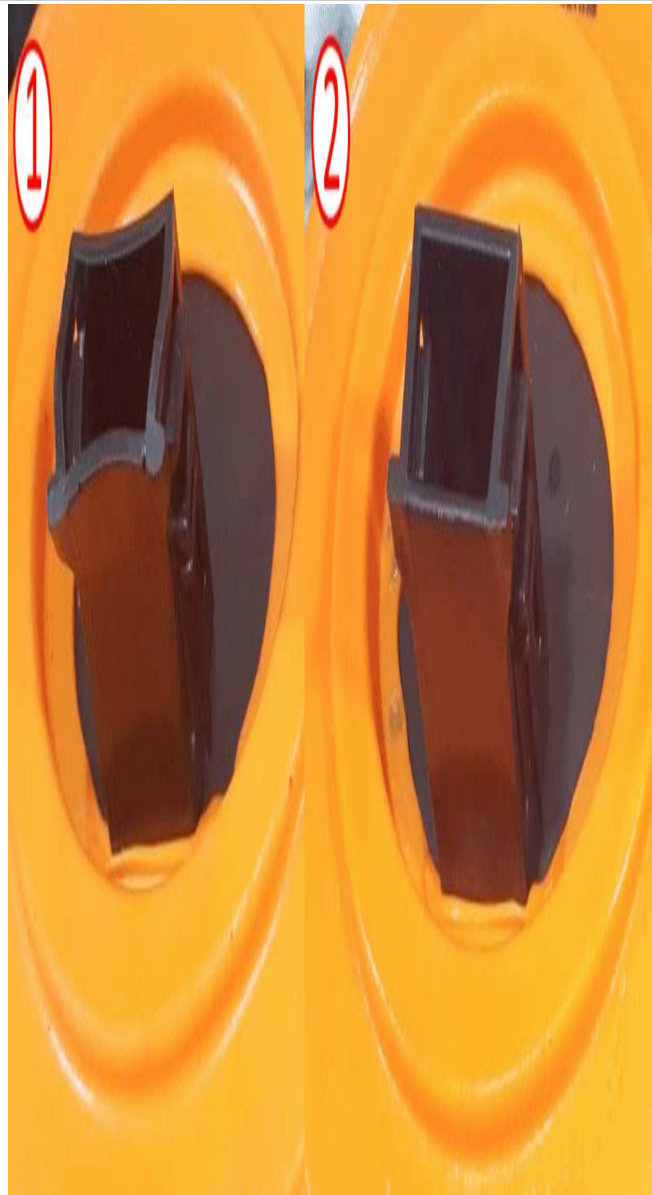
5042522

Perform an inspection of air cleaner element bracket:

- If damage to the bracket (1) has been found, replace the air cleaner element and validate a secure connection between the air cleaner bracket and the mount. Refer to the Service Procedure below.
- If no damage has been found to the bracket (2) and the air cleaner shows no signs of improper sealing to the intake duct, refer to SI for further diagnostics.

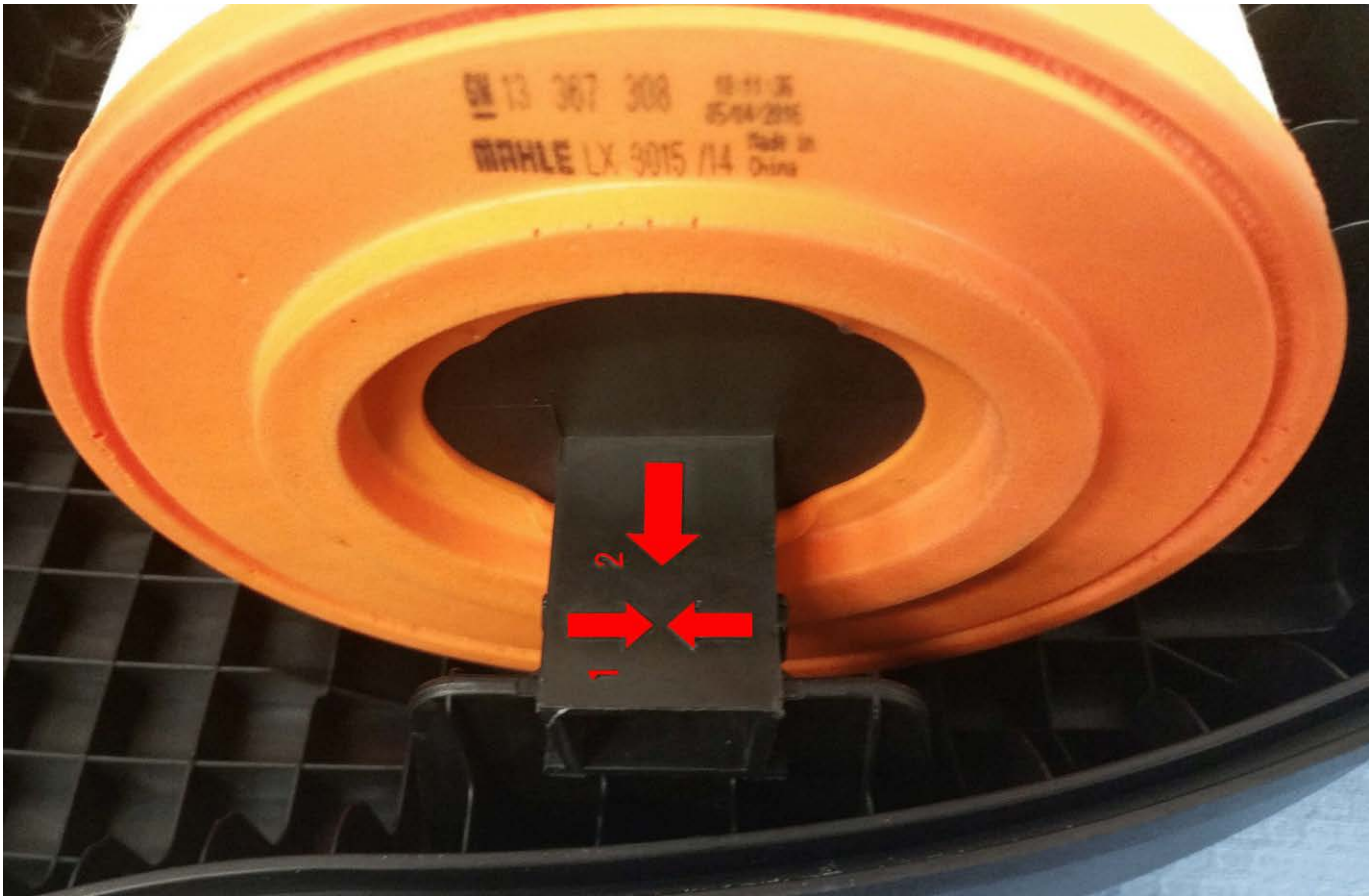
5039529

Important: When removing the air cleaner element, care should be taken not to damage the bracket mount. Follow the instructions on the bracket for air filter removal.

1. Remove the air cleaner housing.
2. Remove the air cleaner element.

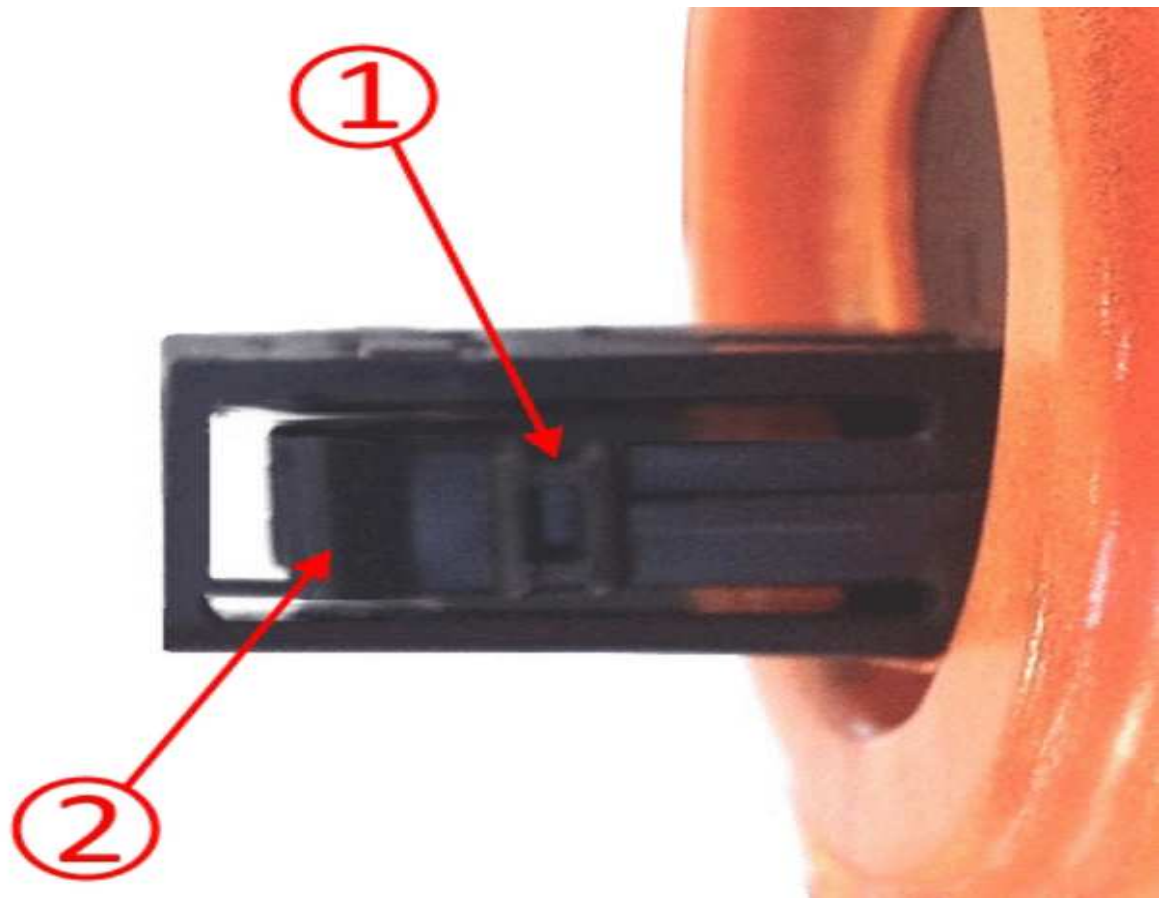
5039828

3. Squeeze the tabs (1) to release the bracket from the mount.
4. Slide the air filter away from the intake duct.
5. Using care, lift the bracket away from the mount and remove the air cleaner.

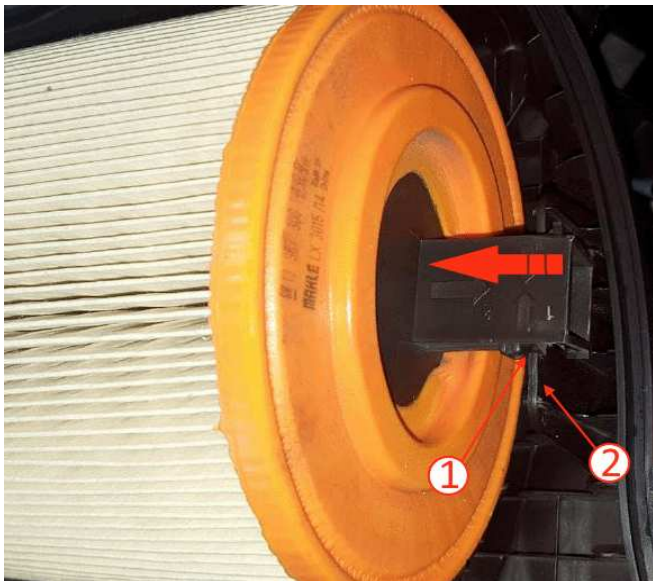
5040297

6. Align the new air cleaner to the air cleaner housing intake duct.
7. Align the bracket (1) to the mount (2).
8. Using care, slide the air cleaner and bracket rearwards till an audible click can be heard.

Note: A properly installed air cleaner should not fall out of the housing when turned over and shaken slightly.

9. Inspect the air cleaner for proper seal around the inlet duct.
10. Install the air cleaner housing.
