TECHNICAL TOPICS POWERTRAIN

Check Engine Lamp with Misfires

18MY – Onward Discover Sport, RR Evoque, Defender, RR / RR Sport PHEV, XE, XF, F PACE, F TYPE, E PACE equipped with AJ20P4

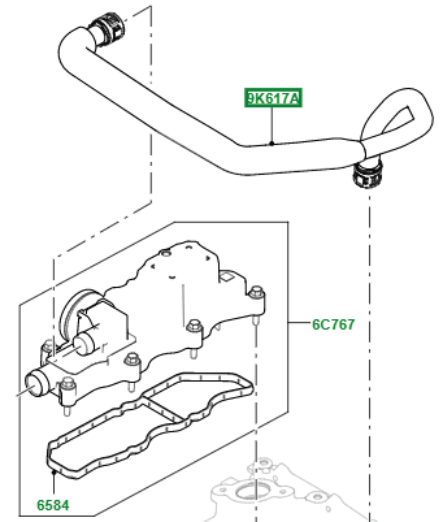
- A vacuum leak is identified from a loose connection of the PCV vent tube at the PCV housing or the intake manifold.
- Minor burrs from the production of the mating surface can lead to a poor seal.

- Inspect the mating surface on the intake manifold and the PCV housing for burrs that may interfere with the latch.
- Replace both affected parts only if an issue is identified with the mating surface.
