Technical Service Bulletin

60 Water entry into cabin from the sunroof area

60 20 45 2056944/5 November 3, 2020. Supersedes Technical Service Bulletin Group 60 number 20-44 dated October 7, 2020 for reasons listed below.

Model(s)	Year	VIN Range	Vehicle-Specific Equipment
Audi e-tron Sportback	2020 - 2021	All	Not Applicable
Q3, Q8, and Audi e-tron quattro	2019 - 2021	All	Not Applicable

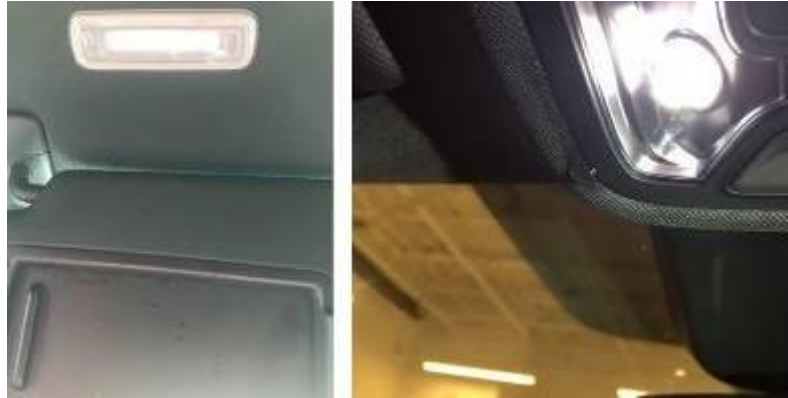
- They see a water drip from the headliner area (Figure 1).

Figure 1. Water intrusion near the headliner.

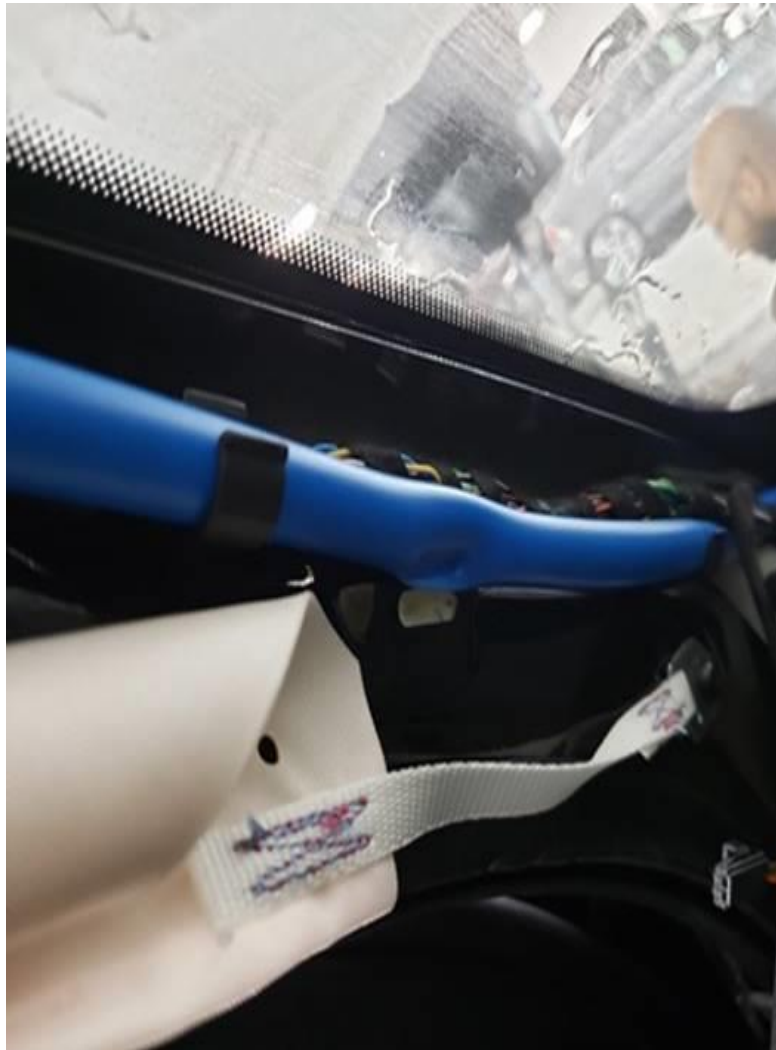
Visually inspect all 4 sunroof drain hoses and valves for any damage or obstruction (Figure 2).

Figure 2. Sunroof drain hose pinched by pillar trim.

Ensure that any water in the sunroof frame drainage areas flows freely. Replace any pinched or otherwise obstructed drain hose(s) or valve(s).

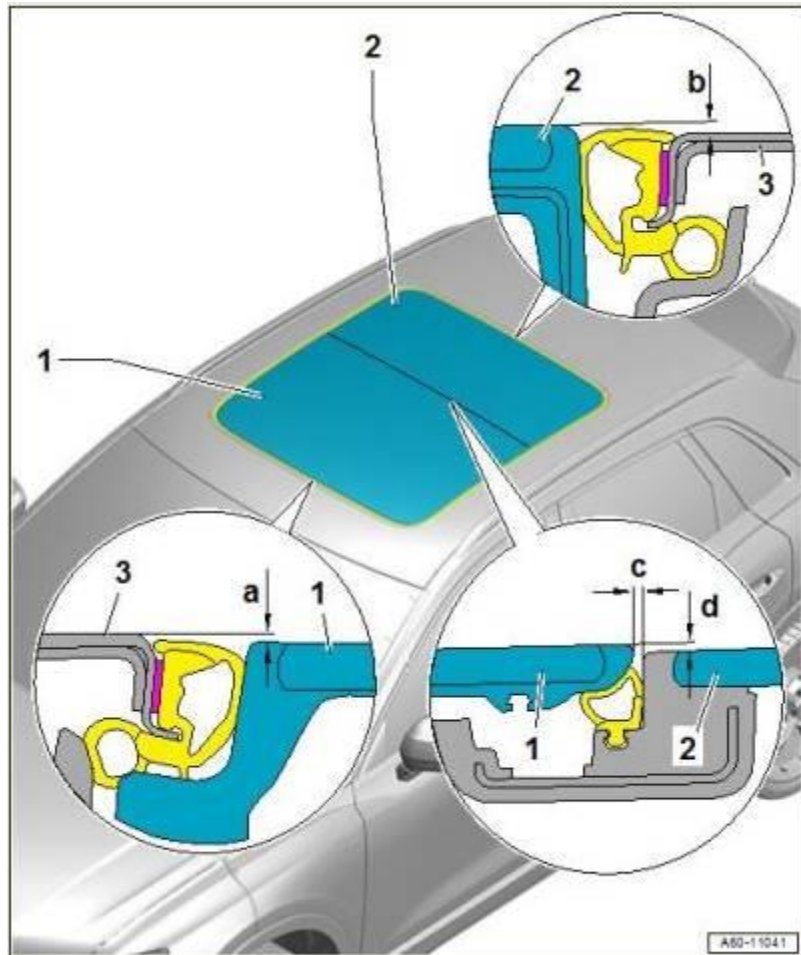
Check all adjustment axes of the sunroof glass panels for poor adjustment (Figure 4).

Figure 4. Front and rear glass panel adjustment.

If after all dimensional measurements are made on the sunroof glass panels a problem is found make the necessary adjustments to the sunroof glass panels.

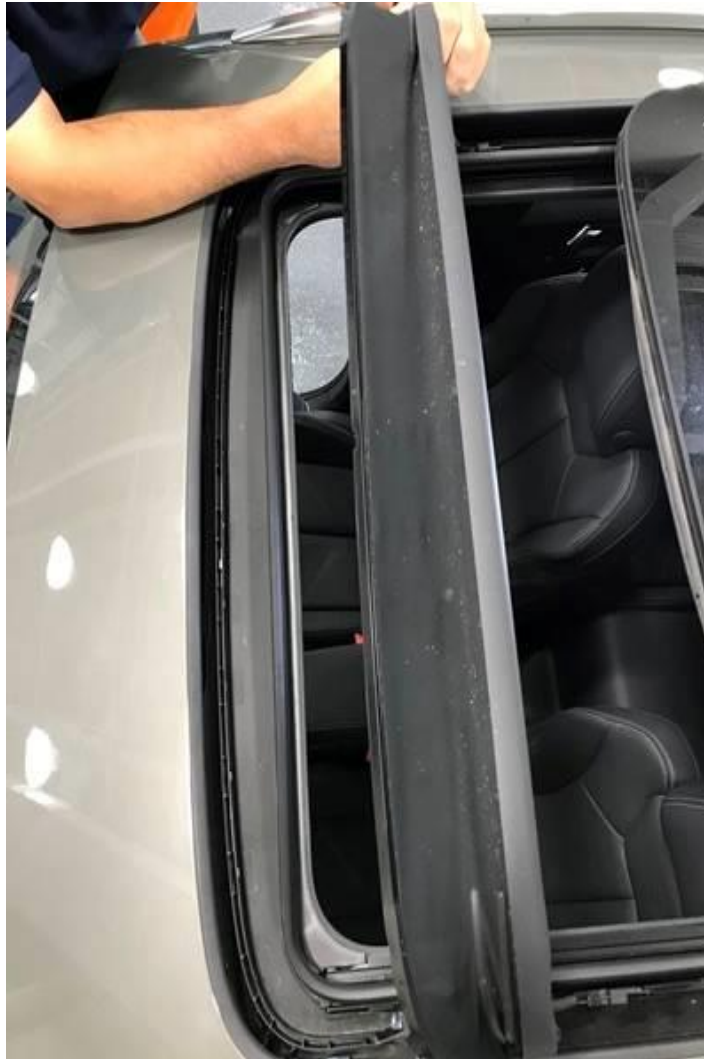
This water drip may not appear until after a driving period when the water travels to the underside of the headliner area during the normal course of driving (Figures 5-7). This occurs due to a slow migration of water along the wind deflector hinge arms and water entry into the stowage area for the wind deflector. This stowage area does not provide water drainage away from the vehicle.

Figure 5. Front sunroof opening with drainage exposed.

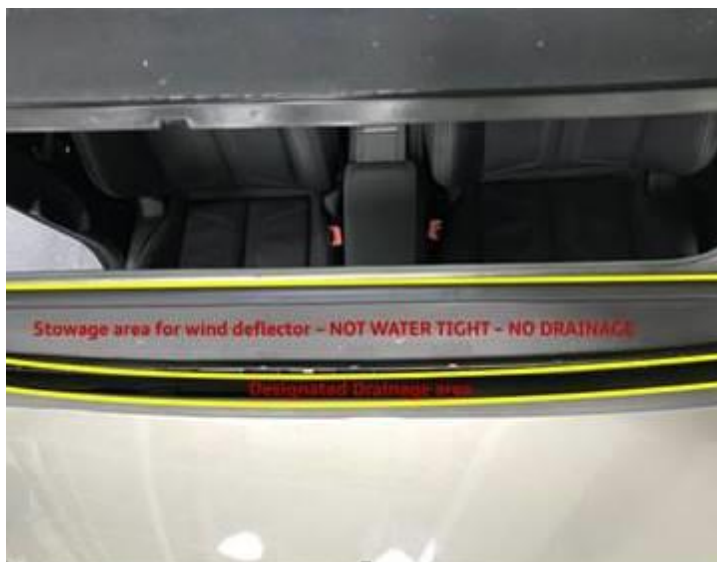
Figure 6. Areas of sunroof opening water elimination capabilities.

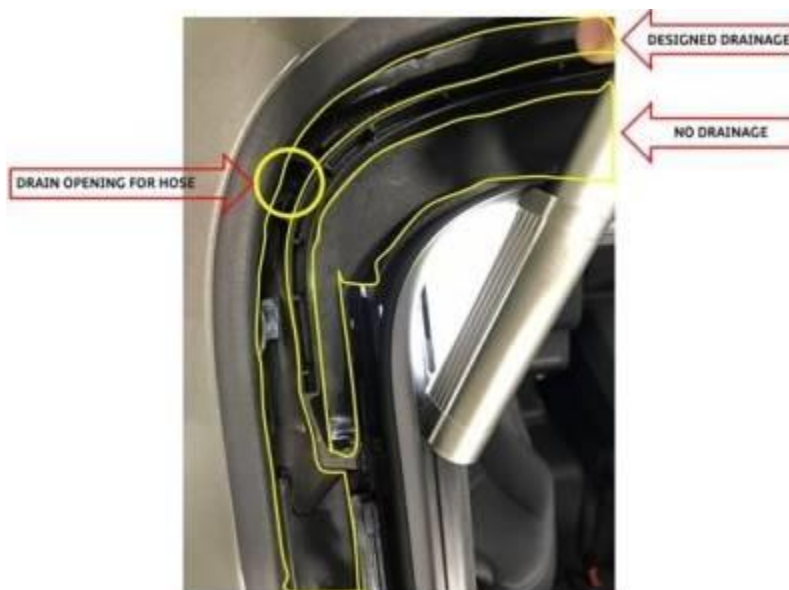
Figure 7. Sunroof water channeling diagram.

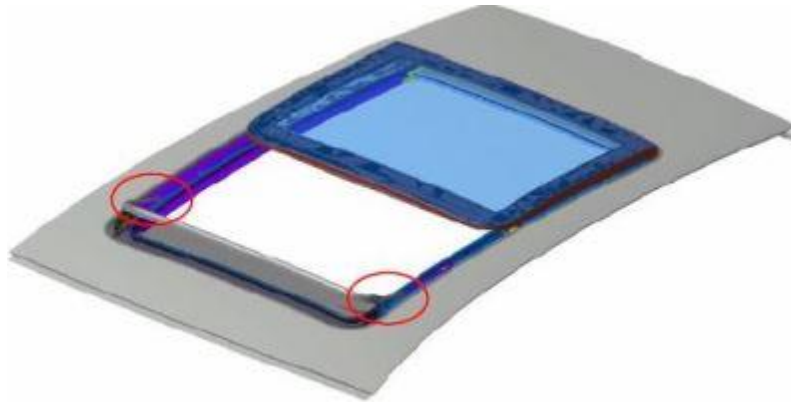
Figure 8. Locating points for the sunroof wind deflector.

5. Open the front sunroof panel completely and locate the mounting points for the sunroof wind deflector (Figure 8).

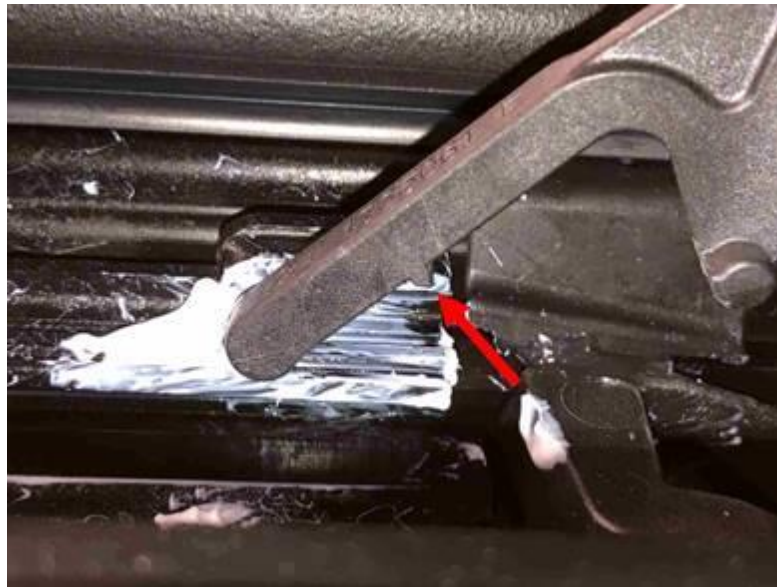
Figure 9. Tabs cast into the redesigned wind deflector.

6. There has been a design change to the wind deflector to enhance the water flow and drainage in the event the wind deflector gets wet. Inspect the area of the wind deflector shown (Figure 9). The redesigned wind deflector has small tabs cast into the deflector structure on both sides. If the wind deflector does not have these tabs replace the wind deflector. Make certain that the replacement wind deflector contains these tabs before installation. With the redesigned wind deflector installed, proceed as follows.

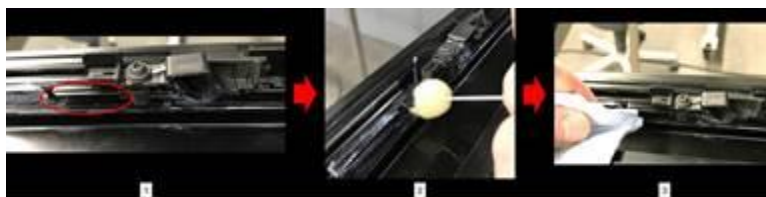
Figure 10. Area of sunroof frame to be cleaned.

7. Using a primer applicator D 009 500 25 (or equivalent) and D 009 401 04 all purpose cleaner (or equivalent) thoroughly clean the area shown (Figure 10). It should be free of any lubricant or contaminants and completely dry.

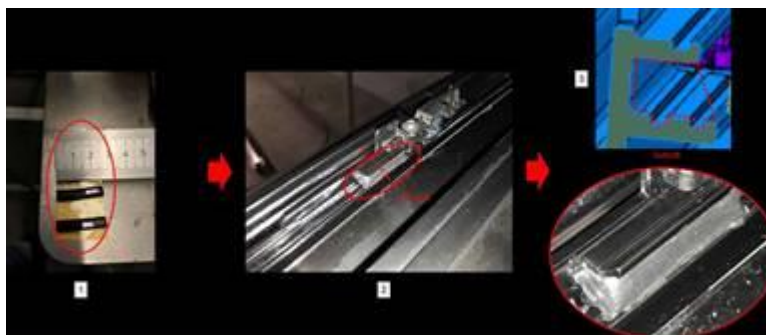
Figure 11. Preparation and application of butyl cord.

8. Cut two 25mm strips of AKL 450 005 05 Butyl adhesive/sealing cord. Firmly press each strip into the groove shown (Figure 11). Both channels shown in the cut away must be completely filled with the butyl cord.

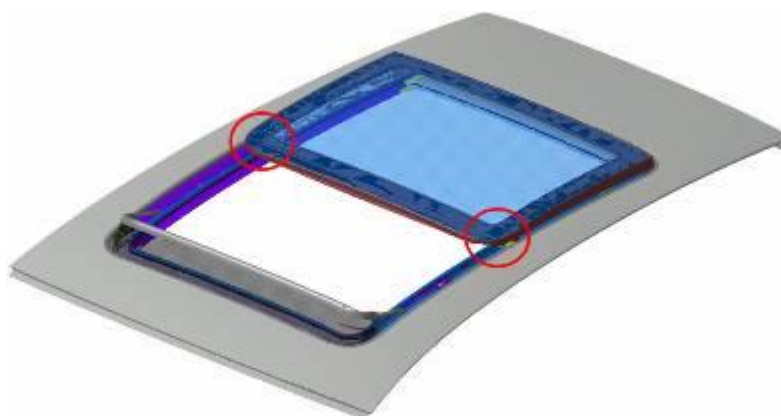
Figure 12. Area of sunroof glass panel to be modified.

9. Next, a modification will be made to the sunroof glass panel (Figure 12) by bonding two small pads to the front corners just inside the rubber 'skirt'. The purpose of this modification is to create a gap between the 'skirt' and the sunroof mechanism beside it, and as a result, prevent water from making contact with the sunroof mechanism and possibly breaching the water channels.

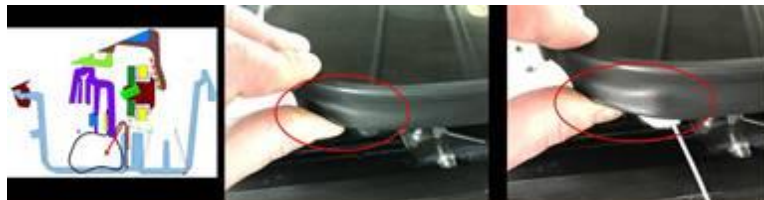
Figure 14. Area of glass panel 'skirt' where bonding agent is to be applied.

11. Apply D 355 205 A2 Bonding Agent using a primer applicator D 009 500 25 (or equivalent). Allow bonding agent to thoroughly dry (Figure 14).

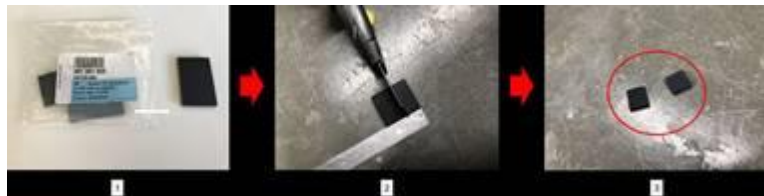
Figure 15. Preparing 2 – 10mm x 10mm pads of 251 201 525 packing.

12. Using 251 201 525 packing cut 2 x 10mm x 10mm pads (Figure 15).

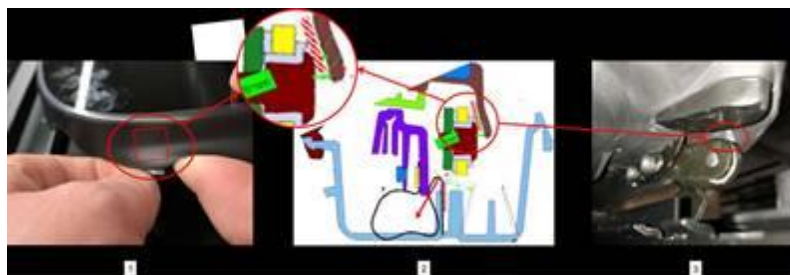
Figure 16. Positioning and application of the 10mm x 10mm pads.

13. Bond each pad to the front areas of the sunroof glass panel 'skirt' as shown in figure 15. A cut away drawing is included to illustrate the precise positioning of each pad from the inside (Figure 16).
