Technical Journal

Left engine pad click sound

REF NO: TJ 33442.11.0	ISSUING DEPARTMENT: Technical Service	CAR MARKET: United States and Canada	
PARTNER: 3 US 7510 Volvo Car USA		ISSUE DATE: 2020-10-20	STATUS DATE: 2020-10-26
FUNC GROUP: 2180	FUNC DESC: Engine mounting	Page 1 of 6

SPA – Left engine pad click sound

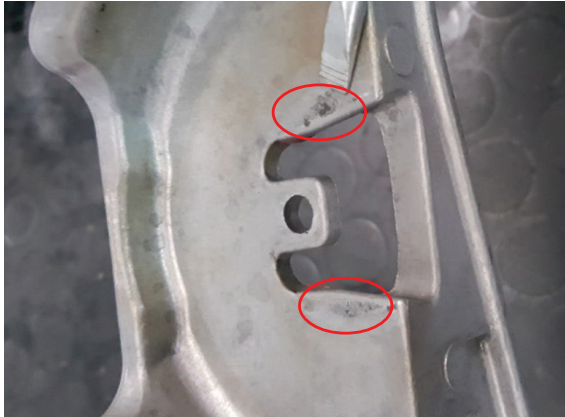
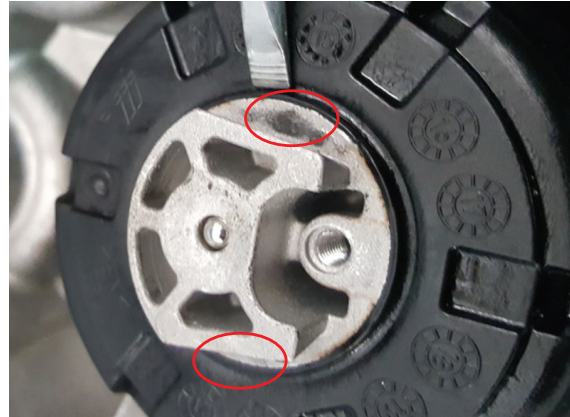
Put lubricating grease with graphite on red marked points as in pictures above.

Separate the engine pad and lubricate with graphite (see attachment), then follow instruction new screw and washer.

Torque 10 NM.

Example of Lubricant to use Wurth P/N 0893240016.

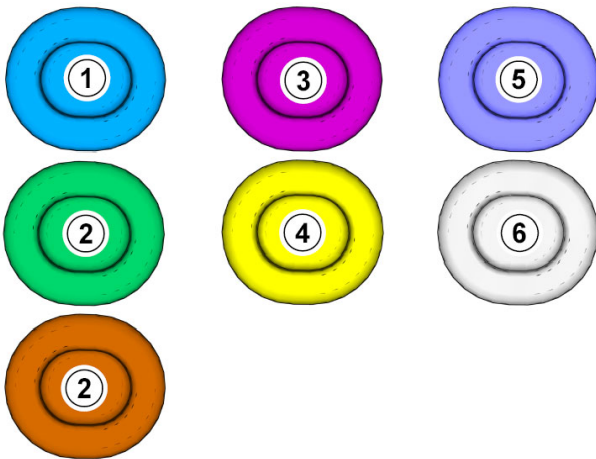
Color symbols

Note! This colour chart displays (in colour print and electronic version) the importance of the different colours used in the images of the method steps.

- 1 . Used for focused component, the component with which you will do something.
- 2 . Used as extra colors when you need to show or differentiate additional parts.
- 3 . Used for attachments that are to be removed/installed. May be screws, clips, connectors, etc.
- 4 . Used when the component is not fully removed from the vehicle but only hung to the side.
- 5 . Used for standard tools and special tools.
- 6 . Used as background color for vehicle components.

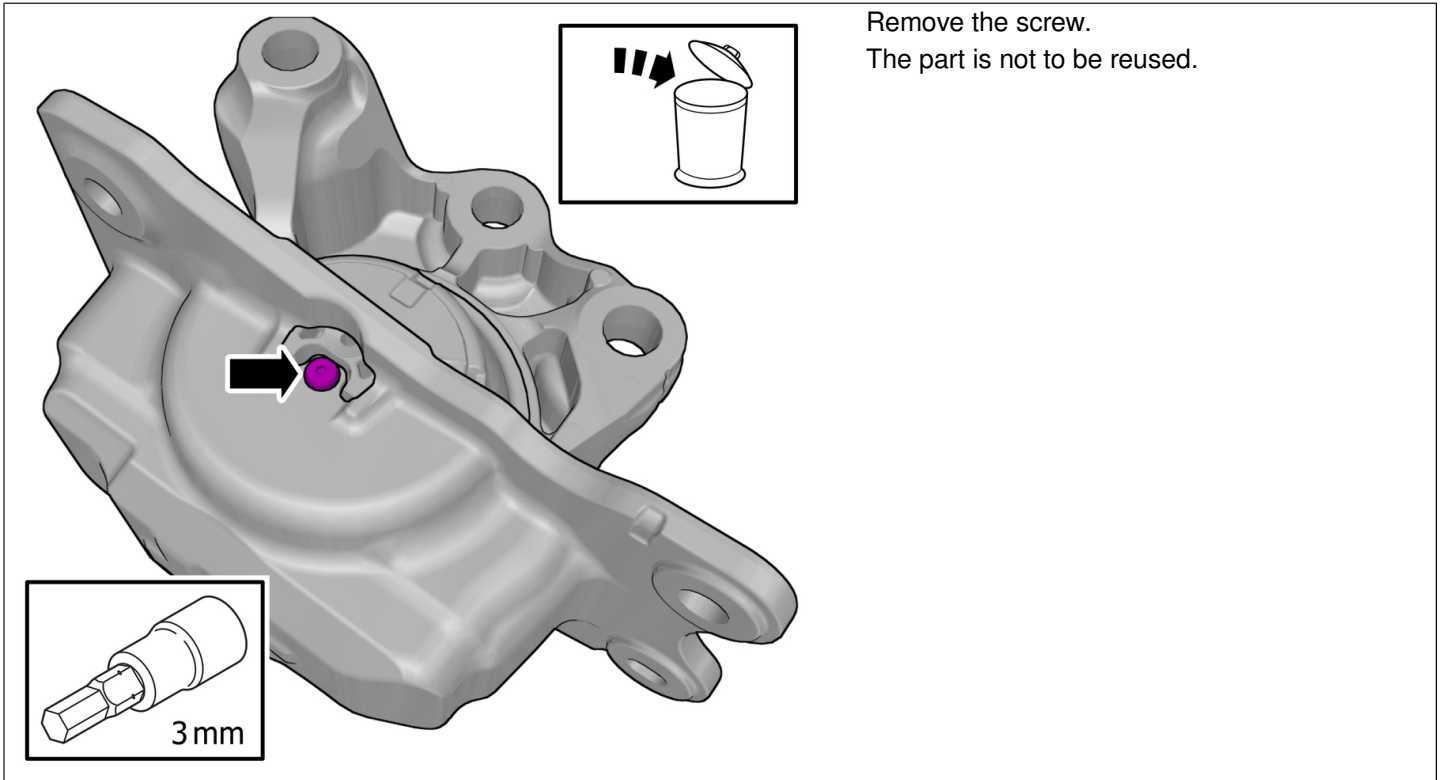
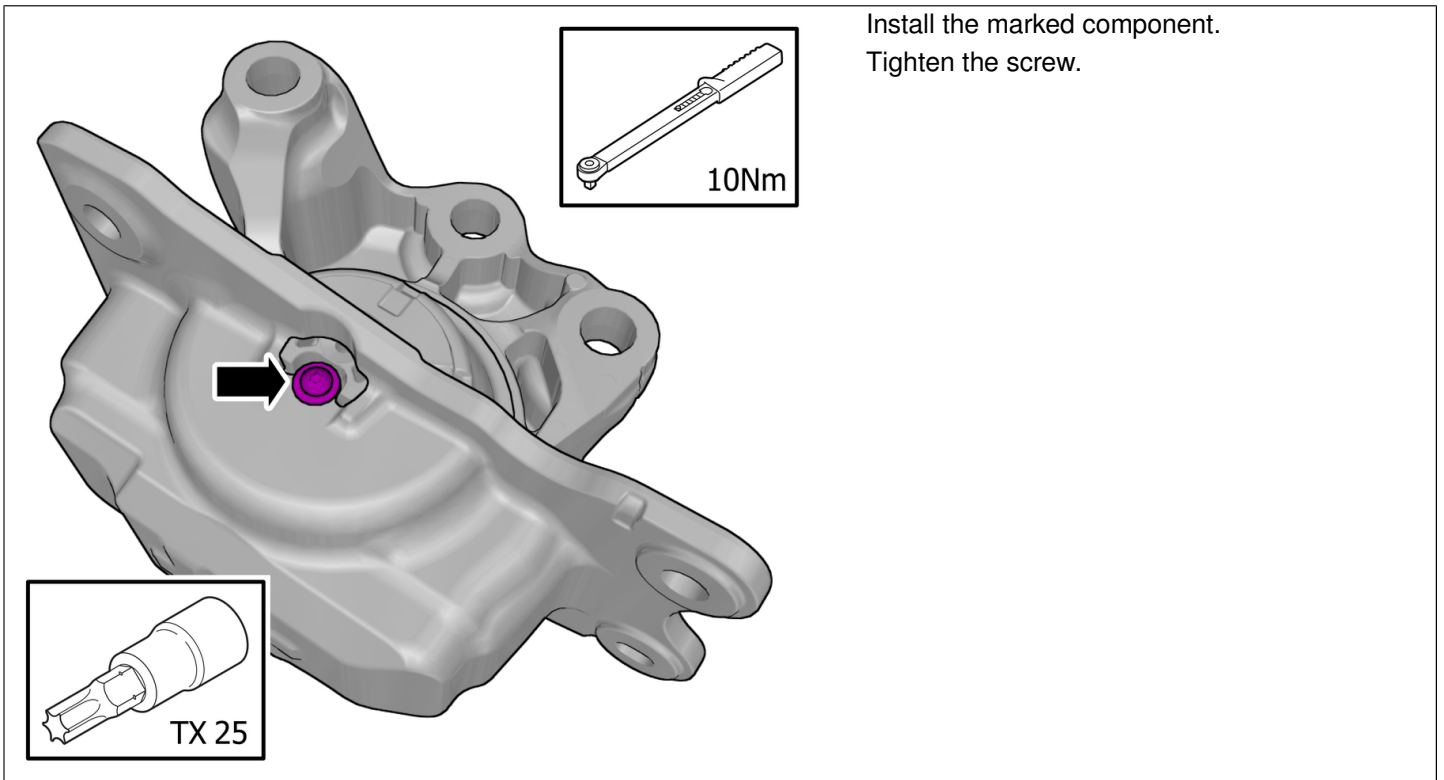
Remove left-hand engine support insulator , refer to:

- Removal, replacement and installation
- 2 - Engine with mountings and equipment
- 21 - Engine
- 218 - engine mounting

To install, reverse the removal procedure.
