**NUMBER:** 31-002-20

**GROUP:** 31 - Collision Bulletins

Aluminum Body Panel Corrosion Repair

This bulletin involves inspecting and if necessary removing corrosion and refinishing the suspect aluminum panels on the vehicle, hood, door, fenders, hinges, swing gates or liftgate panels.

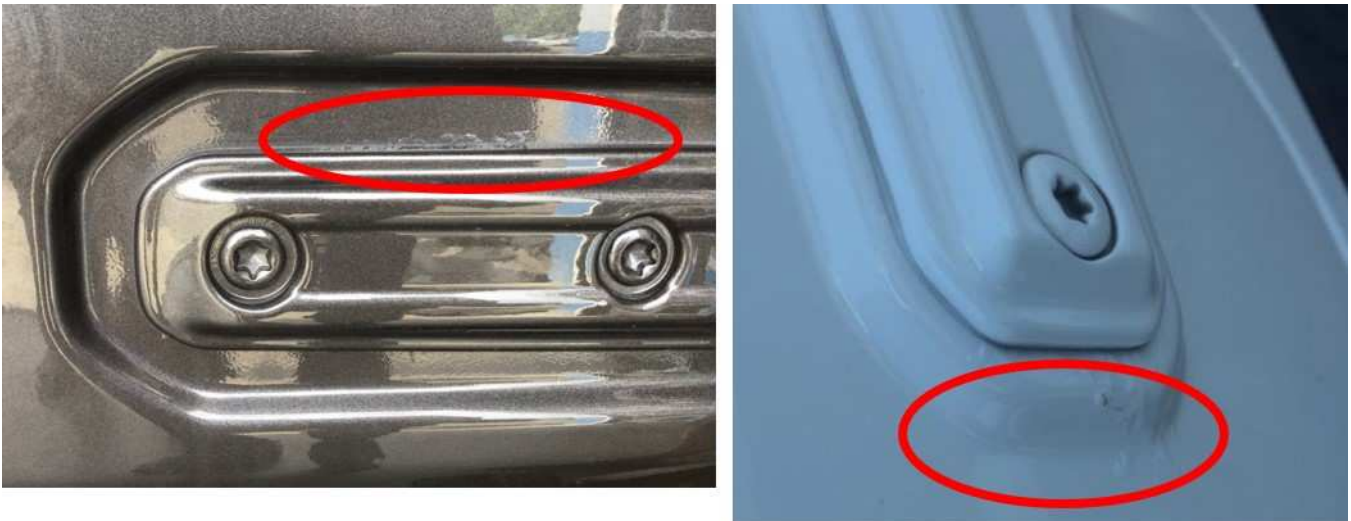
**Fig. 1**  
**Examples of Bubbling**

Aluminum corrosion or bubbling on the doors and/or hinges (Fig. 1) .

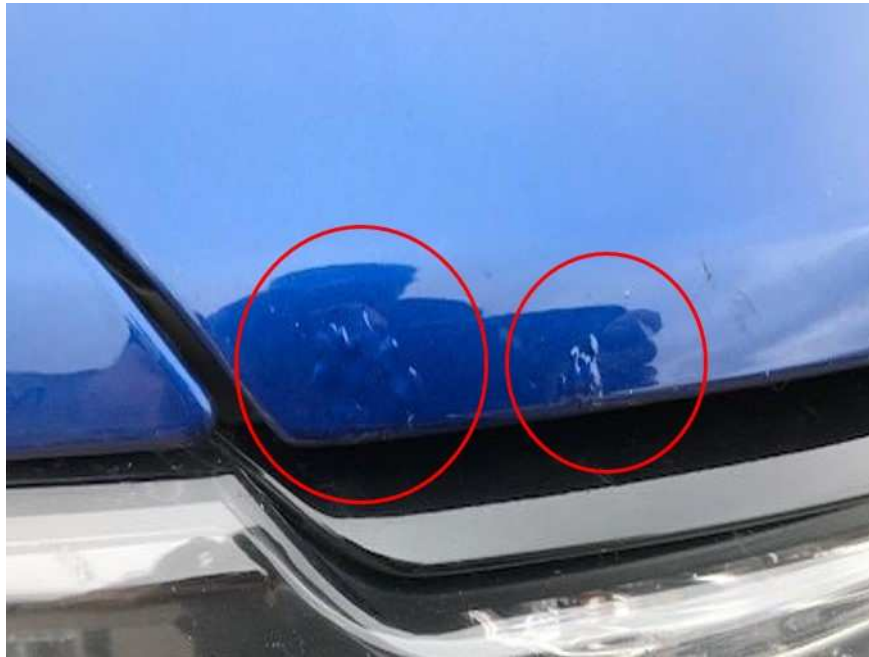
**Fig. 2**  
**Examples of Corrosion Along Leading Edges**

Aluminum corrosion along the leading edge of hood or other exterior surface areas of the doors, fenders or liftgates (Fig. 2) .

Is corrosion evident on the aluminum panel surface (Fig. 2) ?

- YES>>> Must receive authorization from vehicle digital imaging and/or Regional Office. Once approval is received from digital imaging or Regional Office, Proceed to [Step 1](#) of the diagnosis procedure.
  - NO>>> Submit the vehicle digital image for further analysis.
1. Remove blistered paint from the panel surface with 80 grit grinding disc.
  2. After digital imaging or Regional Office approval and removing the initial blistered paint from the panel surface with 80 grit grinding disc, is severe pitting exhibited that cannot be removed with sandpaper, 3M Clean and Strip Disc or equivalent (Fig. 3) ?
