**FORD:**

2006-2015 F-650, F-750

This article supersedes TSB **15-0164** to update the Service Labor Time Standards.

Some 2006-2015 F-Super Duty 650/750 vehicles equipped with exterior tubular stainless steel west coast style mirrors may have a loose mounting bracket due to poor rivet retention.

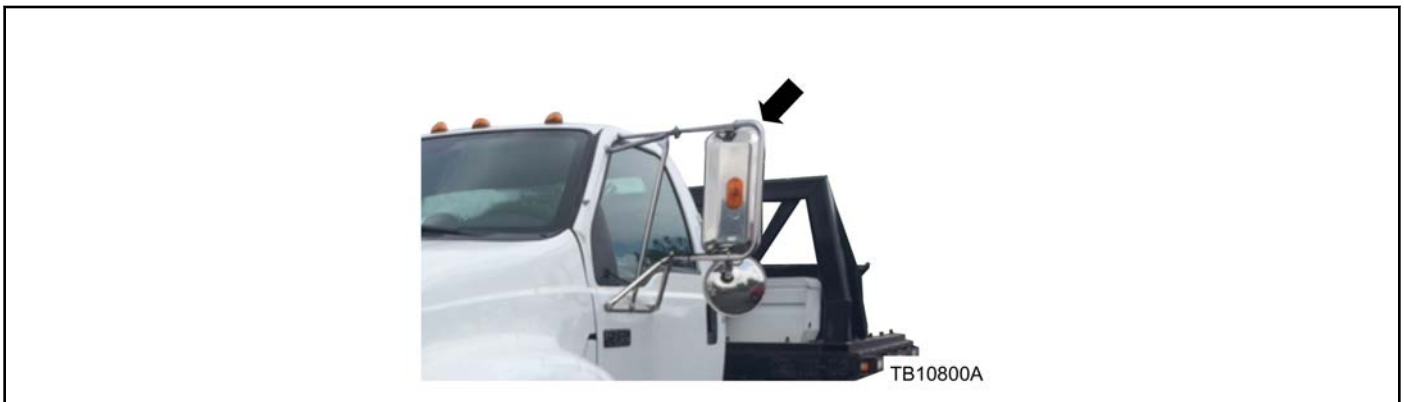
Figure 1 - Article 16-0061

1. Is the vehicle equipped with exterior tubular stainless steel west coast style mirrors? (Figure 1)

- a. Yes - proceed to Step 2.
  - b. No - this article does not apply.
2. Is there a wire harness routed from the door sail panel to the exterior tubular stainless steel west coast style mirror head? (Figure 2)

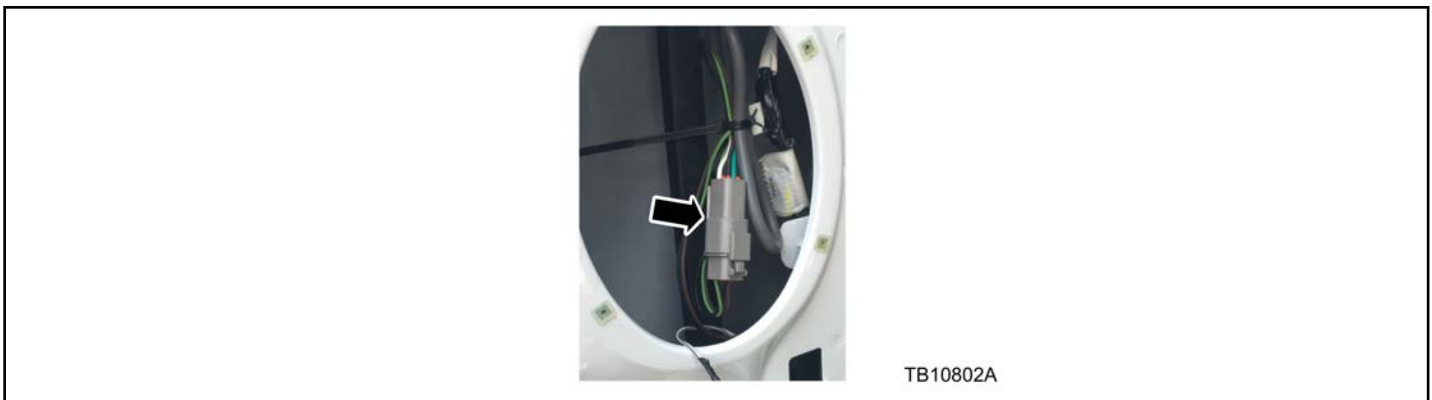
Figure 3 - Article 16-0061

6. Locate the exterior tubular stainless steel west coast style mirror wiring from the door sail area and follow the harness down to the mirror 6-way electrical connector, accessing it via the speaker opening in the door sheet metal. (Figure 3)

7. Is the color of the exterior tubular stainless steel west coast style mirror electrical connector shell black? (Figure 3)
  - a. Yes - cut the yellow/white/green wires 100 mm (4") from the back of the 6-way mirror connector.
  - b. No - cut the green/white/black wires 100 mm (4") from the back of the 6-way mirror connector.
8. Remove the four (4) rubber plugs to access the sail panel retainers.
9. Remove and discard the four (4) exterior sail panel attachment nuts. (Figure 4)
