Bulletin Type.....: Safety Recall

Bulletin No.....: TS-S112

Bulletin Name.....: Steel Rims Offset Improvement

Vehicle Model.....: TS45

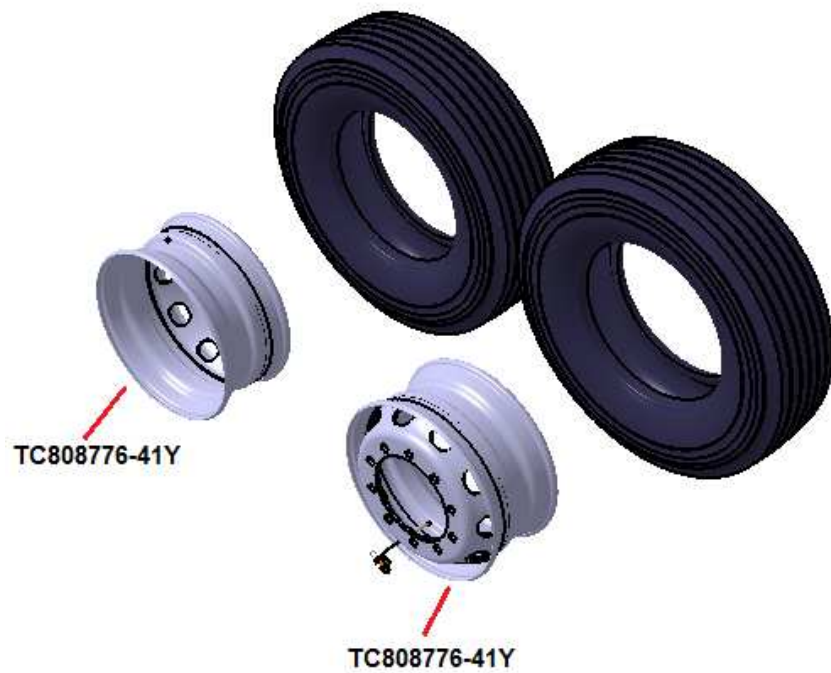
Figure-4

* Remove the existing rims (TC808776-41Y) from the wheels shown in Figure-4.
