STAR ONLINE PUBLICATION

Case Number: S2009000004

Symptom/Vehicle Issue: Oil Leak Between The Engine Oil Cooler/Filter Housing, And The Engine Block.

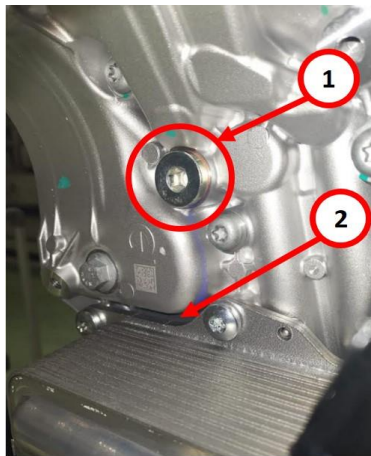
Figure 1.

When the engines are manufactured, the first oil fill is done through an access hole in the oil filter housing assembly. During this first fill, it is possible for residual oil to be spilled, and collect in the gap between the oil cooler and the oil cooler bracket. See (Figure 1).

1. Oil Fill Port
2. Oil Collection area
