GROUP ELE	MODEL 2021MY Forte (BDm)
NUMBER 225	DATE December 2020

TECHNICAL SERVICE BULLETIN

SUBJECT: SERVICE ACTION: LED HEADLAMP REPLACEMENT (SA455)

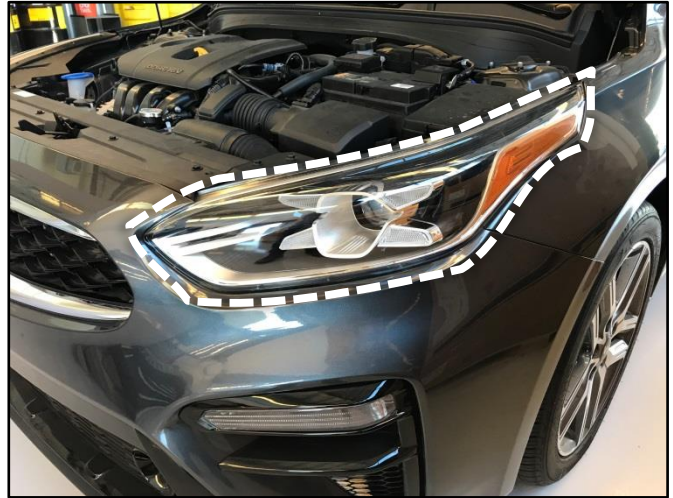
1. Replace the left and/or right headlamp(s) by referring to the “Body Electrical System → Lighting System → Headlamps → Repair procedures” chapter in the applicable Shop Manual on KGIS.

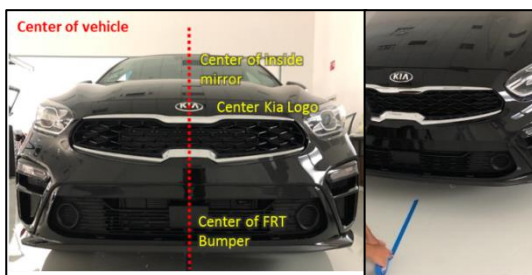
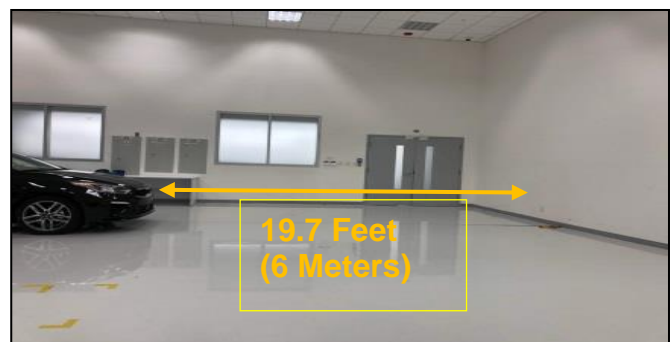
2. Vehicle distance from the wall chart

- Verify proper operation and vertical aiming of headlamps and perform vertical adjustments using the banner, if necessary.

Note: Headlamp beam cut-off line should be below the red dotted line.

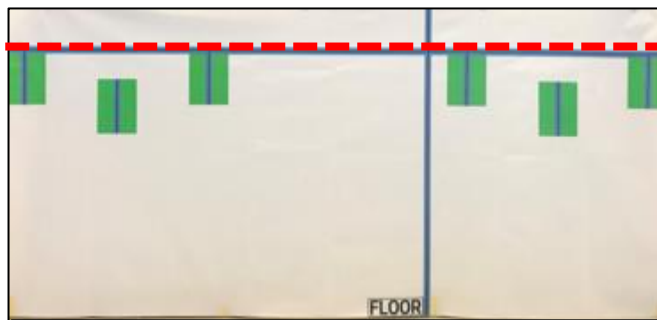
Center line of the vehicle should align with the BLUE vertical line.

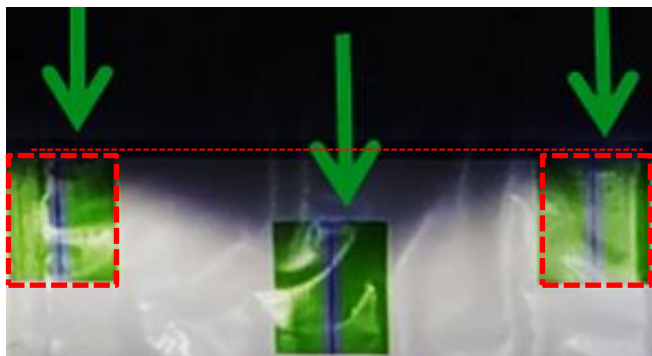
- All lamp beams are below the red dotted line
- LED lamp should light the two outer squares, center square should have some shading.

- Aim the headlamps so the brightest portion falls on the vertical lines as shown in Step 4.

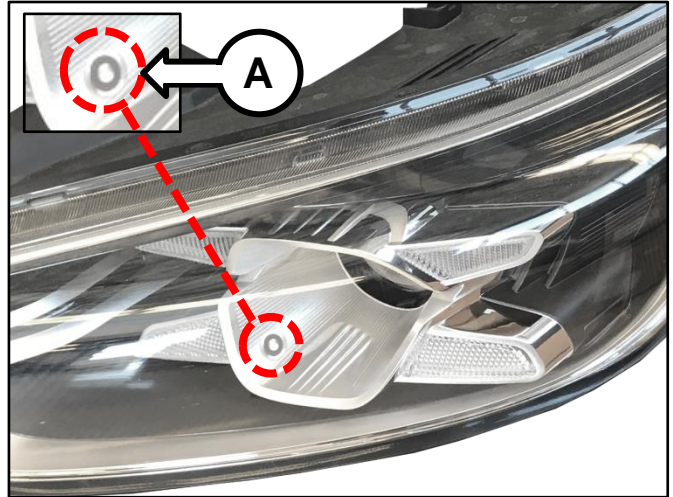
1. Carefully drill a ¼ inch hole (A) through the lens of the old headlamp assembly.

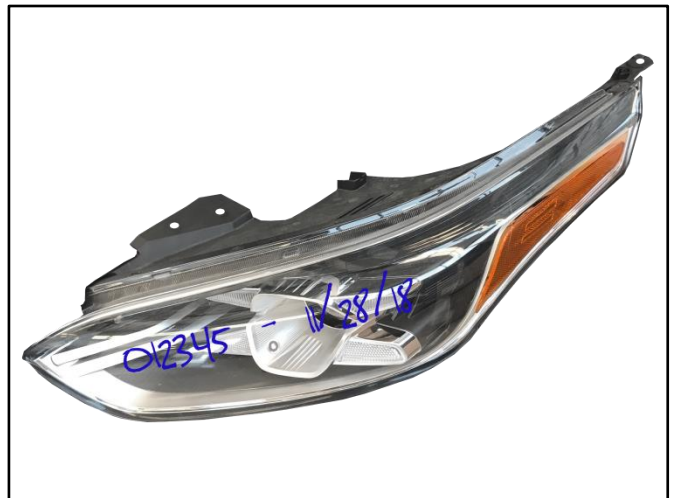
2. With a permanent marker, clearly write the last six numbers of the VIN and RO open-date on the lens.

Example shown -

- Last six of VIN: 012345
- RO Open Date: 11/28/18

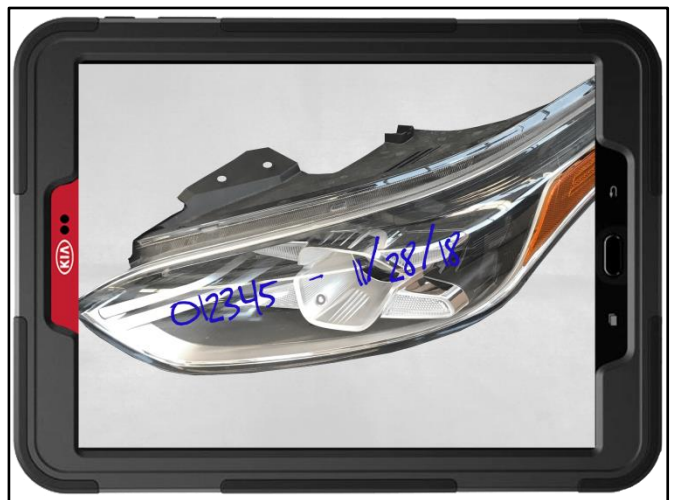
3. Take and submit one (1) KVID* photo of each drilled and marked headlamp to attach to Warranty claim.
 - Drilled hole, last six of VIN, and RO open date **MUST** be clearly visible in photo(s).
 - If replacing one headlamp **one** photo is required for warranty claim submission.
 - If replacing both headlamps **two** individual photos are required for warranty claim submission.

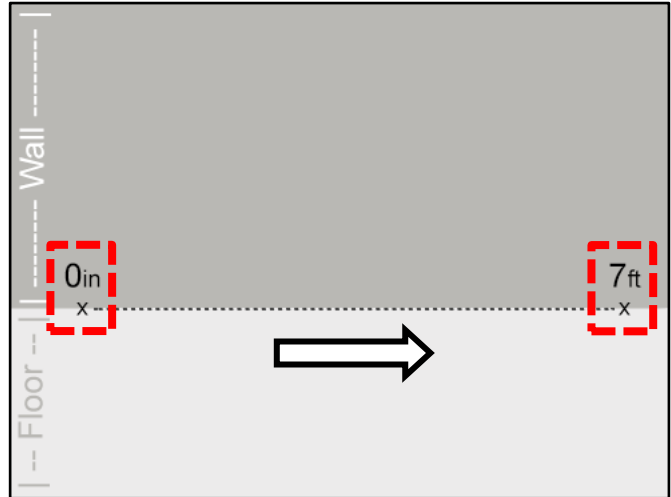
At a blank wall* with at least 7ft. width of space, measure and mark at two (2) locations: 0in. and 7ft. (84in.).

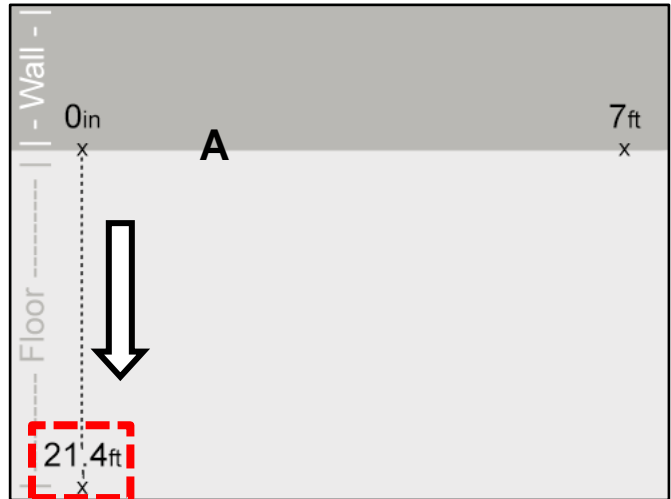
From the 0in mark (A) at the wall, measure and mark a spot 21.4ft. (257.25in.) away from and perpendicular to the wall.

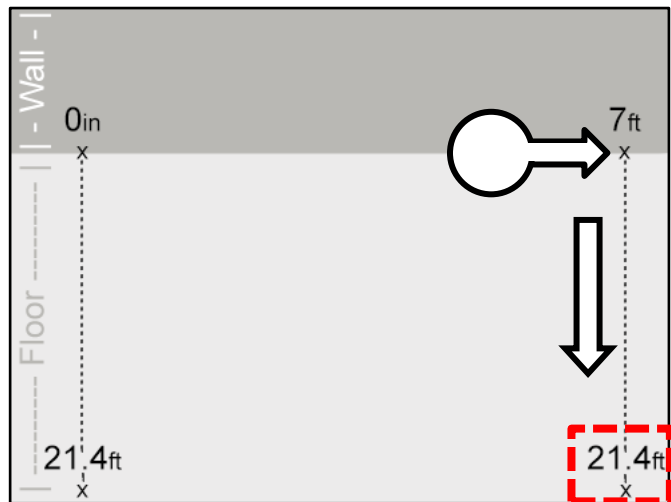
Repeat step 2 but from the 7ft. mark (B) at the wall.

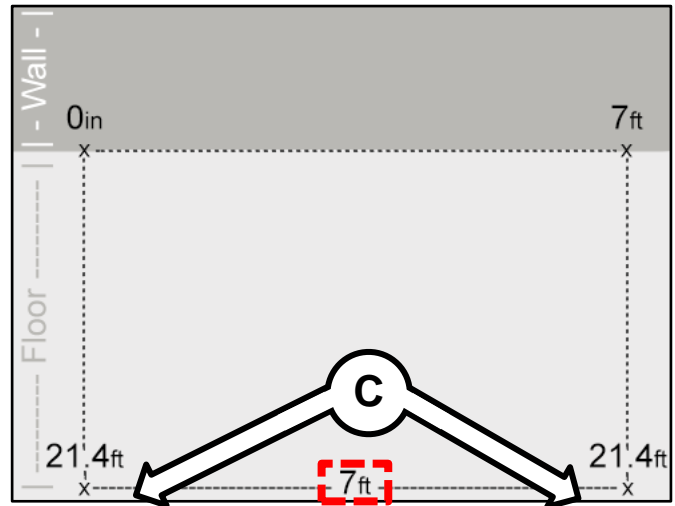
Measure and ensure the distance is 7ft. between both new marks (C).
