JTBO0544NAS2

TECHNICAL BULLETIN

Front/Rear Door Primary Seal Lower Edge Loose/Adrift

MODEL:	MODEL YEAR:	VIN:	ASSEMBLY PLANT:
XF (X260)	2016-2020	Y00001-Y85201	Castle Bromwich

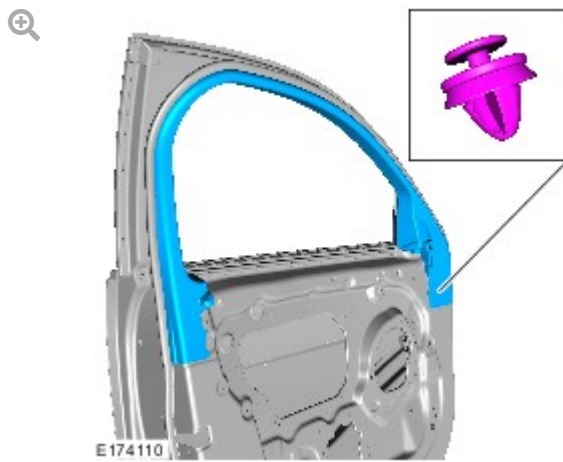
3.

NOTE:**Front left door shown; others similar.**

Remove the door frame interior finisher trim.

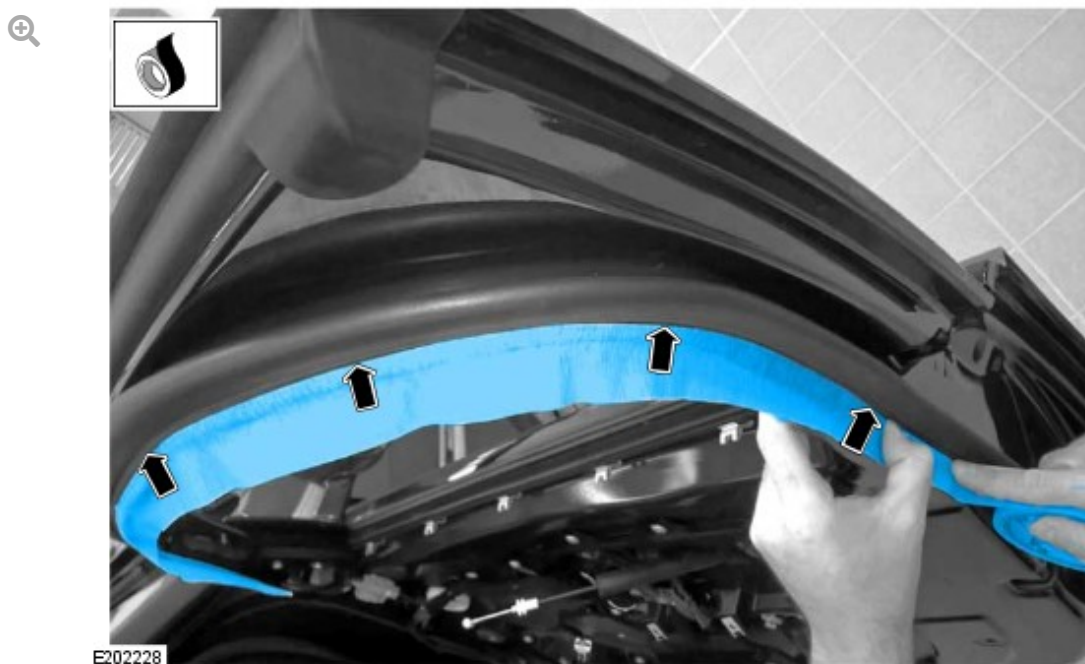
4.

- The taped line must precisely follow the inner edge of the door primary seal.
- Front right door shown; others similar.

Using a suitable tape, mark the position of the inside edge of the door primary seal following its profile around the whole door.

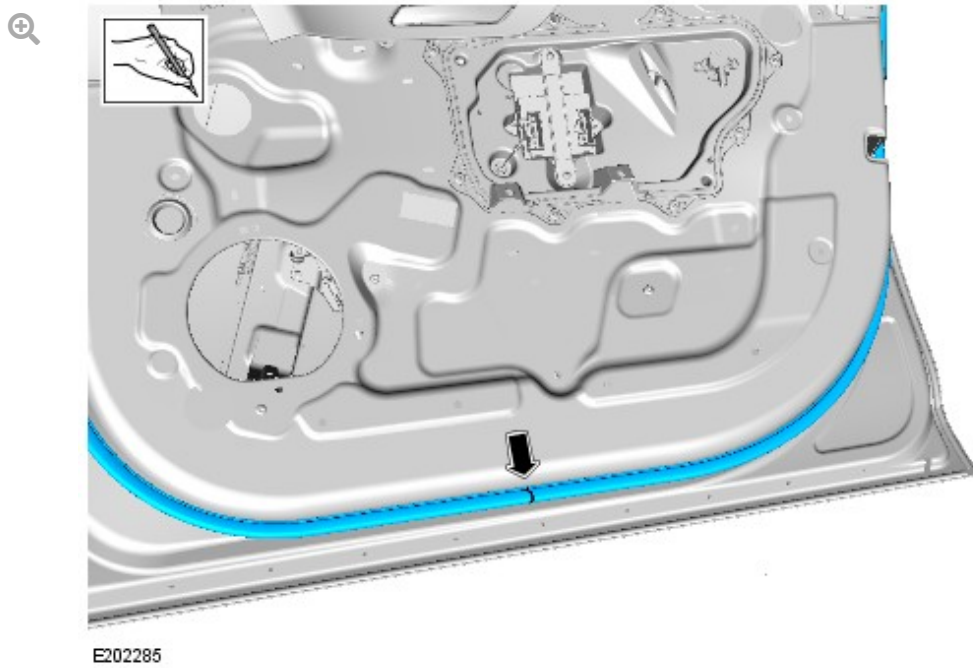
5.

NOTE:**Front right door shown; others similar.**

On the lower edge of the door, mark the center position where the two ends of the door primary seal join on the tape already applied.

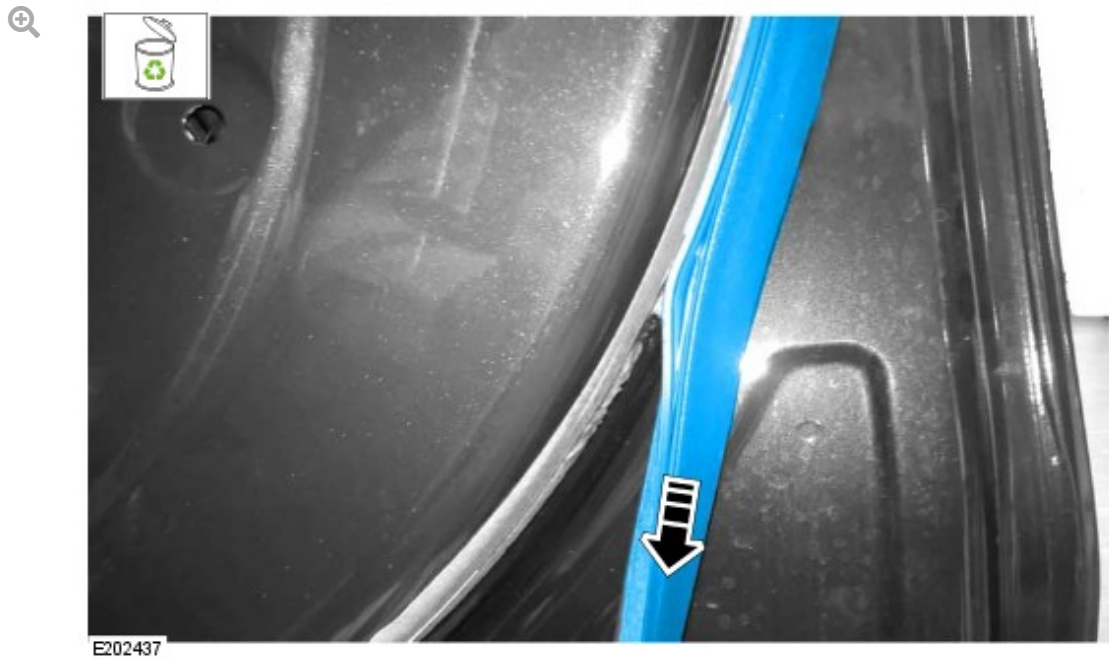
6.

- Take note of the profile orientation of the door primary seal before removal.
- Remove the door seal at 30 degrees to the plane in which it is fitted while keeping it under tension to reduce the amount of adhesive left behind.
- Front right door shown; others similar.

Remove and discard the door primary seal.

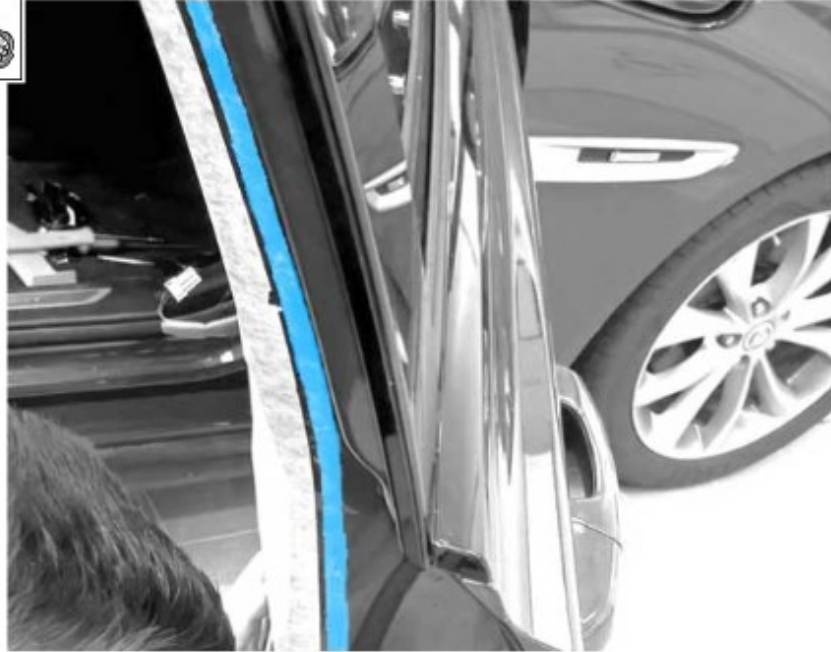
E202283

- Take care not to move or damage the taped line around the door.
- Front right door shown; others similar.

Clean and remove any remaining door seal adhesive from the edge of the door.

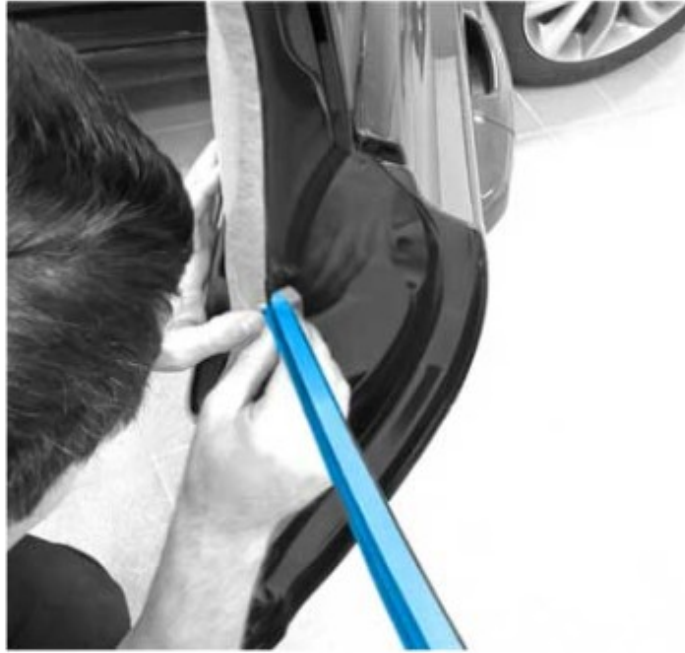
E202295

- **Make sure the replacement door primary seal is installed in the same profile orientation as the original.**
- **Make sure to exactly follow the marked line when installing the new door primary seal.**
- **Front right door shown; others similar.**

Starting with one end of the new door primary seal, start installing the seal against the outside of the taped line at the point previously marked on the lower edge of the door.

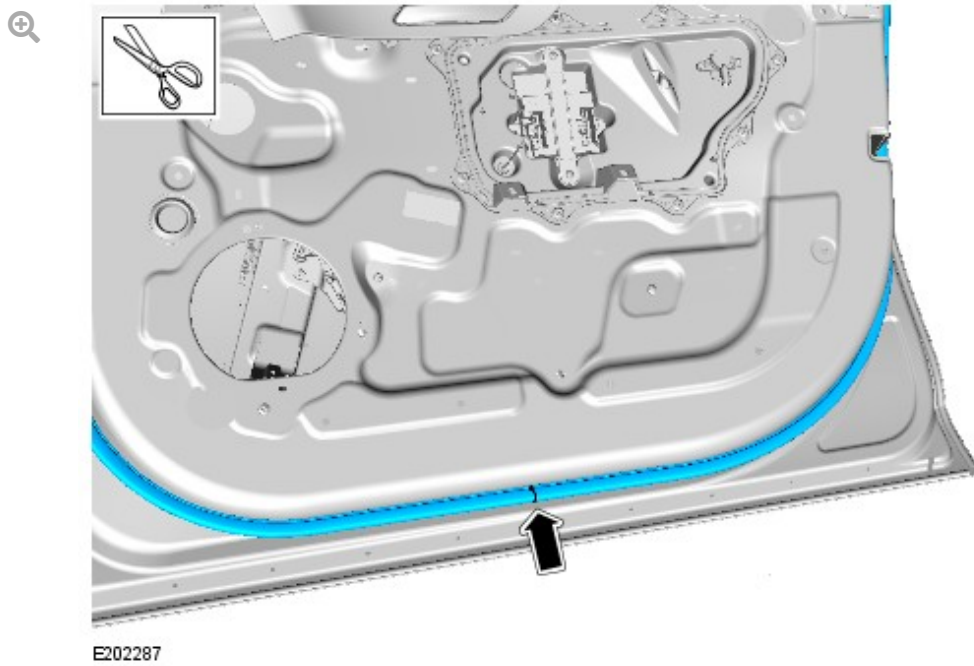
9.

NOTE:**Front right door shown; others similar.**

Using a suitable tool, trim the excess length off the newly installed door primary seal so that it meets the other end of the seal on the lower edge of the door.

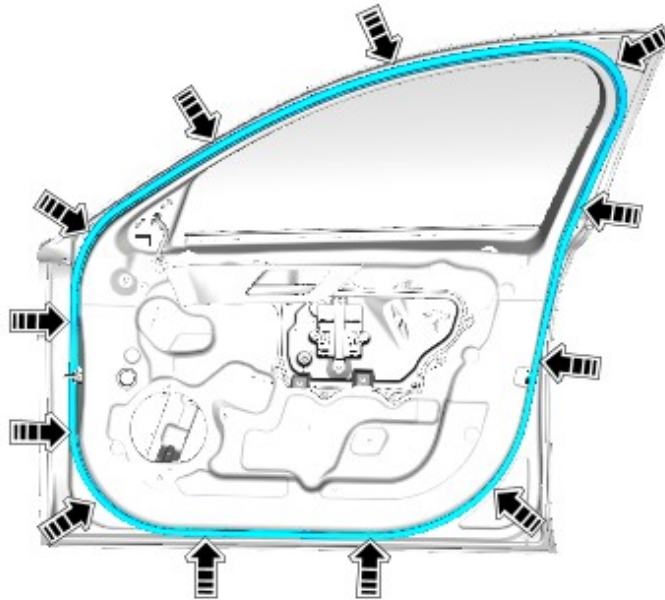
E202438

NOTE:**Front right door shown; others similar.**

After installing the replacement door primary seal, apply pressure to the seal around the full circumference using a roller or similar to make sure the adhesive bonds to the door.

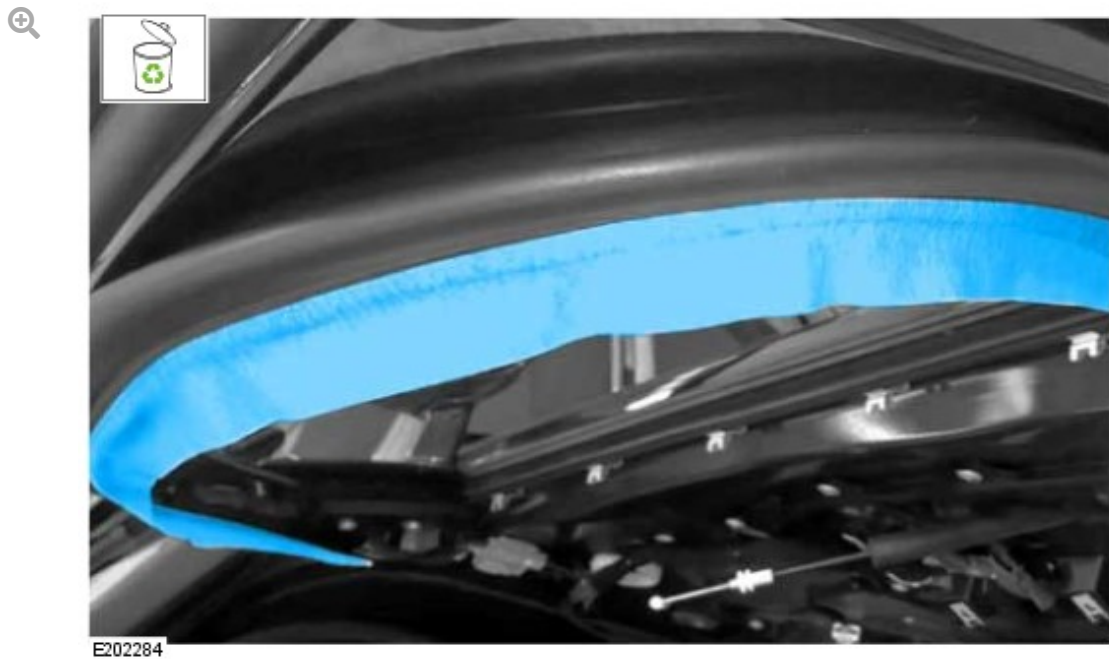
11.

NOTE:**Front right door shown; others similar.**

Remove the tape around the door seal.

- ■ Clean and remove any remaining adhesive.

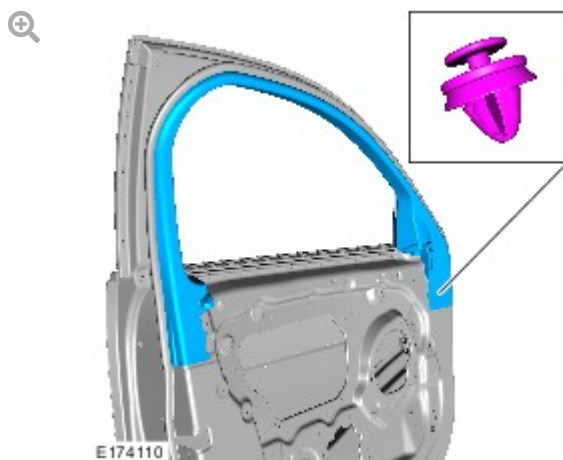
12.

NOTE:**Front left door shown; others similar.**

Install the door frame interior finisher trim.
