JTBO0685NAS4

TECHNICAL BULLETIN

Vibration Felt In Passenger Compartment When Starting and/or Idling Engine

MODEL:	MODEL YEAR:	VIN:	ASSEMBLY PLANT:	APPLICABILITY:
F-PACE (X761)	2018-2020	093634-654838	Solihull	INGENIUM I4 2.0L Diesel/INGENIUM I4 2.0L Petrol

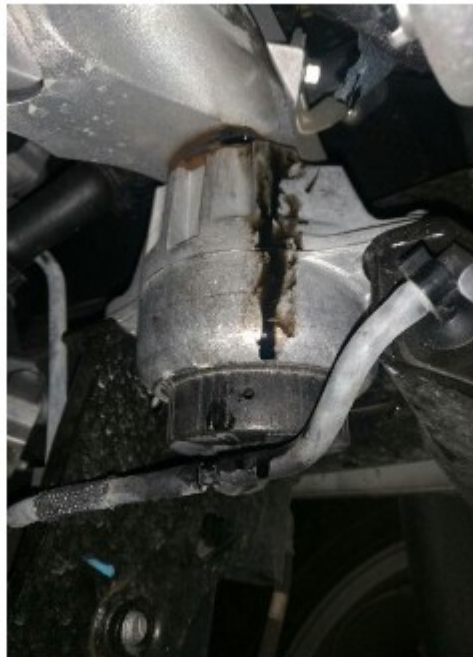
E246391

For the release of the new active engine mounts, the parts team will require a photograph of the damaged/leaking active engine mount(s). Make sure a clear photograph is taken, with the active engine mount still installed to the vehicle, as shown in the illustration.

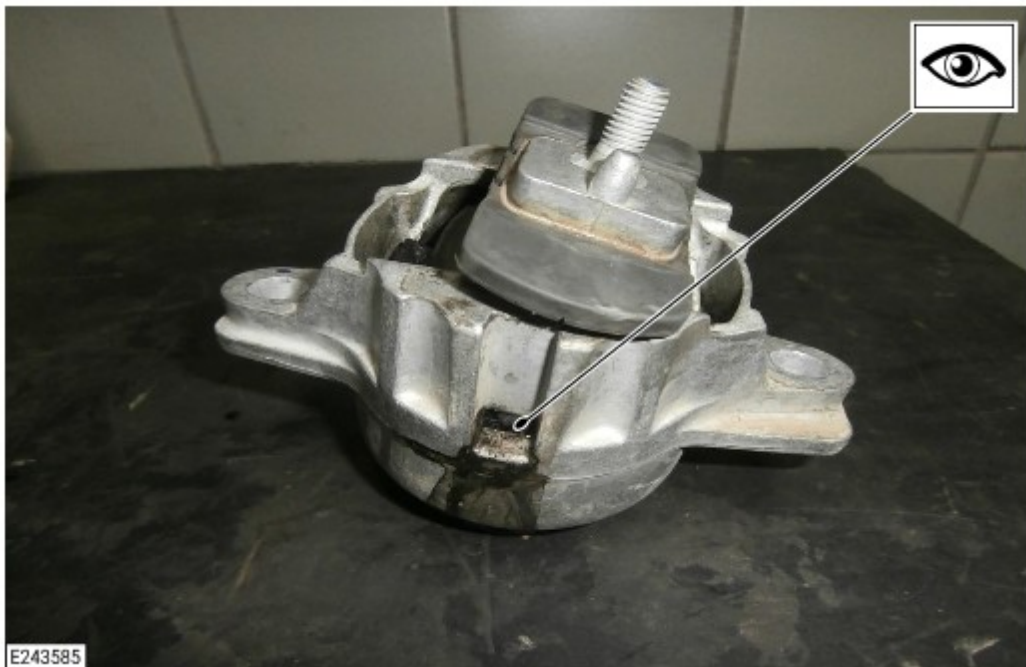
E243585

Example of an excessively worn and/or leaking active engine mount.

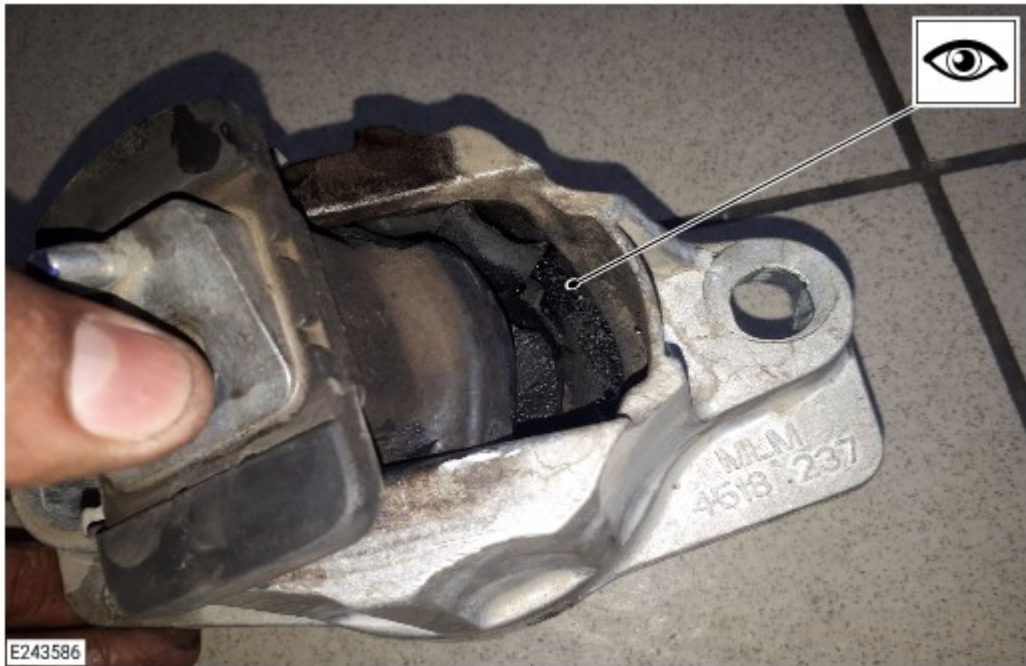
3.

Example of an excessively worn and/or leaking active engine mount.
