**** TECHNICAL INFORMATION NOTICE ****

DATE: December 22, 2020
TO: Mitsubishi Motors US & Puerto Rico Dealer Service and Parts Managers
RE: Voltage Measurement on Low Beam Halogen Headlight Bulbs and 12V Battery for **2019-2020 Outlander (RE) and Outlander PHEV (R-EP) built after February 8, 2019.**
TIN NO. TIN-20-54-001REV2

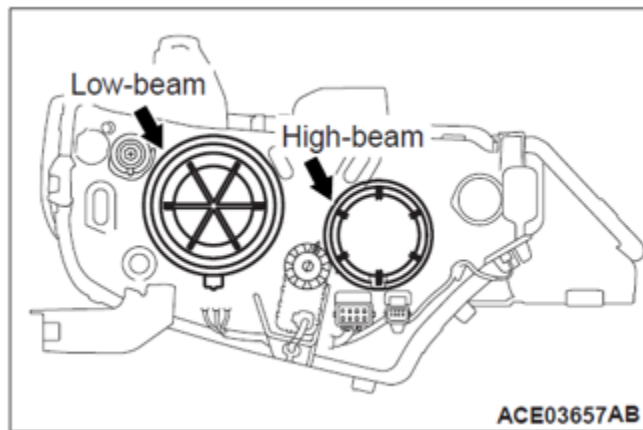
Photo 2

2. Measure and record the voltage at the backside of the low beam halogen headlight bulb connectors (both sides).
 - Turn the low beam headlight connector cover counterclockwise to remove (see Photo 2).
 - Turn the low beam headlight connector counterclockwise to remove from the headlight assembly.
 - Replace any low beam headlight bulbs that are inoperative.
 - Place the voltmeter leads at the respective slots at the backside of the low beam headlight connector (see Photo 3 and Photo 4).
 - Turn ON the headlights to low beam.
 - Measure and record the voltage on both low beam headlight connectors.

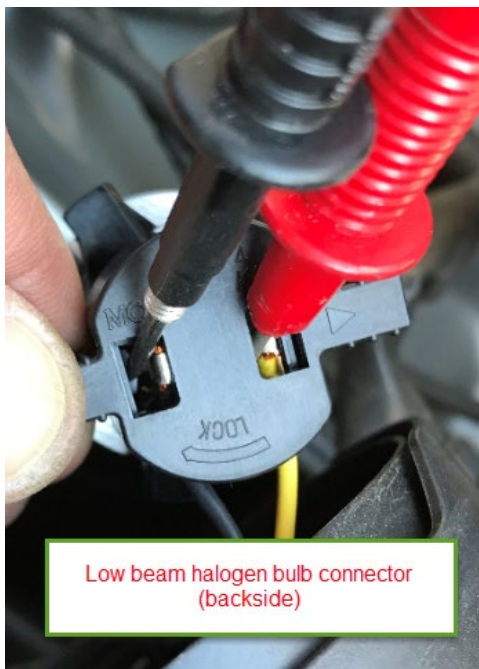
Photo 3

Low beam halogen bulb connector
(backside)
