SERVICE BULLETIN

Bulletin No.....: TS-U111

Bulletin Name.....: Filling Throat Of Fuel Tank

Vehicle Model.....: TS 45

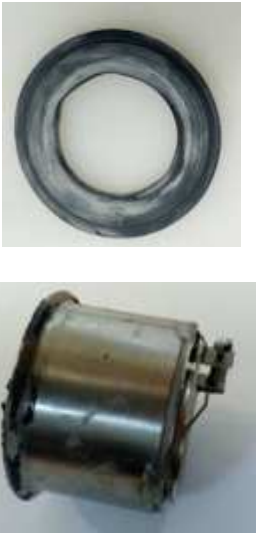
No	Part Number	Definition	Figure	Quantity	Unit
1	RP160120	CAP,FUEL TANK FILLER KIT AFTERSALES

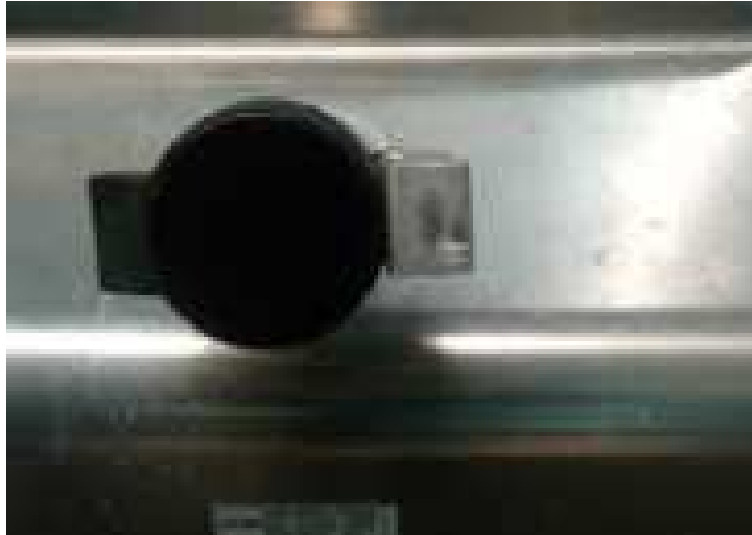
Figure-1

Step 1. Open the fuel tank cap to reach filling throat .(see. **Figure-1**)

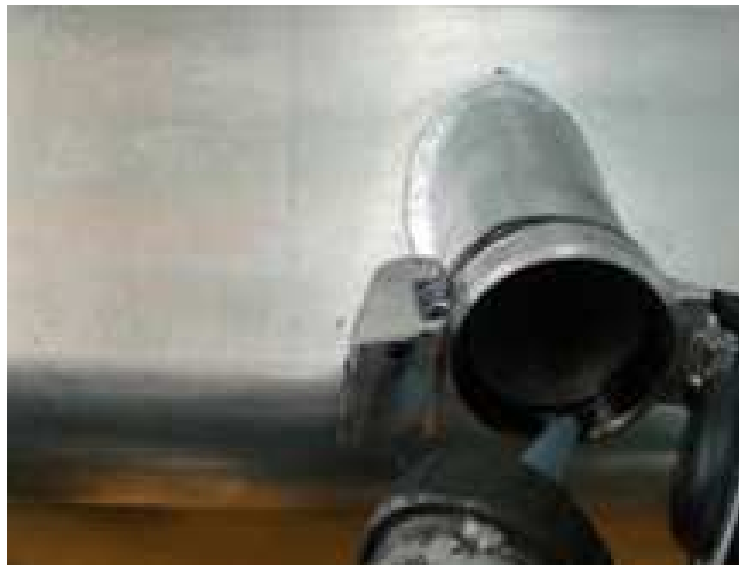
Figure-2

Step 2. Clean fuel residue and Implement sealer on the gap.(see. **Figure-2**)

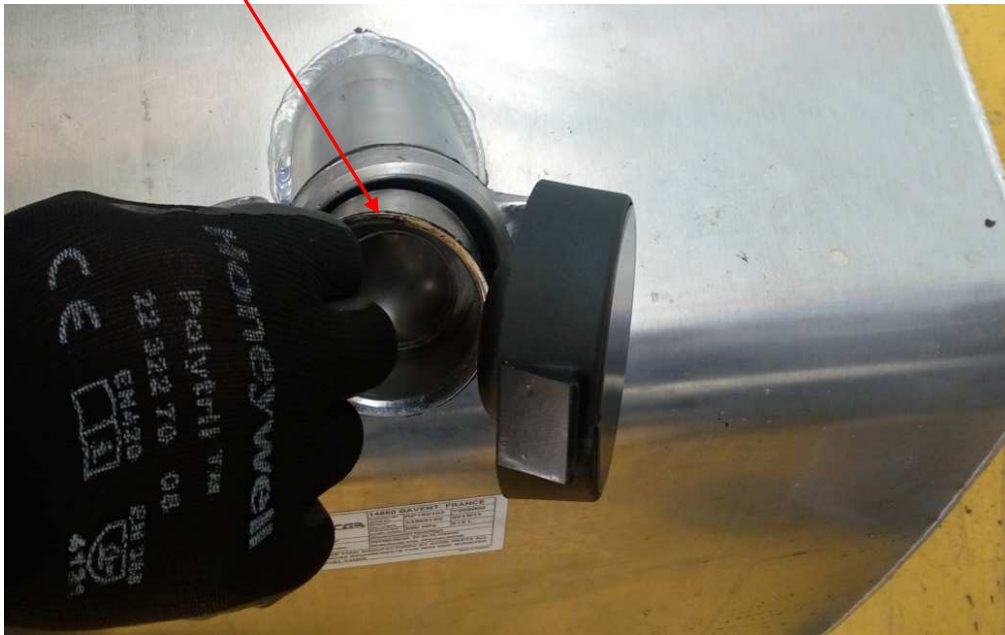
Figure-3

Step 3.Mount the flap inside the filling throat as shown below picture (see. **Figure-3**)

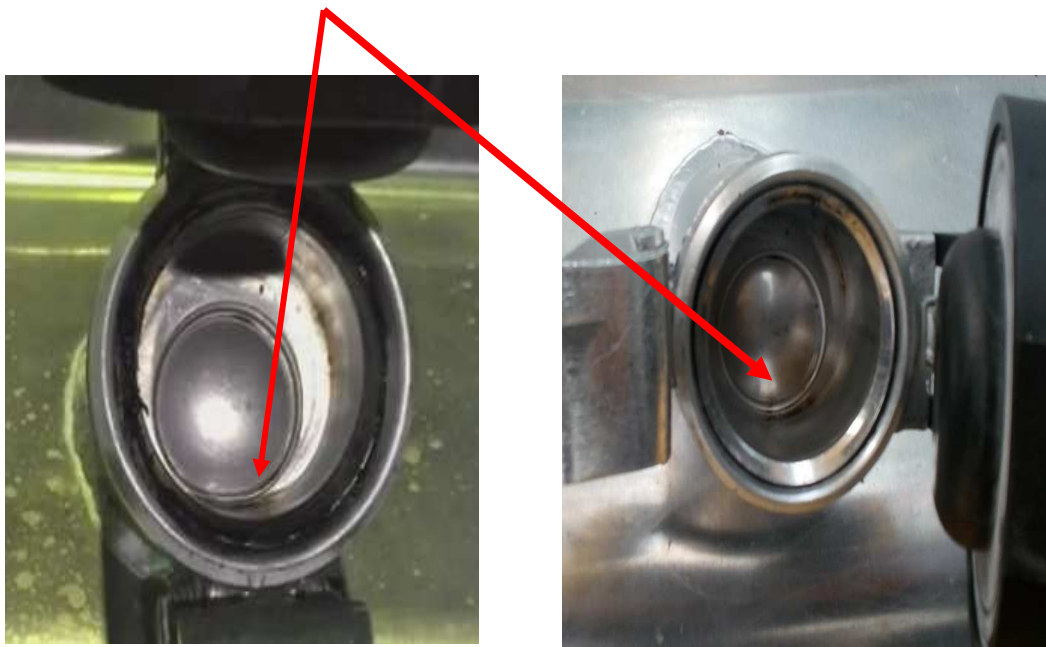
Figure-4

Step 4. . In both positions, flap must be adjusted so as to see the bottom of the tank as shown in figure 4.(see. **Figure-4**)

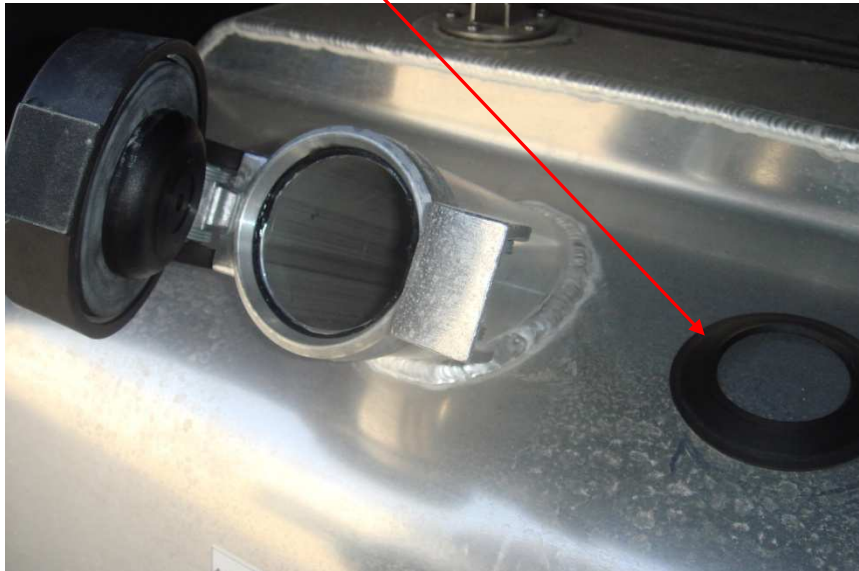
Figure-5

Step 5. Dismount the old gasket. (see. Figure-5)

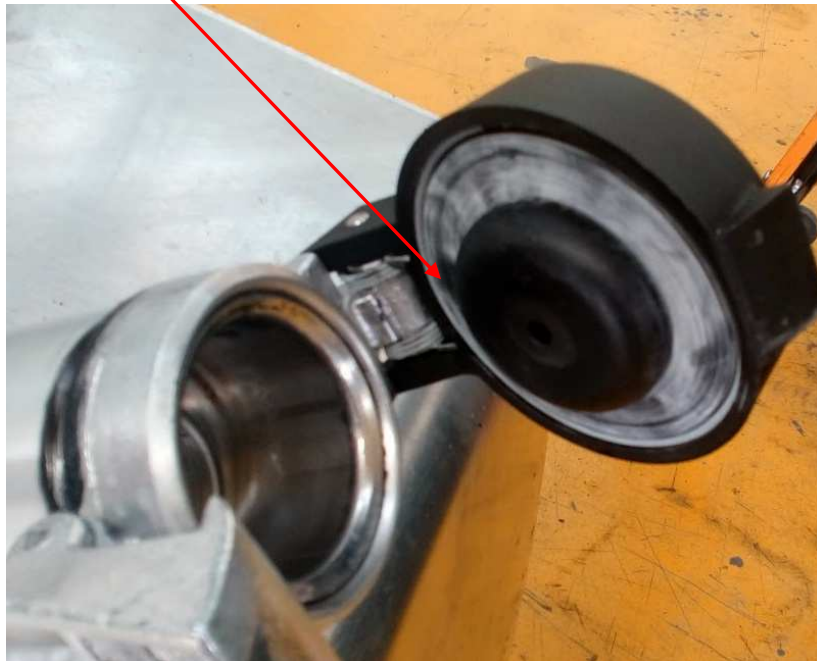
Step 6. Mount new gasket which located in RP160120 numbered kit as shown in Figure-6 (see. Figure-6)
