SUPER SLIDE OUT OPERATION

Bulletin Type:	TSB	Publication Date:	January 28 , 2021
Bulletin #(s):	20-037	Make(s):	ENTEGRA
Job Code(s):	9803561	Model(s):	REATTA XL (MC)
Flat Rate(s):	Inspection only no repair .25 Hour Inspect and install .75 Hour	Model Year(s):	2021

Incident:	POWER SOURCE TO OPERATE THE SLIDE OUT IS NOT SUFFICIENT
Affected Units:	M1MC8051 – M1MC8064
Parts Kit:	Parts Kit #: 20-037EN
	Parts Kit Contents: RELAY BLOCK HARNESS BREAKER DECAL (4) FLAT HEAD SCREWS (2) WASHER HEAD SCREWS
Misc. Tools & Supplies:	SCREW GUN, # 2 SQUARE BIT, DE-PINNING TOOL(amp 1804030-1), 3/8" DEEP WELL SOCKET, RATCHET

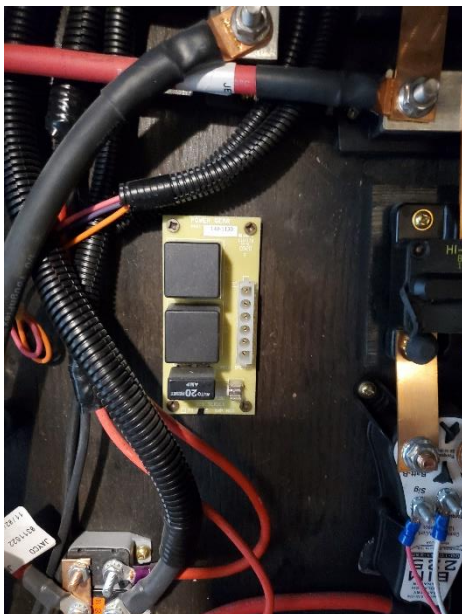
2. Install relay block just above the breakers. As shown in the pictures to the left

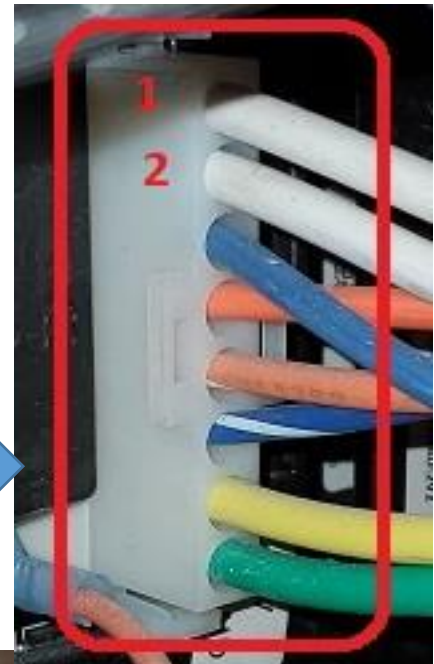
4. De-pin, wire 1 and 2 (gray and gray/black wires) as shown in picture to the right

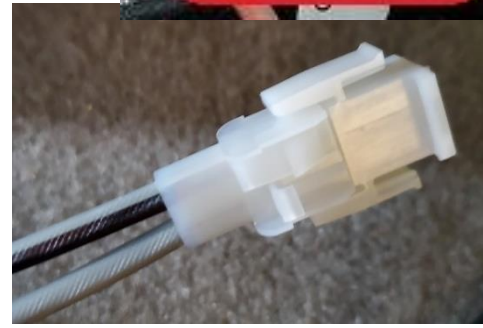
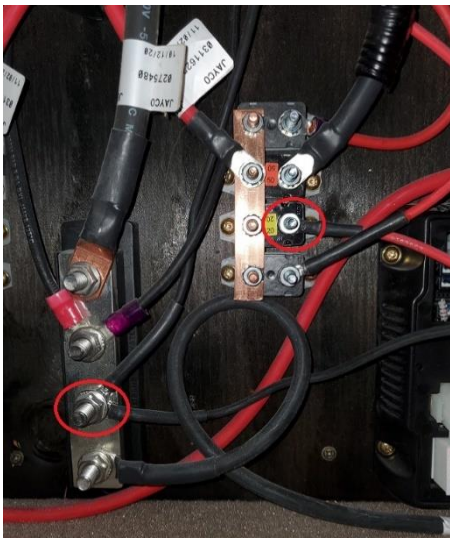
- 5. Insert wires into 2 pin connector of harness provided, matching colors on connector
- 6. Insert orange and blue wire into 8 Pin connector on G-12 in place of the gray wires you just removed
 - a. Orange in position 1
 - b. Blue in position 2

- 7. Connect red wire(ring terminal) to breaker that you installed
- 8. Connect black wire(ring terminal) to ground bar in electrical compartment
- 9. Plug in 8 pin connector to G-12
- 10. Plug 6 pin connector to relay that you installed
- 11. Apply new label beside breakers
- 12. Test operation of slide out.
