# SERVICE BULLETIN

Classification: EM20-007a	Reference: NTB20-043a	Date: January 22, 2021
------------------------------	--------------------------	---------------------------

## 2014-2020 ROGUE; AIR DUCT REPLACEMENT

**APPLIED VEHICLES:** 2014-2020 Rogue (T32)

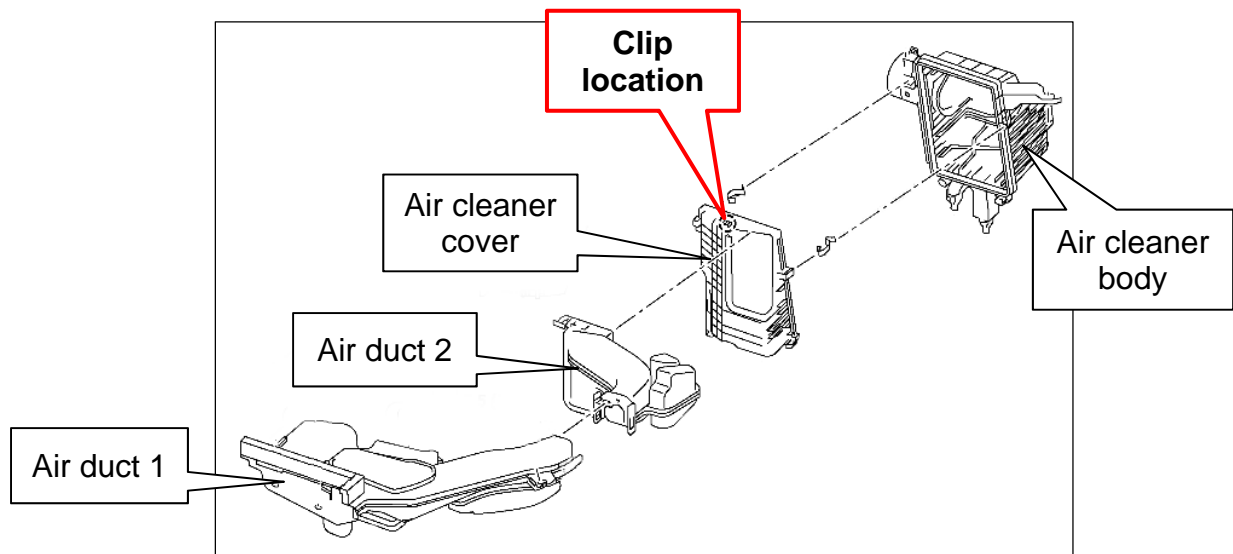
Air duct 1, air duct 2, or the air cleaner cover shown in Figure 1 needs to be replaced.

Inspect for a clip in the location shown in Figure 1 and Figure 2.

- If a clip is present, then the vehicle **IS** equipped with the updated parts; no further action is needed. Individual parts may be replaced as needed.
- If a clip is **NOT** present, then the vehicle is equipped with older parts. See **SERVICE PROCEDURE** on the next page.

1. Inspect the air cleaner body for a clip in the location shown in Figure 1 and Figure 2.
  - If a clip is present, then the vehicle is equipped with the updated parts; no further action is needed. Individual parts may be replaced as needed.
  - If a clip is **NOT** present, then the vehicle is equipped with older parts. All components listed in the **PARTS INFORMATION** section must be replaced.
    - For removal and installation, refer to the Electronic Service Manual (ESM) section: **REPAIR > ENGINE > ENGINE MECHANICAL > REMOVAL AND INSTALLATION > AIR CLEANER AND AIR DUCT.**
2. Install the new clip into the location shown in Figure 2.
