Bulletin Type.....: Safety Recall

Bulletin Name.....: Steel Rims Offset Problem

NHTSA.....: 16V-591

Vehicle Model.....: TS45

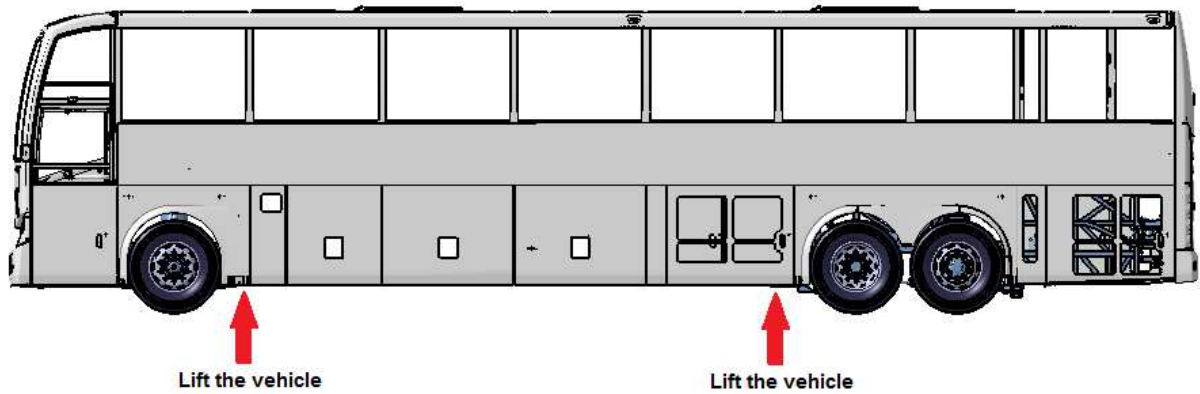
Figure-1

* Lift the vehicle up by using jack, from a jack points shown in Figure-1.

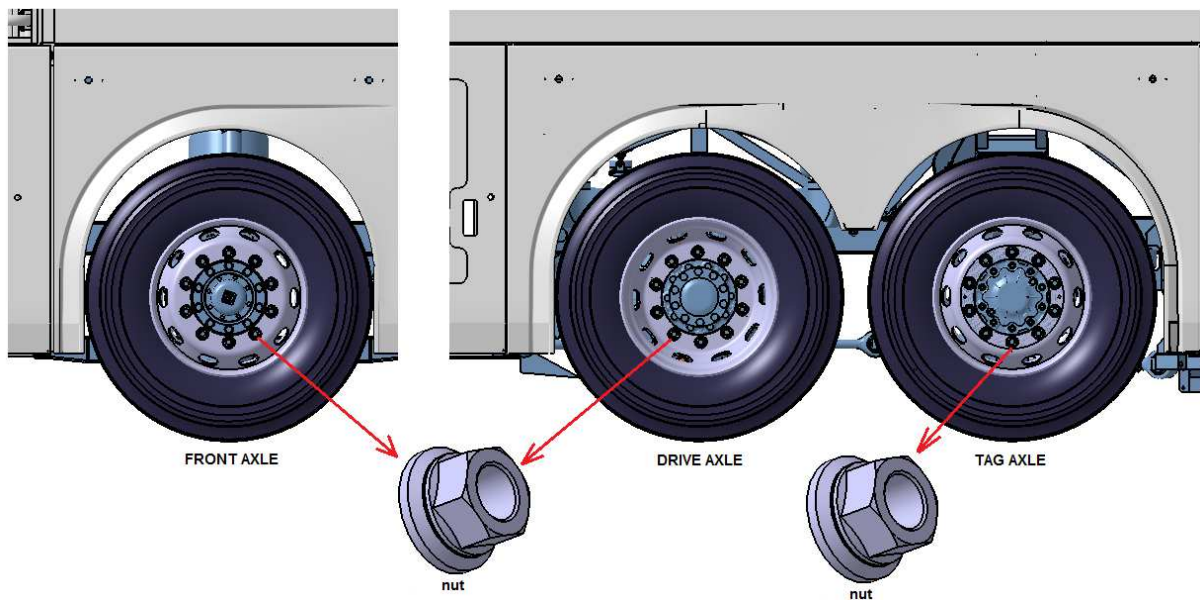
Figure-2

* Remove all the wheel nuts shown in Figure-2.

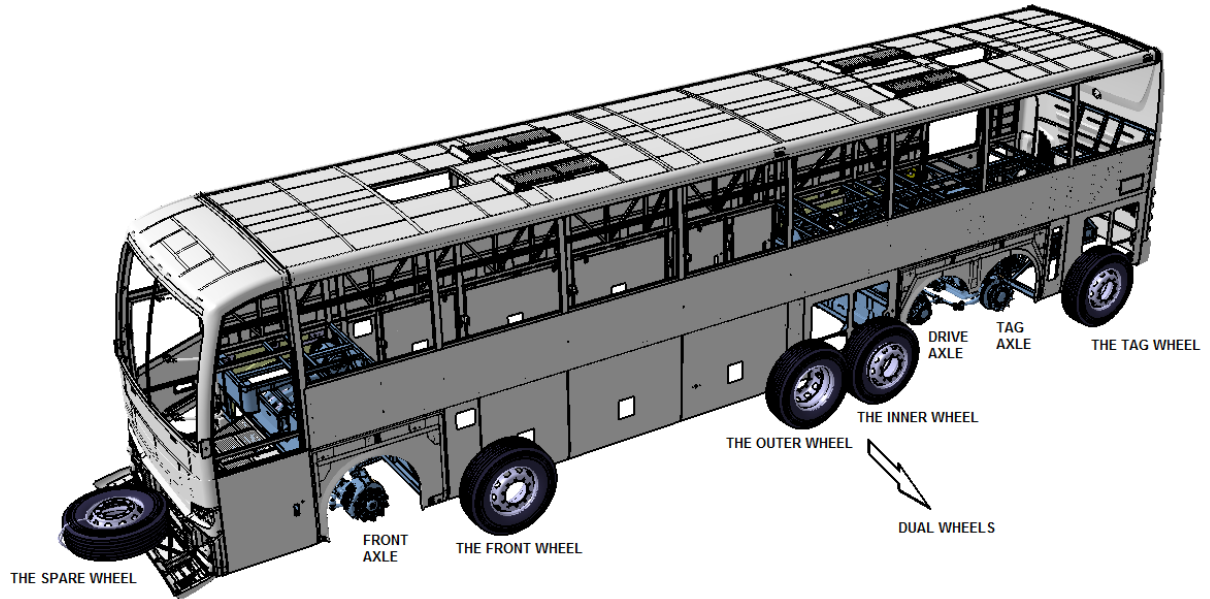
Figure-3

* Remove front, dual and tag wheels from related axles and also pull the spare wheel out shown in Figure-3.

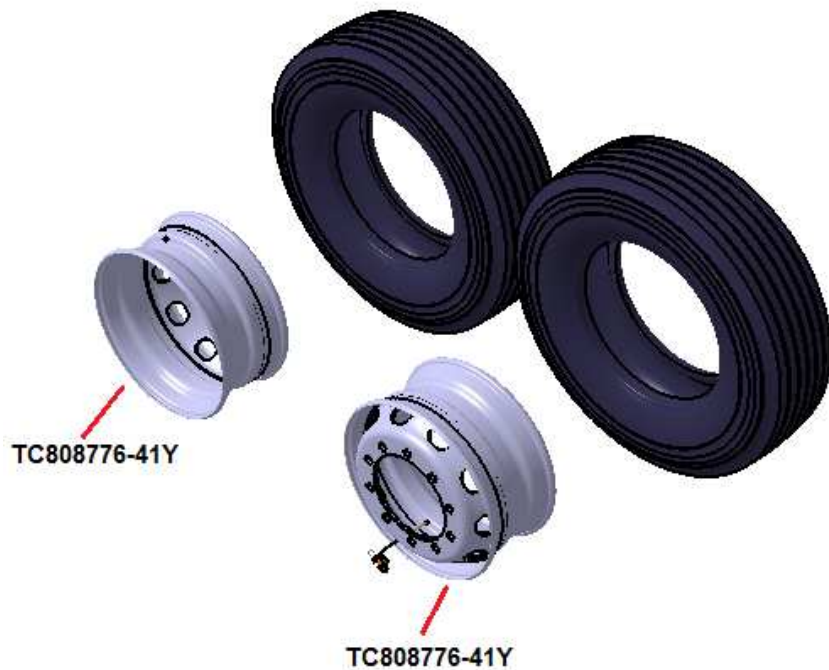
Figure-4

* Remove the existing rims (TC808776-41Y) from dual wheels shown in Figure-4.

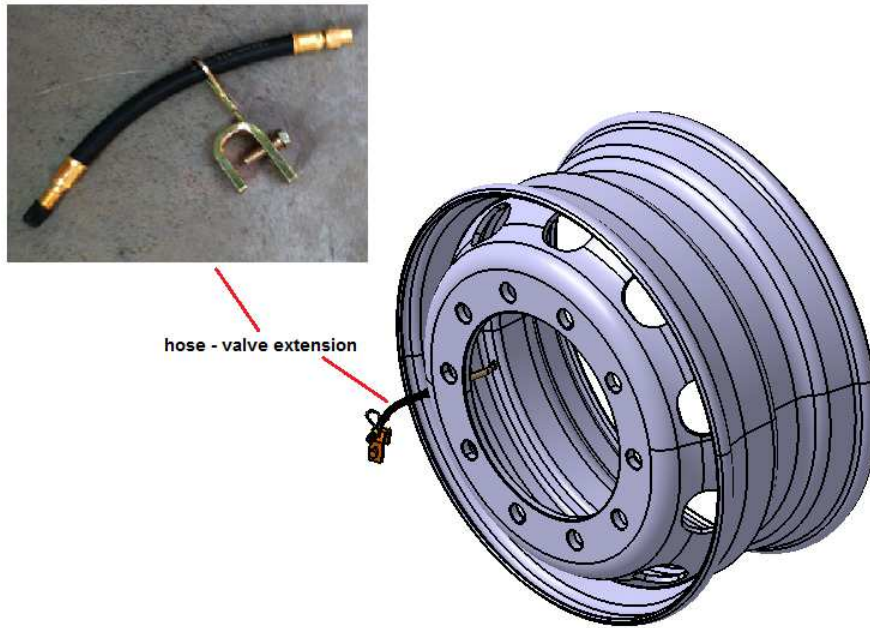
Figure-5

* Remove the hose - valve extension from the inner rim shown in Figure-5.

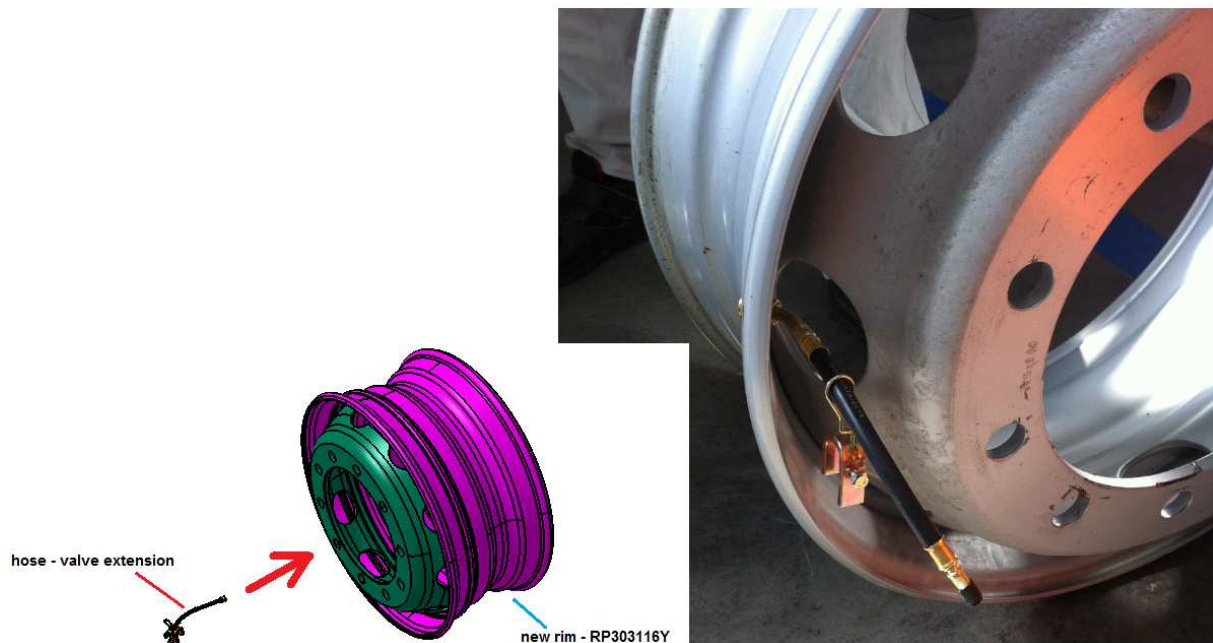
Figure-6

* Install hose - valve extension to the new inner rim shown in Figure-6.

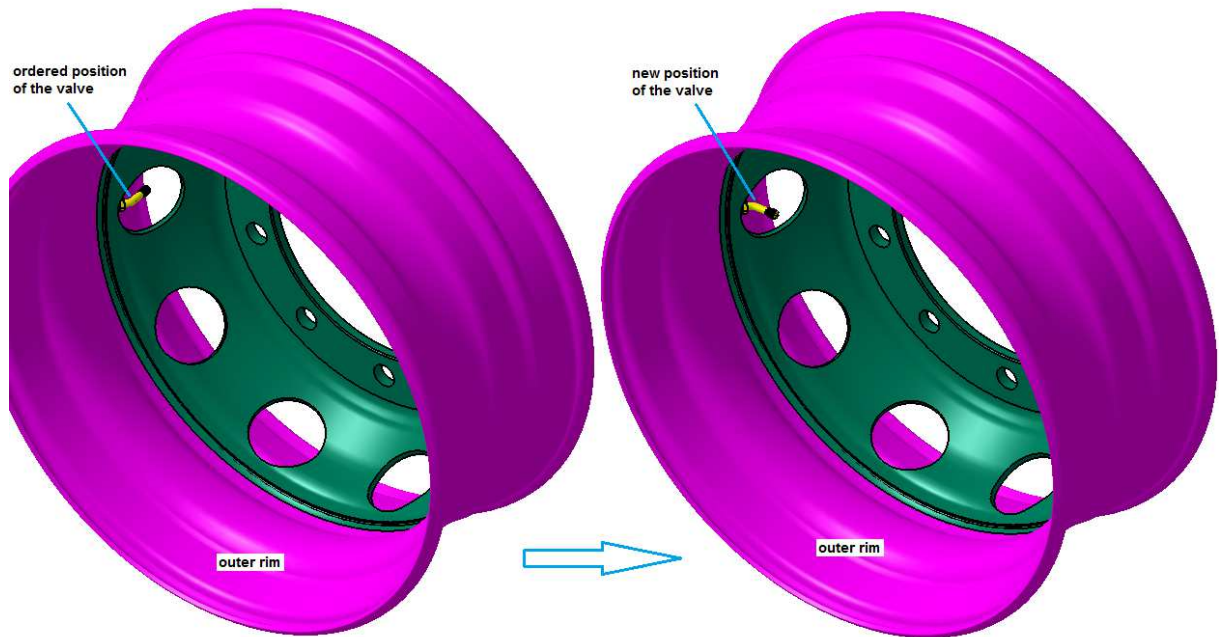
Note : The valve available on the outer rim should be positioned according to the inflating angle as shown in the picture below;

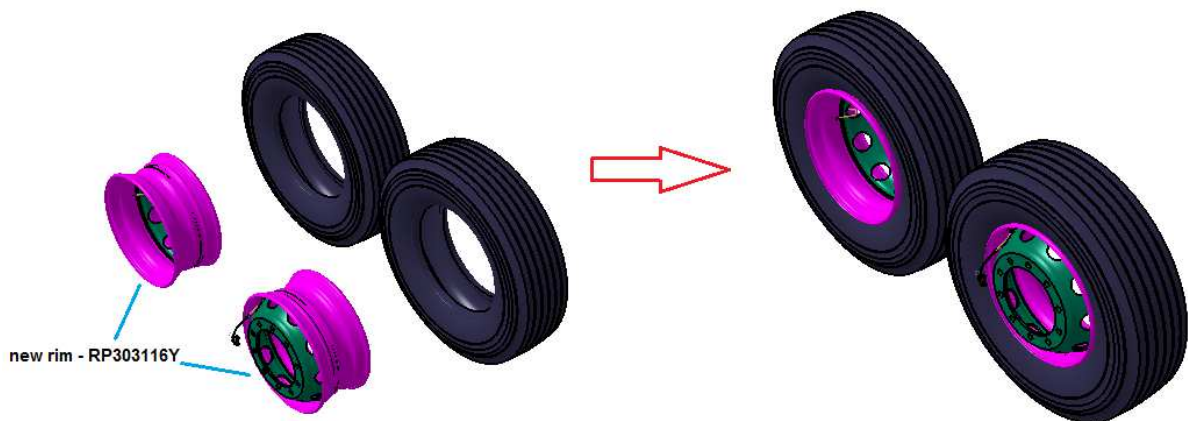
Figure-7

* Install new rims to the wheels shown in Figure-7.

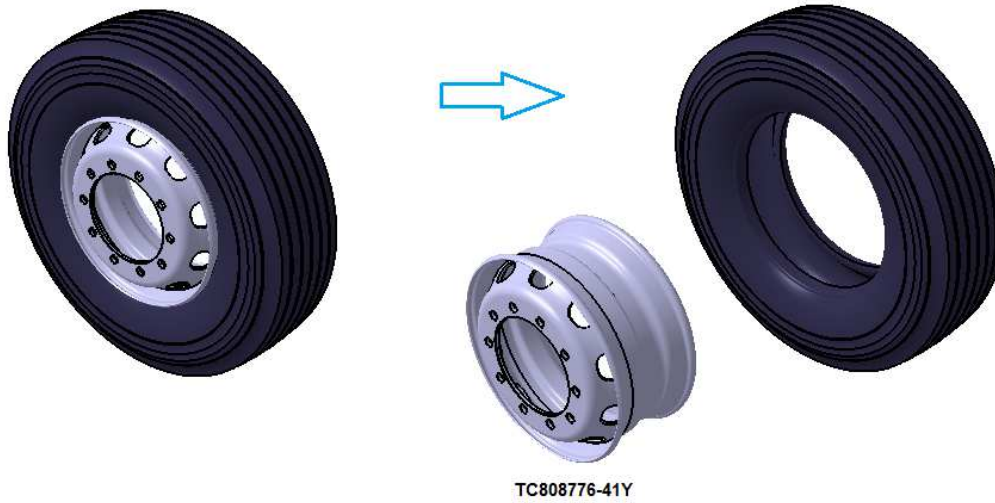
Figure-8

* Remove the existing rims (TC808776-41Y) from the front, tag and spare wheels shown in Figure-8.

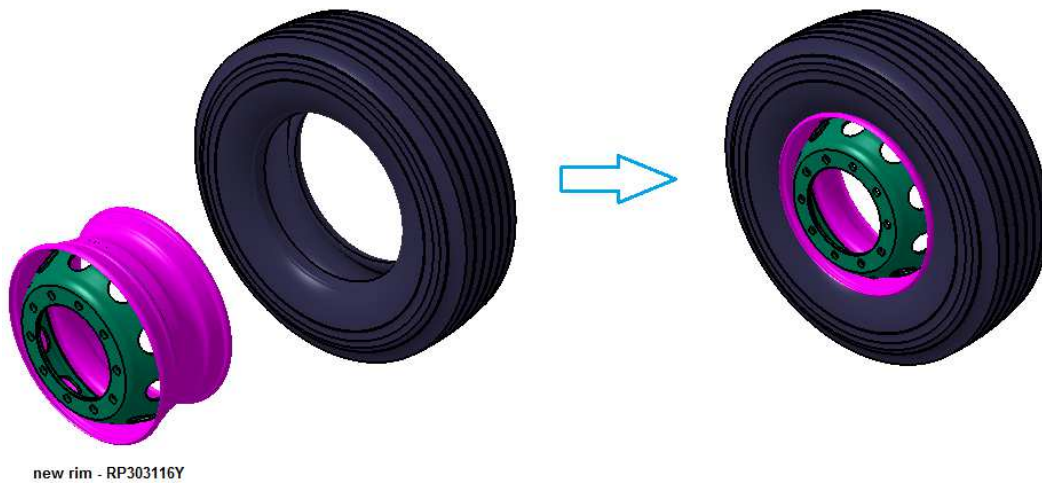
Figure-9

* Install new rims to the front, tag and spare wheels shown in Figure-9.

Note : After installing the new rims, all axle tires must be balanced.

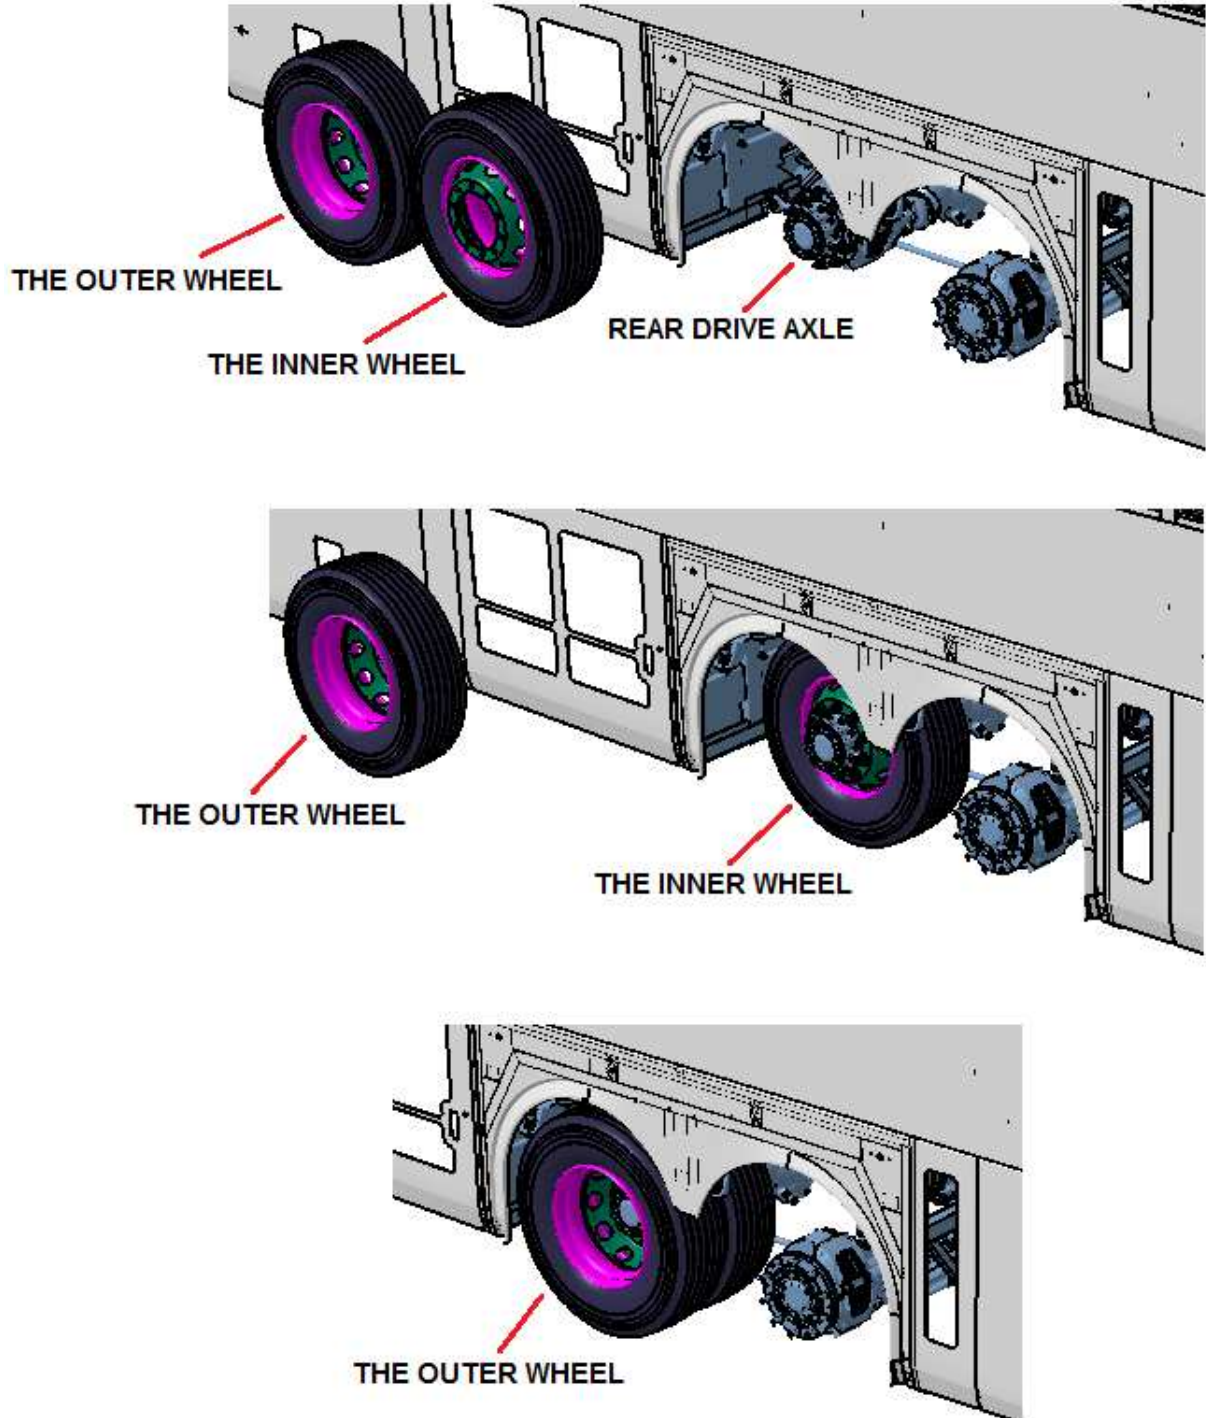
Figure-10

* Install dual wheels to the rear drive axle respectively shown in Figure-10.

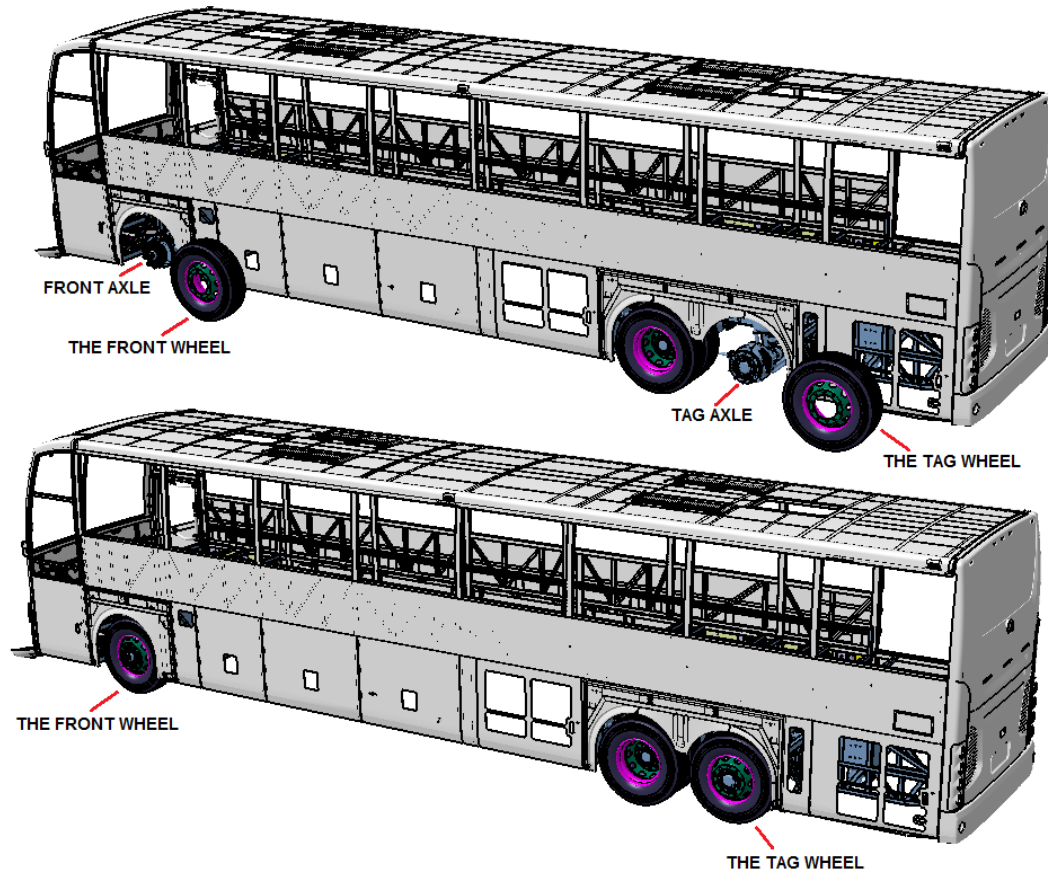
Figure-11

* Install tag and front wheels to the related axles shown in Figure-11.

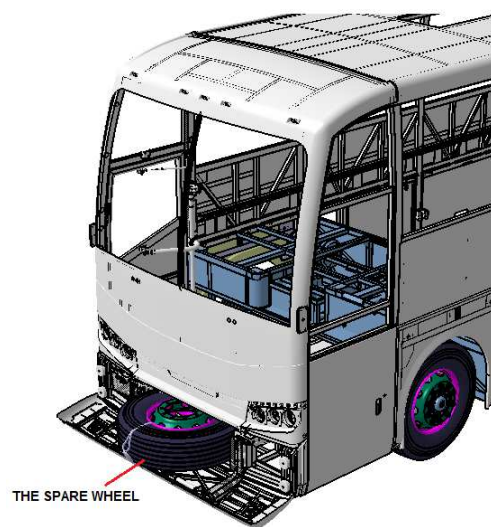
Figure-12

* Install the spare wheel to its room shown in Figure-12.

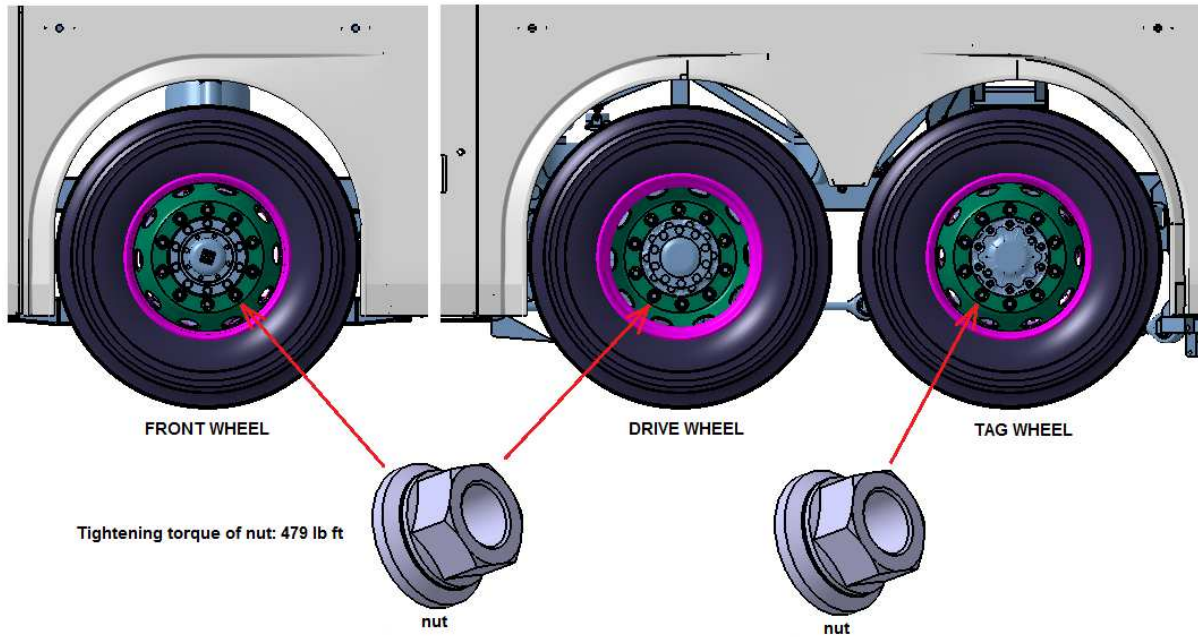
Figure-13

* Install and fix all the nuts with the given tightening torque (479 lb ft) shown in Figure-13.
