Technical Service Bulletin

46 Brake pulsation diagnostic guidelines

46 21 23 2022584/10 February 10, 2021. Supersedes Technical Service Bulletin Group 46 number 19-12 dated May 31, 2019 for reasons listed below.

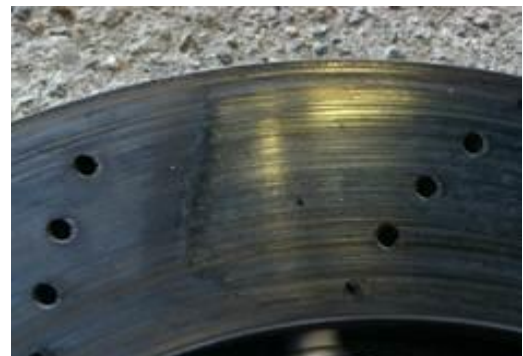
Figure 2. Deposits on the brake disc.

Condition: Brake pad material smeared on the brake disc (Figure 2). This condition can create DTV.

Common cause: An overly-aggressive driving style, which results in frequent sharp braking without proper cooling off periods.

Service: Replace the brake discs and pads.

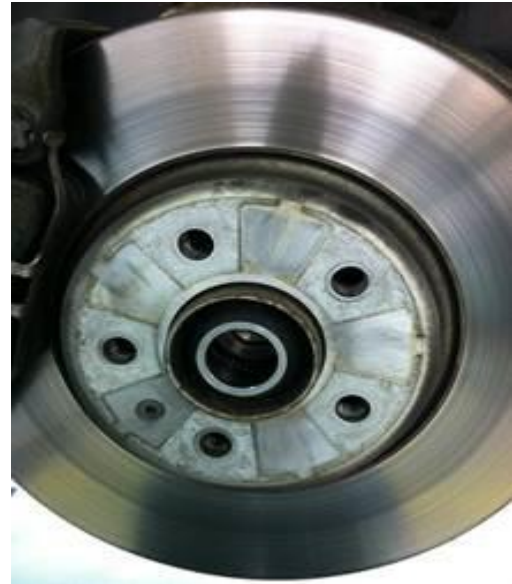
Figure 3. Brake disc with heat marks.

Condition: Blue-tempered or overheated brake discs (Figure 3).

Common cause: Failed component(s) causing constant brake application. This can also be caused by an overly-aggressive driving style, which results in frequent sharp braking without proper cooling off periods.

Service: Replace the brake disc and pads.

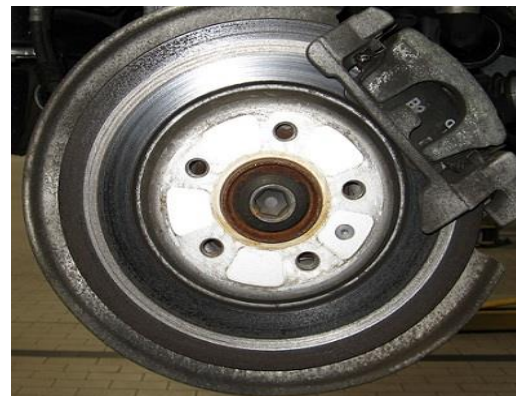
Figure 4. Corrosion/rust build-up.

Condition: Corrosion/rust build-up on the brake discs (Figure 4). This condition can create DTV.

Common causes:

- Exposure to road salt during winter months, high humidity, or moisture.
- Vehicle not being driven for prolonged periods of time.
- A gentle driving style with very light brake application may not be enough to remove build-up (such as rust or corrosion) on the brake discs and pads.

Service: With careful consideration of the traffic situation, perform 2-3 ABS stops from speeds above 50mph. Between each stop, allow the brake components to cool by driving the vehicle for more than one minute at speeds greater than 50mph. Do not perform ABS stops if brand new pads and/or discs are installed. Replace brake disc and pads if the condition is not eliminated.

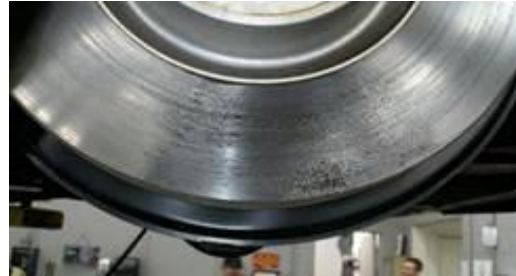
Figure 5. Pad marks on the brake disc.

Condition: Pad material transfer or corrosion marks from brake pads on the brake disc, also known as “pad marks” (Figure 5). This condition can create DTV.

Common cause: These marks can appear if the vehicle has not been driven for a prolonged period of time or if the brakes are exposed to high humidity or moisture.

Service: With careful consideration of the traffic situation, perform 2-3 ABS-stops from speeds above 50mph. Between each stop, allow the brake components to cool by driving the vehicle for more than one minute at speeds greater than 50mph. Do not perform ABS stops if brand new pads and/or discs are installed. Replace brake disc and pads if the condition is not eliminated.

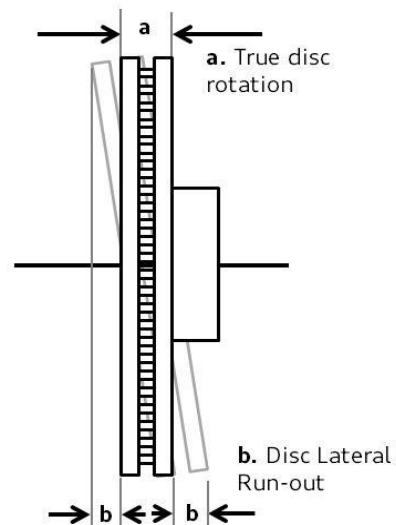
Figure 6. True disc rotation (a) and disc lateral run-out (b).

Condition: Excessive brake disc or wheel hub run-out (Figure 6). Measure according to the *Run-out Measurement Instructions* listed below.

- **Over-torqued or improperly-torqued wheels** (torque sticks, impact gun, etc.) can distort the brake disc and hub, causing a run-out condition. Refer to Elsa for proper torque values and procedures for the VIN.
- **Wheels that are not Audi-approved** may not have the same contact surface on the back of the wheel and may not have the correct center bore dimension, which can distort the brake disc and hub, causing a run-out condition.
- **External impact or rust build-up** between brake disc and hub.

Service: Replace brake disc(s) and/or hub(s) if measurements exceed the maximum value listed in the *Run-out Measurement Instructions*.

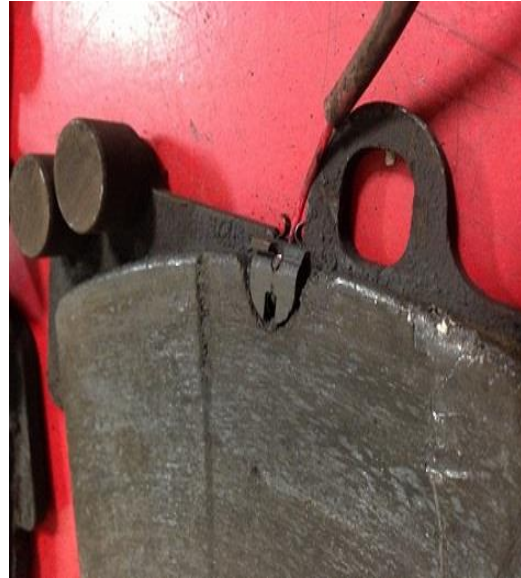
Figure 7. Worn brake pad.

Condition: Worn brake pads (Figure 7).

Common cause: As brake pads and discs reach their wear limit, their dampening characteristics are reduced.

Service: Replace worn brake pads and discs.

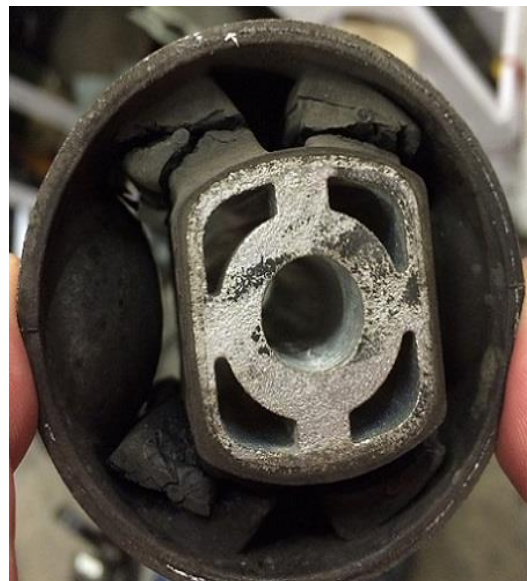
Figure 8. Damaged suspension bushing.

Condition: Faulty, damaged, or aftermarket suspension components (ball joints, links, tie rods, bushing, etc.) can significantly amplify vibration/pulsation or lead to body vibrations which only become noticeable when braking (Figure 8 and Figure 9).

Service: Diagnose these components accordingly.

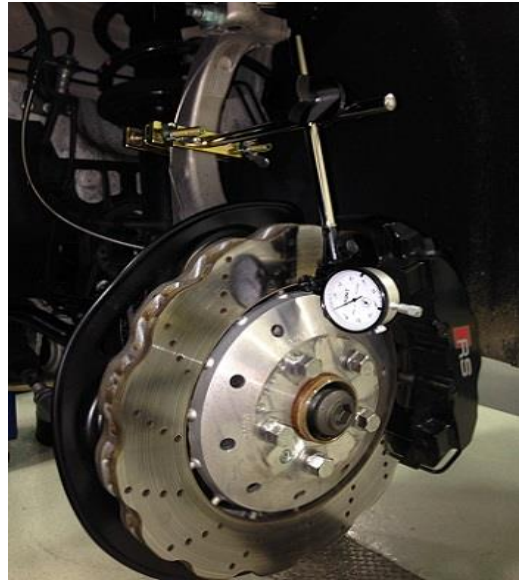
- All surfaces that will be measured must be free of rust/corrosion build-up or pad material transfer.
- VAS6079/1 (or similar measurement tool) is securely attached to the vehicle (Figure 11).
- The brake disc is secured to the hub with 5 bolts.
- Axle bolt/nut is installed and properly torqued.
- Run-out measurements should be taken with all parts installed on the vehicle.

Figure 11. Example of the run-out measurement tool VAS6079/1 properly secured to a solid suspension component.

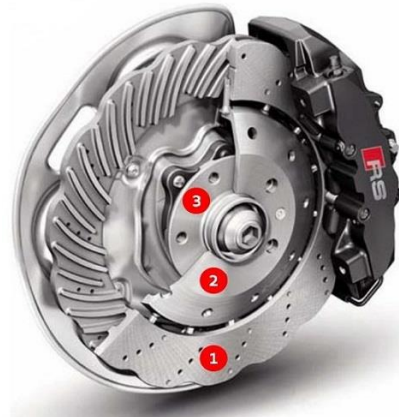
Disc braking surface (Figure 12, point 1):

- Disc hub and wheel hub run-out impact this value.
- Maximum run-out: **0.06 mm / 0.002"**.

Disc hub (center of the brake disc) (Figure 12, point 2):

- Wheel hub run-out impacts this value.
- Disc hub run-out impacts the disc braking surface run-out.
- Maximum run-out: **0.03 mm / 0.0012"**.

Wheel hub (without the disc installed) (Figure 12, point 3):

- This value impacts the disc hub and disc braking surface run-out. High run-out can distort the brake disc.
- Maximum run-out: **0.02 mm / 0.0008"**.

Figure 12. Run-out measurement locations: disc braking surface (1), disc hub (2), wheel hub (3).
