### Fuel Pump Inspection Dealer Inventory

Reference: PC791  
Date: February 2, 2021

## PC791 – 2021 ROGUE FUEL PUMP INSPECTION

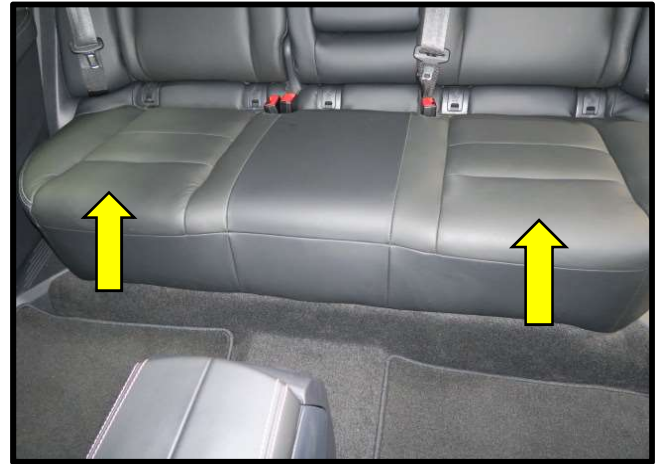
- Open the LH and RH rear doors
- Lift upward in the areas shown in Figure 1 to disengage the seat cushion hooks
- Pull the seat cushion up and move it forward
- Disengage the seat belt buckles
- (If equipped) Lift the seat cushion up and disengage the rear heated harness connectors
- Remove the rear seat cushion and place in a safe clean area to prevent staining and damage to the seat cushion

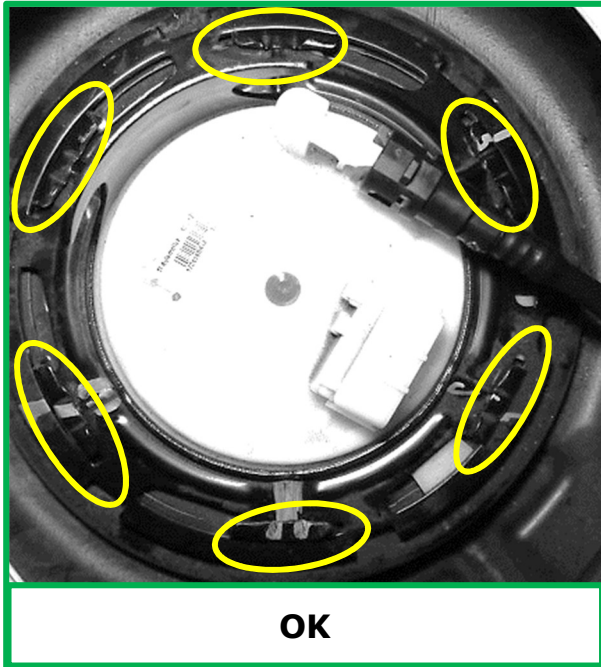
4. Verify the fuel pump lock ring is installed correctly.
  - Make sure the fuel pump lock ring is correctly installed with all locking tabs engaged with lock ring

- If the fuel pump lock ring **IS** installed correctly, continue to **Step 6** for next inspection.
- If the fuel pump lock ring is **NOT** installed correctly, continue to **Step 5** to replace the fuel pump packing (O-ring) and correctly install the fuel pump lock ring.

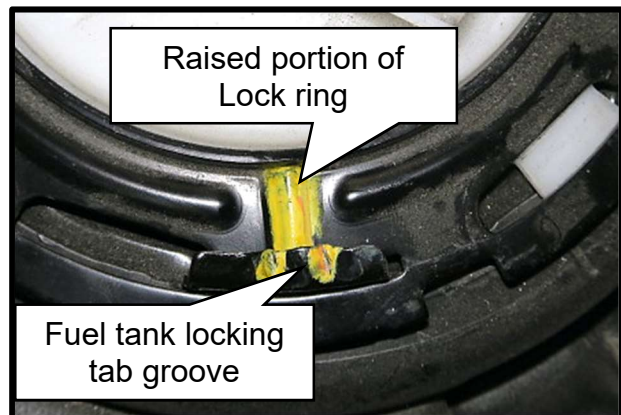
Figure 6

- i) Make sure all (6) locking tabs are aligned within the lock ring
  - j) Using J-45747 and tighten the fuel pump lock ring until the raised portion of the lock ring is engaged into the groove of the fuel tank locking tab (Figure 6)

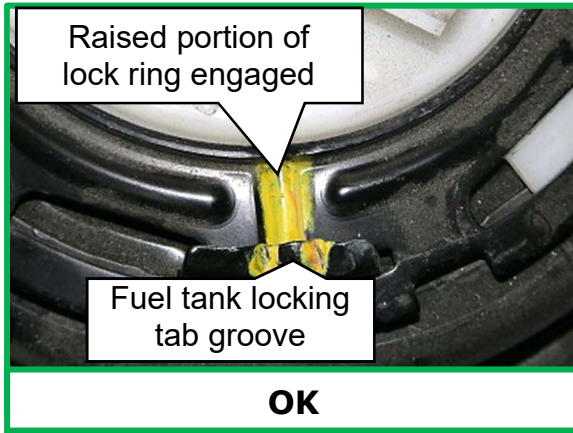
6. Verify the fuel pump lock ring is fully engaged.
  - Be sure the raised portion on the fuel pump lock ring is resting in the groove of the fuel tank locking tab shown in Figure 8

- If the locking Ring is positioned correctly (Figure 8), continue to **Step 7**
- If the locking ring is **NOT** positioned correctly (Figure 9), use J-45747 to correctly position the locking ring.
