NUMBER: 23-016-13

Driver And/Or Passenger Seat Fore/Aft Movement During Acceleration And/Or Braking

This bulletin involves replacing the power seat track drive block bolts on front driver and/or passenger seat.

2011- 2013	(LC)	Challenger
2011- 2013	(LD)	Charger
2011- 2013	(LX)	300

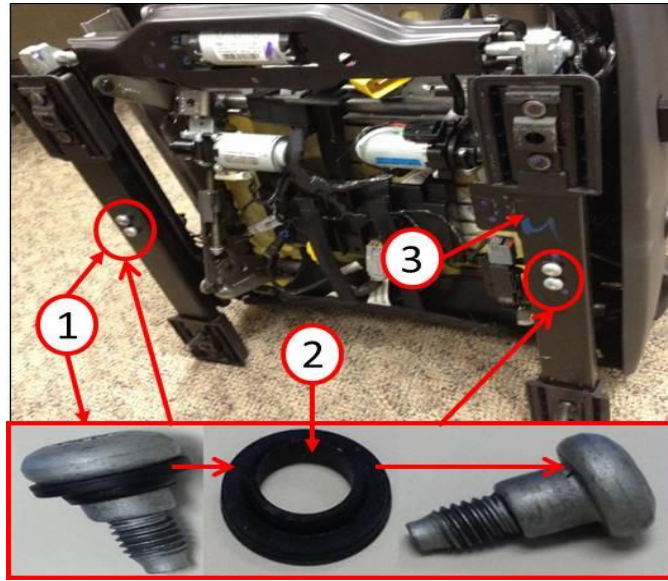
Fig. 1 Replace Drive Block Bolts

- 1 - Drive Block Bolts (bottom of seat frame)
- 2 - Plastic Drive Block Spacer (transfer from old to new bolt)
- 3 - Seat Frame (view from bottom)

2. Remove one of the drive block bolts (1) from the bottom of the seat frame at a time and remove the plastic spacer (2) from the old bolt and reinstall it on the new bolt p/n 68203613AA.
3. Reinstall the new bolt into the bottom of the seat frame (3) and tighten it to 15Nm(11ft/lbs.). Repeat for the remaining bolts and/or seat.
