Corrosion on the Back Door Steel Reinforcement Panel Around the Opener Switch and Rear Camera

Service Category Vehicle Exterior

Section Door/Hatch

YEAR(S)	MODEL(S)	ADDITIONAL INFORMATION
2017 - 2021	Prius Prime

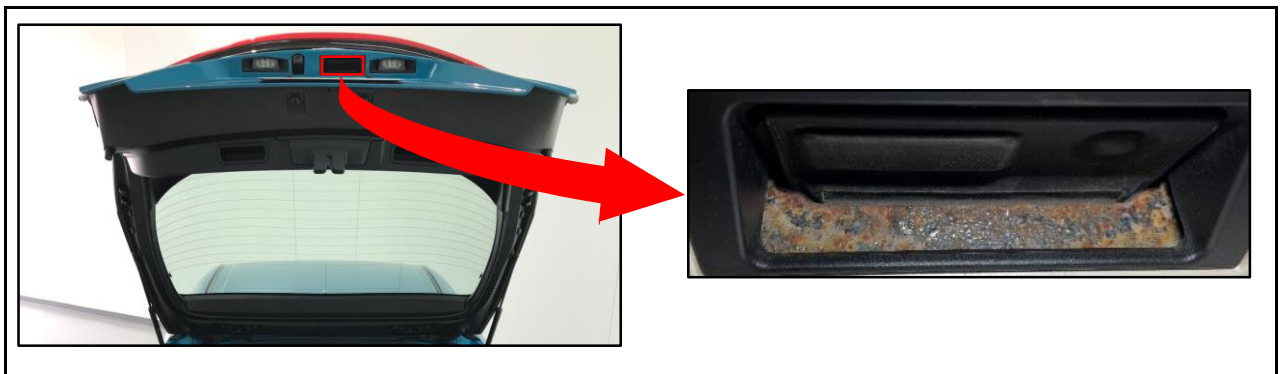
Figure 1.

Some 2017 – 2021 model year Prius Prime vehicles may exhibit corrosion on the back door sub-assembly steel reinforcement panel visible below the opener switch and rear camera. Follow the Repair Procedure in this bulletin to address this condition.

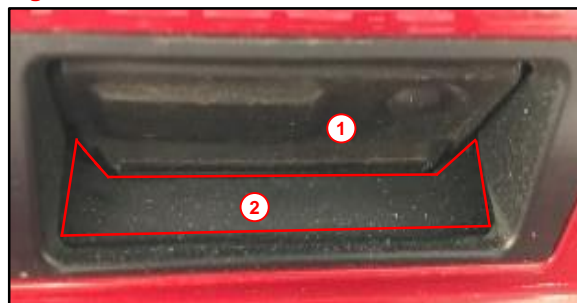
Figure 2.

- Only a small portion of the steel reinforcement panel is visible below the back door opener switch when assembled (Figure 2).
- Coat the part of the steel reinforcement panel that is NOT visible with wax (Figure 3).

1	Back Door Opener Switch
2	Visible Steel Reinforcement Panel

- Apply wax to the hidden portion of the back door steel reinforcement panel.

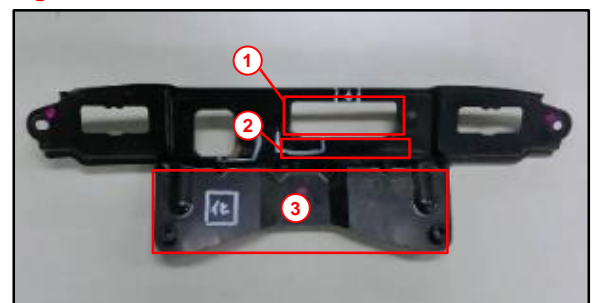
Figure 3.

1	Back Door Opener Switch Hole
2	Visible Steel Reinforcement Panel
3	Hidden Steel Reinforcement Panel

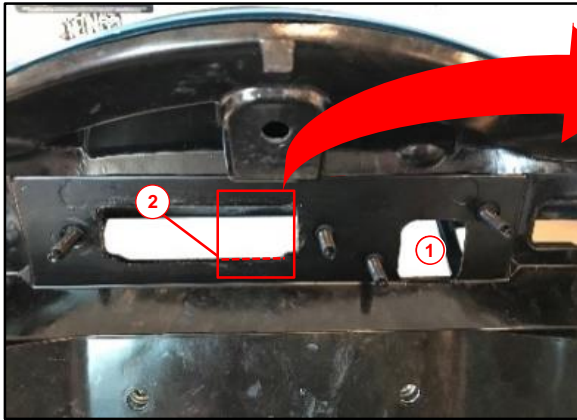
Figure 4.

1	Hole for Rear Camera
2	Cavity Between the Steel Reinforcement Panel and Interior CFRP Panel

- A. Lightly pry the interior CFRP and steel reinforcement panel apart with a small pry tool (Figure 5).
- B. Use an applicator wand kit to spray cavity wax in the cavity between the steel reinforcement panel and the Interior CFRP panel (Figure 5).

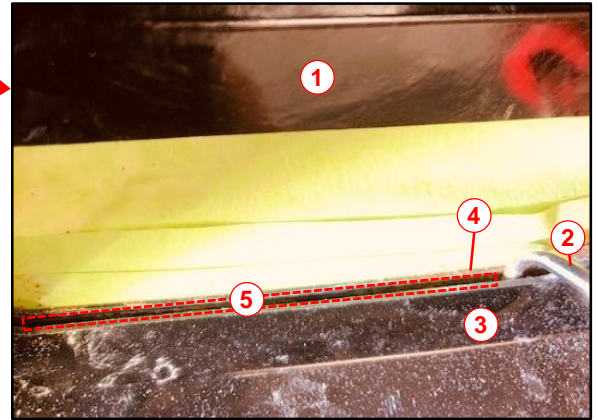
Figure 5.

1	Exterior CFRP Panel
2	Pry Tool
3	Interior CFRP Panel
4	Steel Reinforcement Panel
5	Cavity Between the Steel Reinforcement Panel and Interior CFRP Panel

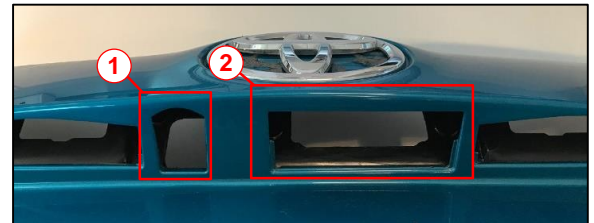
Figure 6.

1	Rear Camera Hole
2	Back Door Opener Switch Hole

- A. Use 80 – 180 grit sandpaper to remove rust from the exposed steel reinforcement panel surface at the back door opener switch and rear camera hole locations (Figure 6).

- To remove organic contaminants, use waterborne cleaner PPG™ SWX35 (or equivalent).
- To remove petroleum-based contaminants such as cavity wax, use solvent-based cleaner PPG™ SX330 (or equivalent).

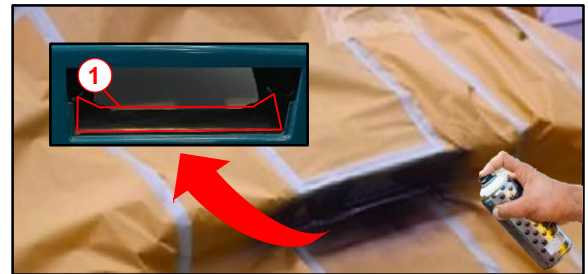
Figure 7.

1	Visible Back Door Steel Reinforcement Panel
---	---

A. Apply spray etch primer to the exposed portions of the back door steel reinforcement panel (Figure 7). Ensure ALL of the exposed area is coated and allow it to dry per the material manufacturer's recommendations.

Coat the exposed portions of the back door steel reinforcement panel surrounding both the door opener switch and the rear camera.

7. Apply two top coats to the back door steel reinforcement panel.
 - A. Apply two coats of black satin top coat to the visible area of the back door steel reinforcement panel surrounding the back door opener switch and rear camera holes (Figure 7) and allow each coat to dry according to material manufacturer recommendation. The completed repair is illustrated in Figure 9 and Figure 10.

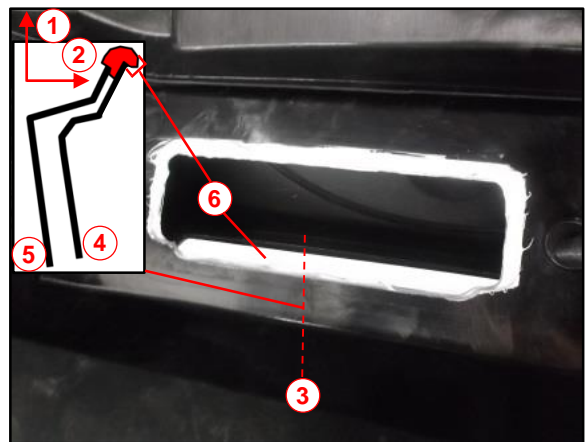
Figure 8.

1	Up
2	Rear
3	Cross-section
4	Steel Reinforcement Panel
5	Interior Panel
6	Sealer ≤ 1.5 mm Thick

A. Use urethane seam sealer to fill the edge gap between the interior CFRP panel and the steel reinforcement panel (Figure 8) to prevent water entry between the two panels. Allow the sealer to dry per the manufacturer's recommendations.

To ensure proper fit of the back door opener switch and rear camera to the reinforcement panel when reassembling, the sealer should be no more than 1.5 mm thick.

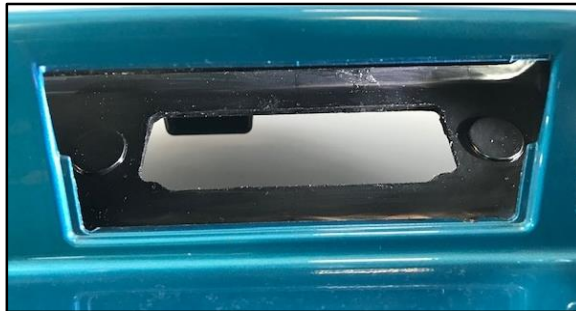
Figure 9.

1	Visible Front Area of Steel Reinforcement Panel Painted Black With No Visible Rust
----------	---

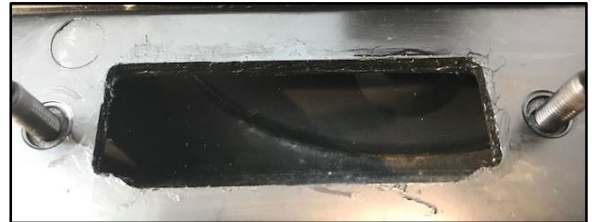
Figure 10.

1	Rear View of the Gap Between Interior CFRP and Steel Reinforcement Panel Filled With Sealer
----------	--
