Technical Service Bulletin

13 Instructions for a poly V-belt and toothed belt, if it came into contact with coolant

13 21 13 2062387/1 March 9, 2021.

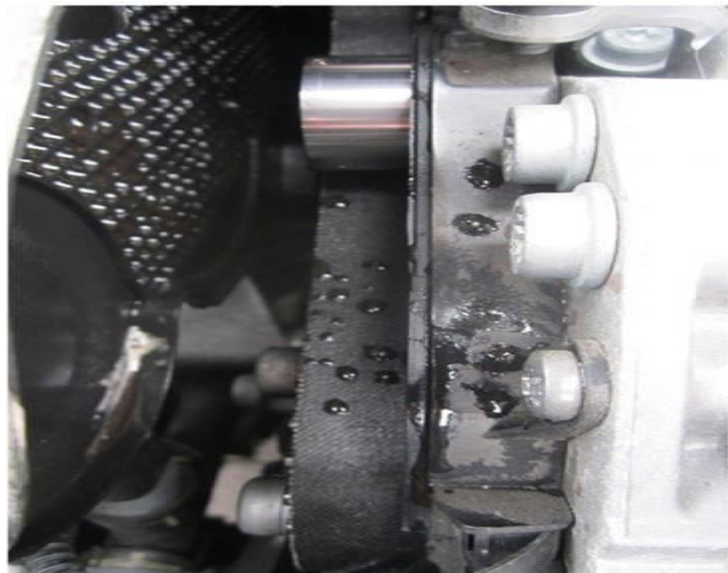
- A toothed belt which was briefly in contact with coolant (Figure 1) and was dried again it does not need to be replaced.

Figure 1. Example of the toothed belt that was briefly in contact with coolant.

If a toothed belt has been removed, always check it for signs of wear or damage before installing it again.

- If the toothed belt is exposed to coolant for an extended period of time, it must be replaced.
