Technical Service Bulletin

80 The interior vehicle heating is insufficient and the engine coolant is discolored

80 21 11 2062583/1 March 19, 2021.

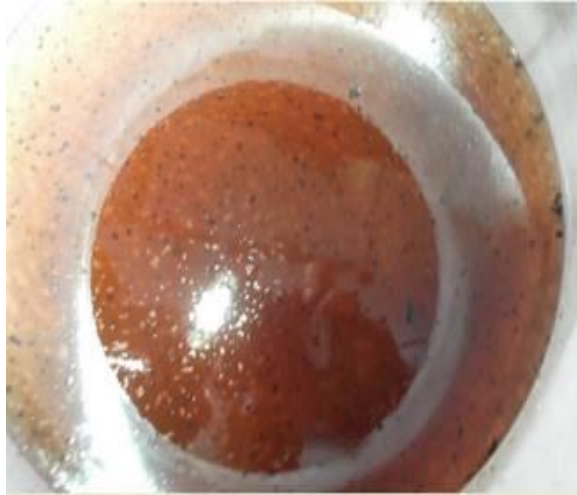
1. Examples of what the appearance of the discoloration of both the coolant as well as the coolant reservoir (Figures 1 – 4). This coolant contamination is not engine oil or transmission fluid.

Figure 1. Suspended particulate matter.

5. Clean and flush the cooling system using cooling system cleaning set, part number G 052 525 A3 as follows (Figure 5):

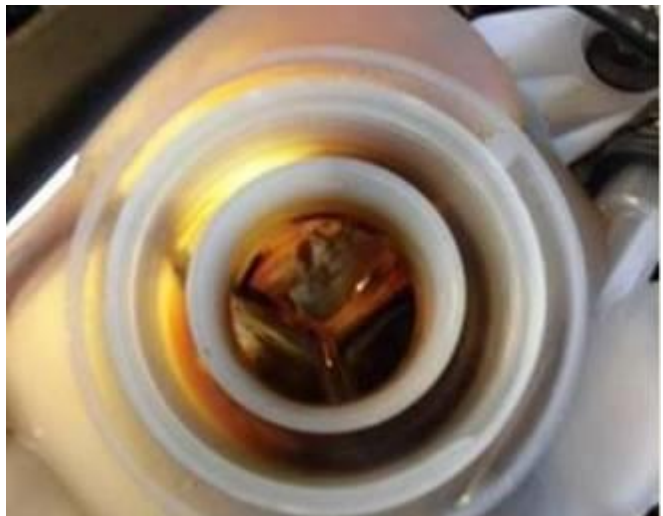
Figure 2. 'Brownish' discoloration.

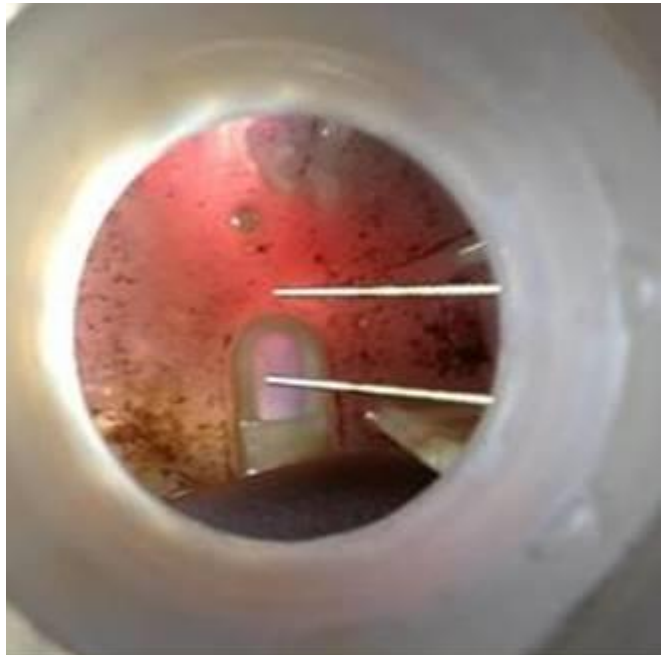
Figure 4. *Particulate matter.*

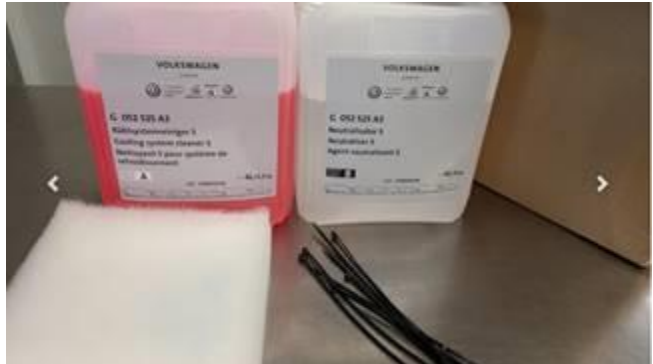
Figure 5. Cooling system cleaning set.

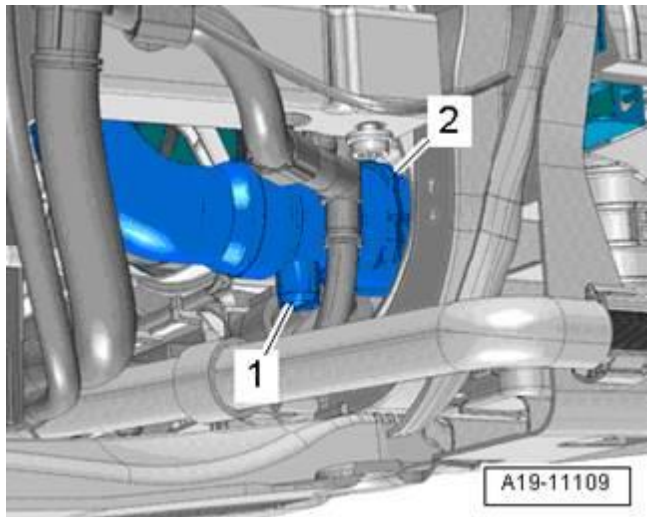
Figure 6. Drain the coolant.

6. Drain coolant when the engine is warm and the coolant thermostat is open according to the procedure in ElsaPro (Figure 6).

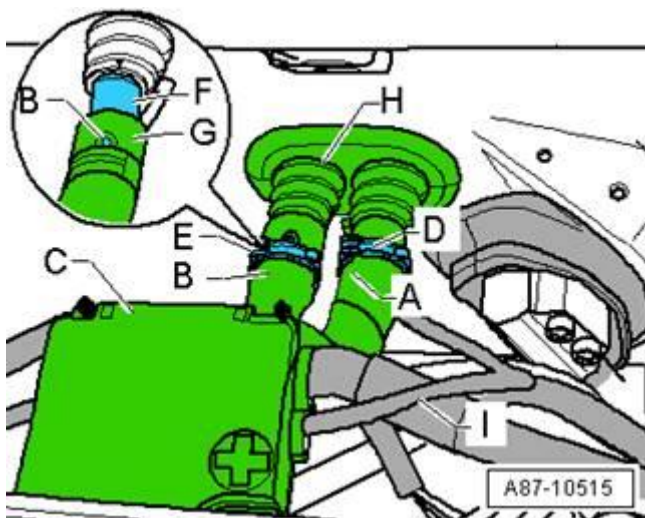
Figure 7. Heater core connections.

7. Flush the heat exchanger(s) with water in the **opposite flow direction**. Do not exceed 2 bar of water pressure (Figure 7).

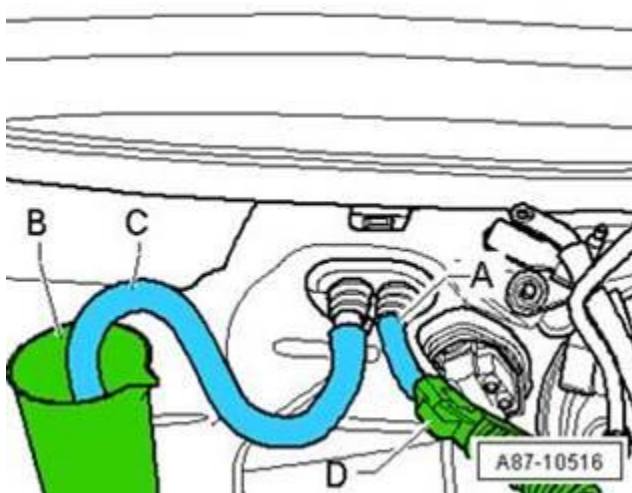
Figure 8. Blowing out heater core.

8. Blow the coolant out of the heat exchanger(s) in the **opposite flow direction** (Figure 8).

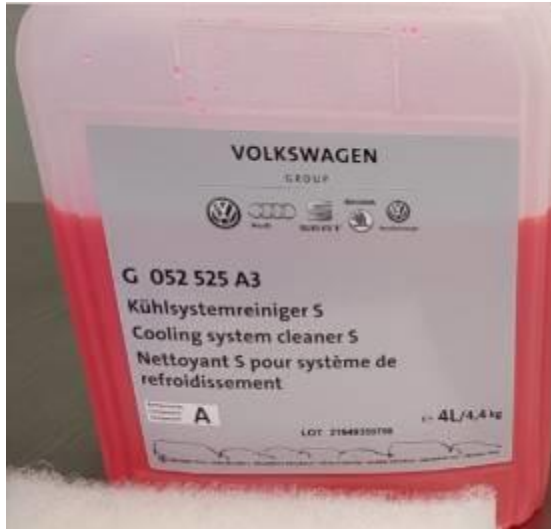
Figure 9. Cooling system cleaner 'S'.

9. Add 3.0 liters of cooling system cleaner 'S' and the balance of the fill with coolant (Figure 9). Perform bleeding procedure. Run the engine for 90 minutes with this mixture with the cabin heating on full hot and HI fan. If equipped, also set the rear HVAC unit to full hot and HI fan.

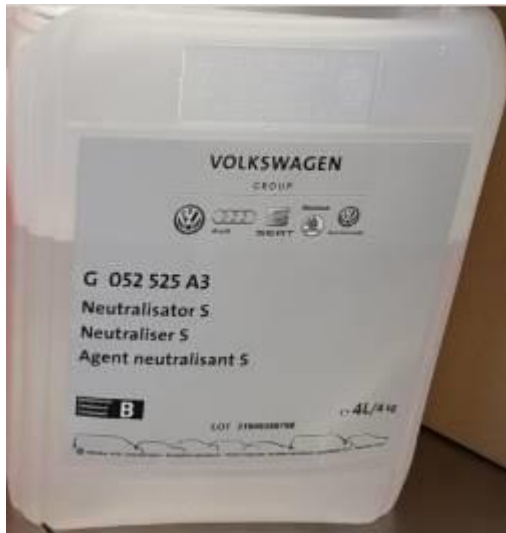
Figure 10. Neutralizer 'S'.

10. Drain the cleaning solution.
11. Add 3.0 liters of neutralizer 'S' and the balance of the fill with coolant. Perform bleeding procedure (Figure 10). Run the engine for 15 minutes with this mixture with the cabin heating on full hot and HI fan. If equipped, also set the rear HVAC unit to full hot and HI fan.

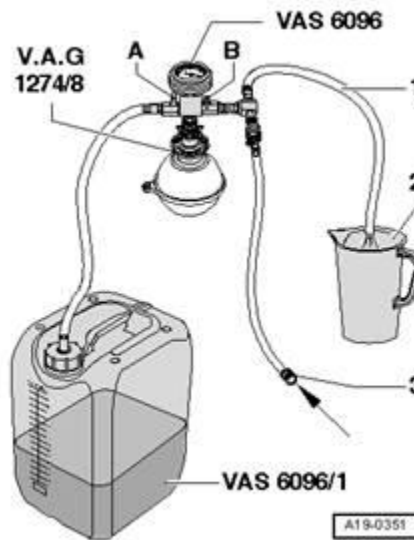
Figure 11. Cooling system filling.

13. Fill the cooling system with plain distilled water (Figure 11). Perform bleeding procedure. Again, set the cabin heating to full hot and HI fan. If equipped, also set the rear HVAC unit to full hot and HI fan. Run the engine at approximately 2000 rpm until the cooling fans activate. Continue to run the engine at this speed for an additional 3 minutes.

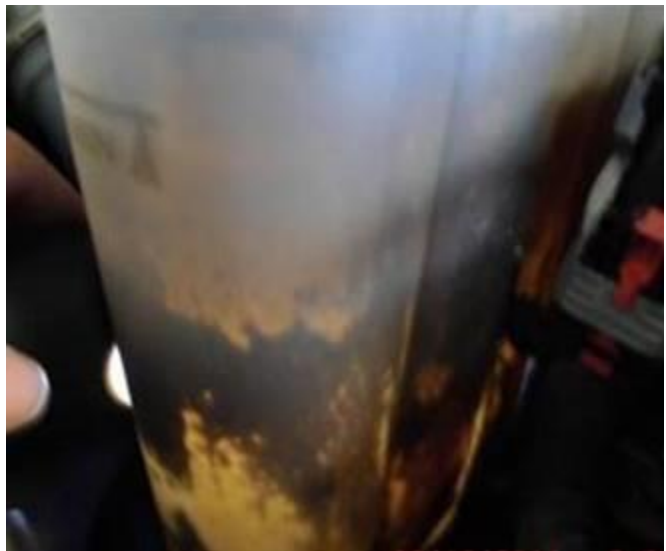
Figure 12. Discolored coolant expansion tank.

14. Drain the distilled water fill.
15. Repeat this rinse process an additional cycle (repeat steps 13 and 14).
16. Once again, drain the distilled water fill.
17. If the coolant expansion tank is still discolored after the cleaning process it must be replaced (Figure 12).

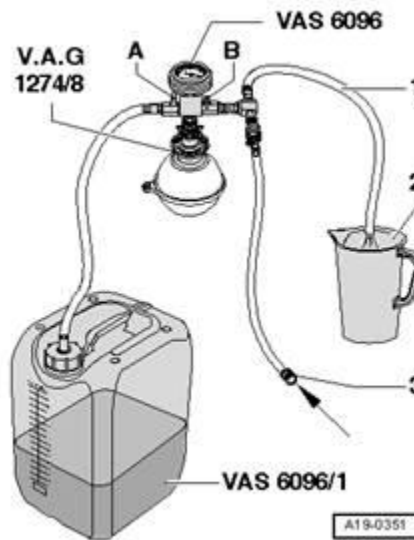
Figure 13. Cooling system filling.

18. Fill the cooling system with coolant at the proper mix ratio of coolant and distilled water according to the procedure in ElsaPro (Figure 13). Perform bleeding procedure.
