TO: Mercedes-Benz Dealer Principals, General Managers, Sales Managers, Service Managers, Parts Managers	FROM: Gregory Gunther, Department Manager, Vehicle Compliance and Analysis, Engineering Services
RE: Emission Recall Campaign Notification Check Activated Carbon Filter MY18-19 C/E-Class (205/238 platforms)	DATE: February 12, 2021

Campaign No. 2020090018, February 2021

SUBJECT: **Model C/E-Class vehicles (205, 238 platform)**
Model Year 2018-2019
Check Activated-Carbon Filter

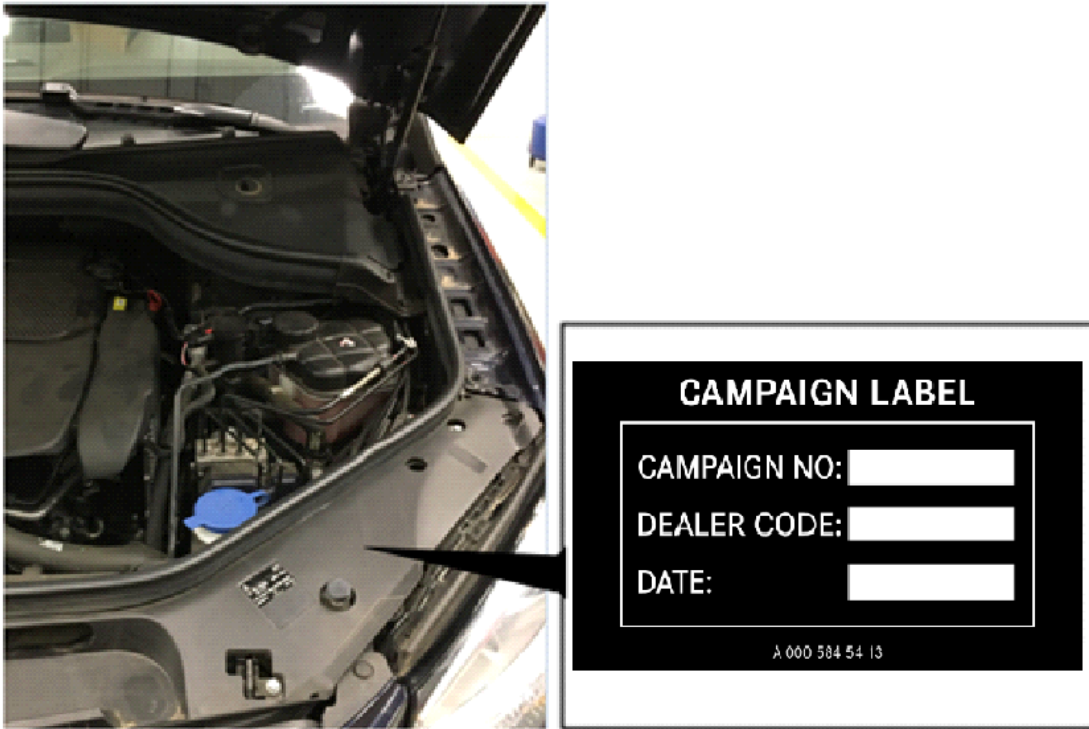
Figure 2

Apply Proof of Correction Label (A 000 584 54 13) to area identified in Figure 2. Fill in Campaign 200918 your dealer code, and the date of the repair, using a black permanent marker.

i Note: Clean bonding surface prior to affixing label.
