# Technical Service Bulletin

## 91 Radio: Noise from FM/AM sources while the rear window heater is active

91 21 86 2062713/1 March 29, 2021.

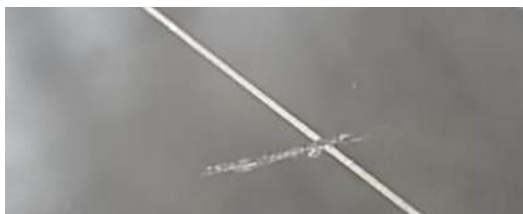
Micro-cracks in the heating or antenna wires that are printed on the rear window can cause electro-magnetic interference in the radio antenna boosters.

Most often, damaged heating or antenna wires are caused by outside influence, for example the storage of objects with sharp edges (umbrellas or large containers) on the hat shelf or trunk of the vehicle that contact and scrape against the rear window.

2. Inspect the rear window for damage and scratches possibly caused by outside influence (see Figure 1 for an example of a scratch indicating misuse).

**Figure 1.** Scratched rear window, visible with the naked eye.

In case such damage is found, inform the customer that the damage is caused by outside influence and that the repair cannot be billed on warranty before replacing any parts.

3. Replace the rear window.
