Technical product information

| Topic | Water leak/wind noise diagnosis |
| Brand | Bentley |
| Transaction No. | 2062622/1 |

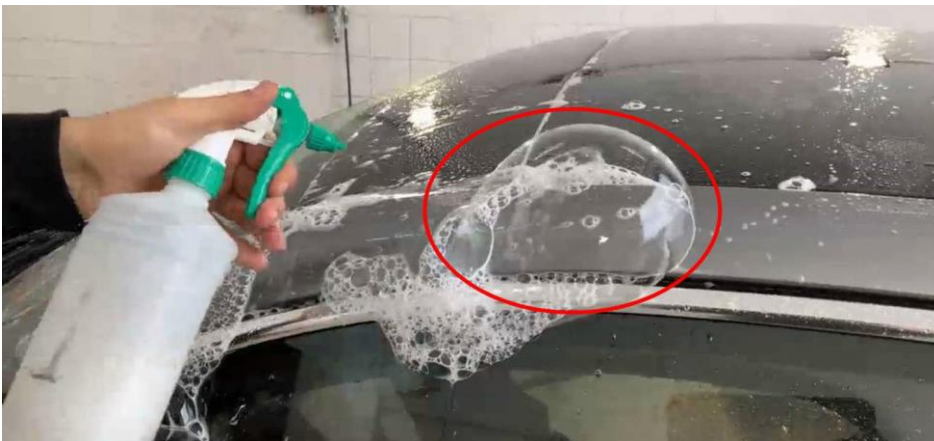
Figure 1

1) Referring to the example shown in Figure 1–Apply a suitable soapy solution to the exterior of the vehicle to the location in which the leak or wind noise is evident

2) With extreme care - Pass an airline into the cabin by slightly lowering one of the windows opposite the area being tested (All other windows should remain closed)

- With an air nozzle/gun attached carefully blow air around the suspected area
- The operative on the outside of the vehicle should watch for bubbles, the bubbles will confirm the location of the leak

3) Conduct a further inspection to determine the reason for the leak - *For example an incorrectly fitted seal*
