<b>Technical Service Bulletin:</b> TSB170085	<b>Released Date:</b> 08-Mar-2021
<b>Fault Code 5867: PACCAR™ Chassis with Battery Disconnect Switch</b>

## Fault Code 5867: PACCAR™ Chassis with Battery Disconnect Switch

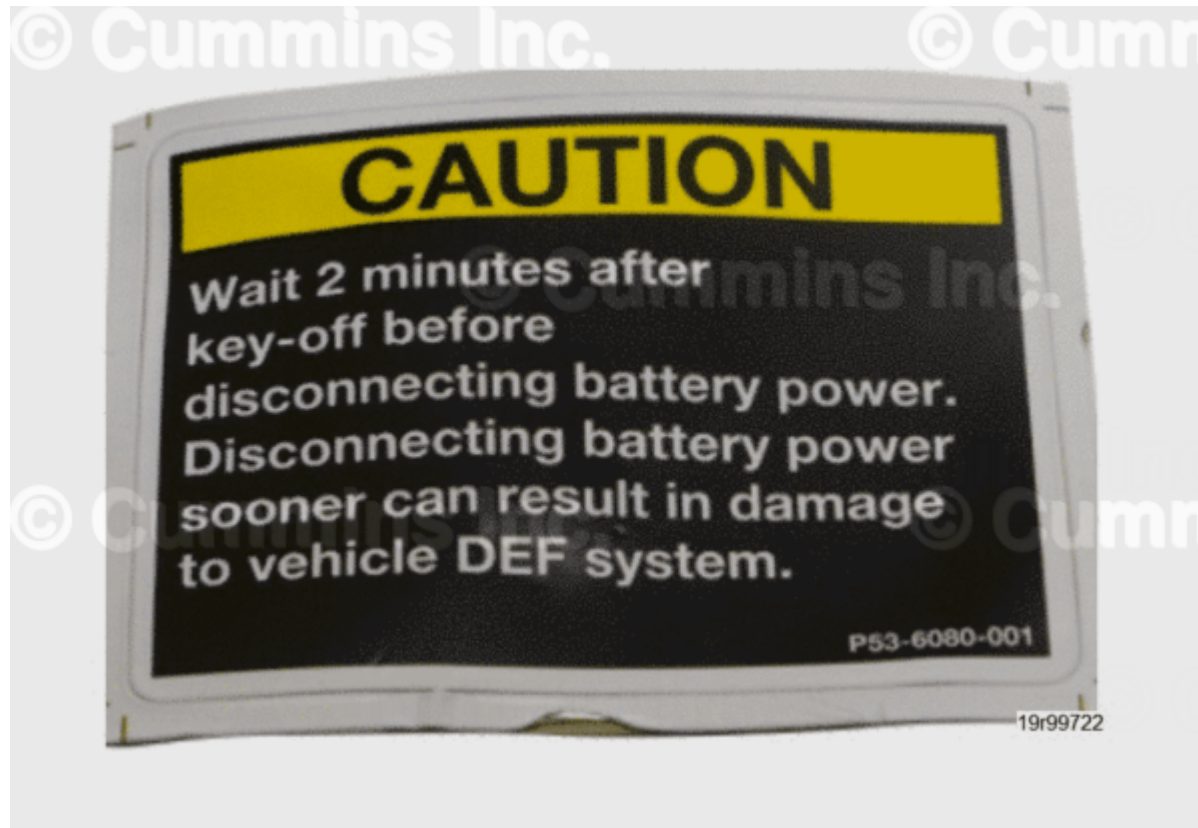
Figure 1, Battery Disconnect Direction Sticker.

- PACCAR™ chassis do **not** provide a dedicated power source to the aftertreatment DEF dosing unit. Units equipped with battery disconnect switches can interrupt the DEF system power down and purge sequence, logging Fault Code 5867.

- Verify notification sticker directing proper power down procedures is affixed to chassis near battery disconnect switch. Contact local PACCAR™ support location for battery disconnect power notification sticker See Figure 1 below.
- Inform operator of proper power down procedure which requires two minutes before disconnecting power using battery disconnect switch.
