BULLETIN NUMBER:  
**IB11-L-003D**

## FUEL CONTAMINATION – INCORRECT FUEL FILLER NECK INSTALLATION

- 2011 - current Isuzu NPR/NPRHD/NPRXD/NQR/NRR  
Equipped with a diesel engine

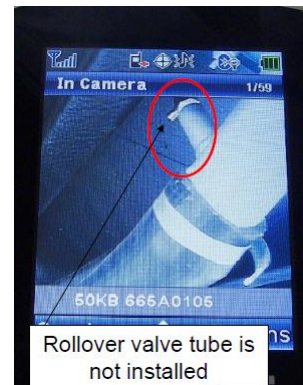
## INCORRECT INSTALLTION

Fuel filler necks found in these conditions will result in fuel contamination

**ROLLOVER VALVE TUBE is not installed.**

Use the information below to confirm the fuel filler neck is installed correctly. If the filler neck installation is incorrect, use the information below to repair the fuel filler neck. ***Detailed information regarding fuel filler neck installation can be found in Isuzu's Body Builder Guide.***
