SERVICE BULLETIN

APPLICABILITY: 2018MY Forester
2018-19MY WRX

NUMBER: 10-98-20R

SUBJECT: New Air Conditioning (A/C) Compressor Availability

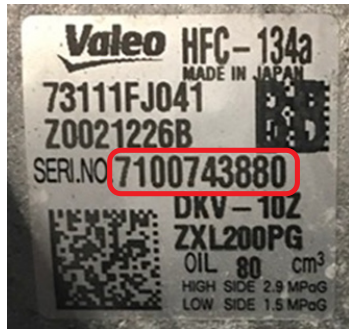
This Service Procedure involves an inspection of the 10-digit Serial Number on the compressor label to determine the unit's production date BEFORE ordering / replacing the assembly.

In this example (710043880), the “7” indicates the production year as 2017 (an “8” would be 2018, etc.). The next 2 digits, “10” indicates October as the production month (a “09” would be September, etc.). **NOTE:** Any compressor with a production date of **810 or HIGHER (October 2018 or newer)** had the new valve component installed at manufacture and does NOT require replacement.

After confirming the customer's system performance and / or sound concern AND the label Serial Number is determined to be **809 or before**, proceed with replacing the A/C compressor assembly following the procedure in the applicable Service Manual.
