**Removing and Installing Drive Belt: Observe Specified Procedure (55/21)**

Vehicle Type: **Panamera Turbo (971)/Panamera Turbo S E-Hybrid (971)/Panamera GTS (971)  
Cayenne Turbo (9YA/9YB)/Cayenne Turbo S E-Hybrid (9YA/9YB)/Cayenne GTS (9YA/9YB)**

Concerns: **Belt tensioner**

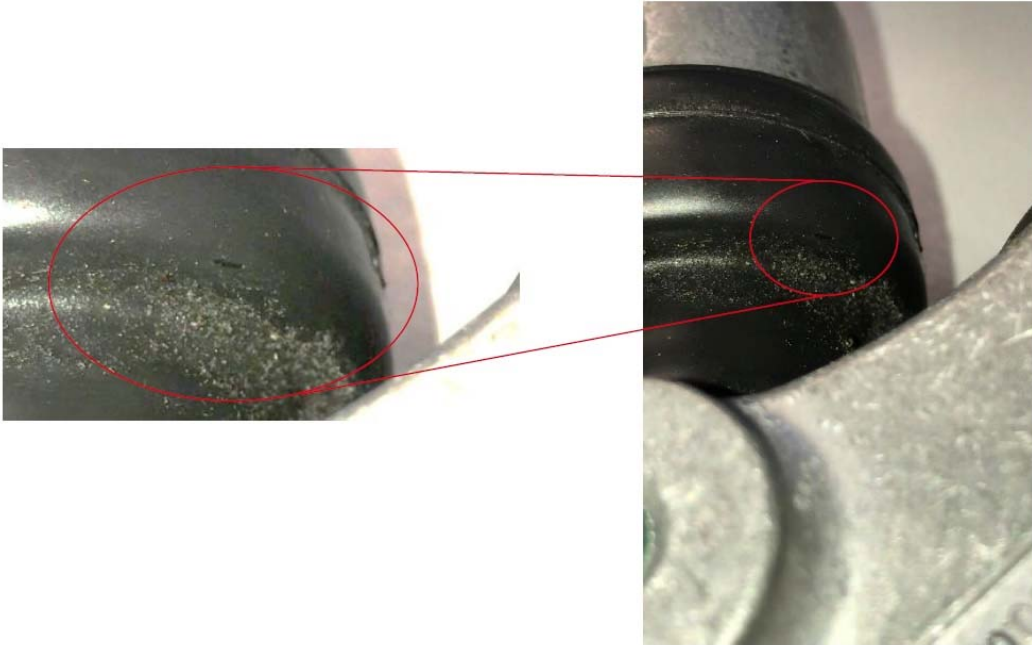
Information: **Internal tests have shown that the dust boot on the belt tensioner can be damaged by relieving the tension on the belt tensioner too much (fully) when removing or installing the drive belt.**

*Belt tensioner*

For this reason, when removing and installing the drive belt, make sure that you only relieve the tension on the belt tensioner as much as required to allow you to remove and install the drive belt. There is no need to relieve the tension on the belt tensioner fully for removing and installing the drive belt.

See also the relevant Workshop Manual ⇒ *Workshop Manual '137819 Removing and installing drive belt (V8 biturbo)'* to avoid damaging the belt tensioner.
