BT13-017

2011-2013 QX56; SECOND ROW SEAT HEATERS DO NOT WORK

APPLIED VEHICLE: 2011-2013 QX56 (Z62) equipped with 2nd row heated seating only

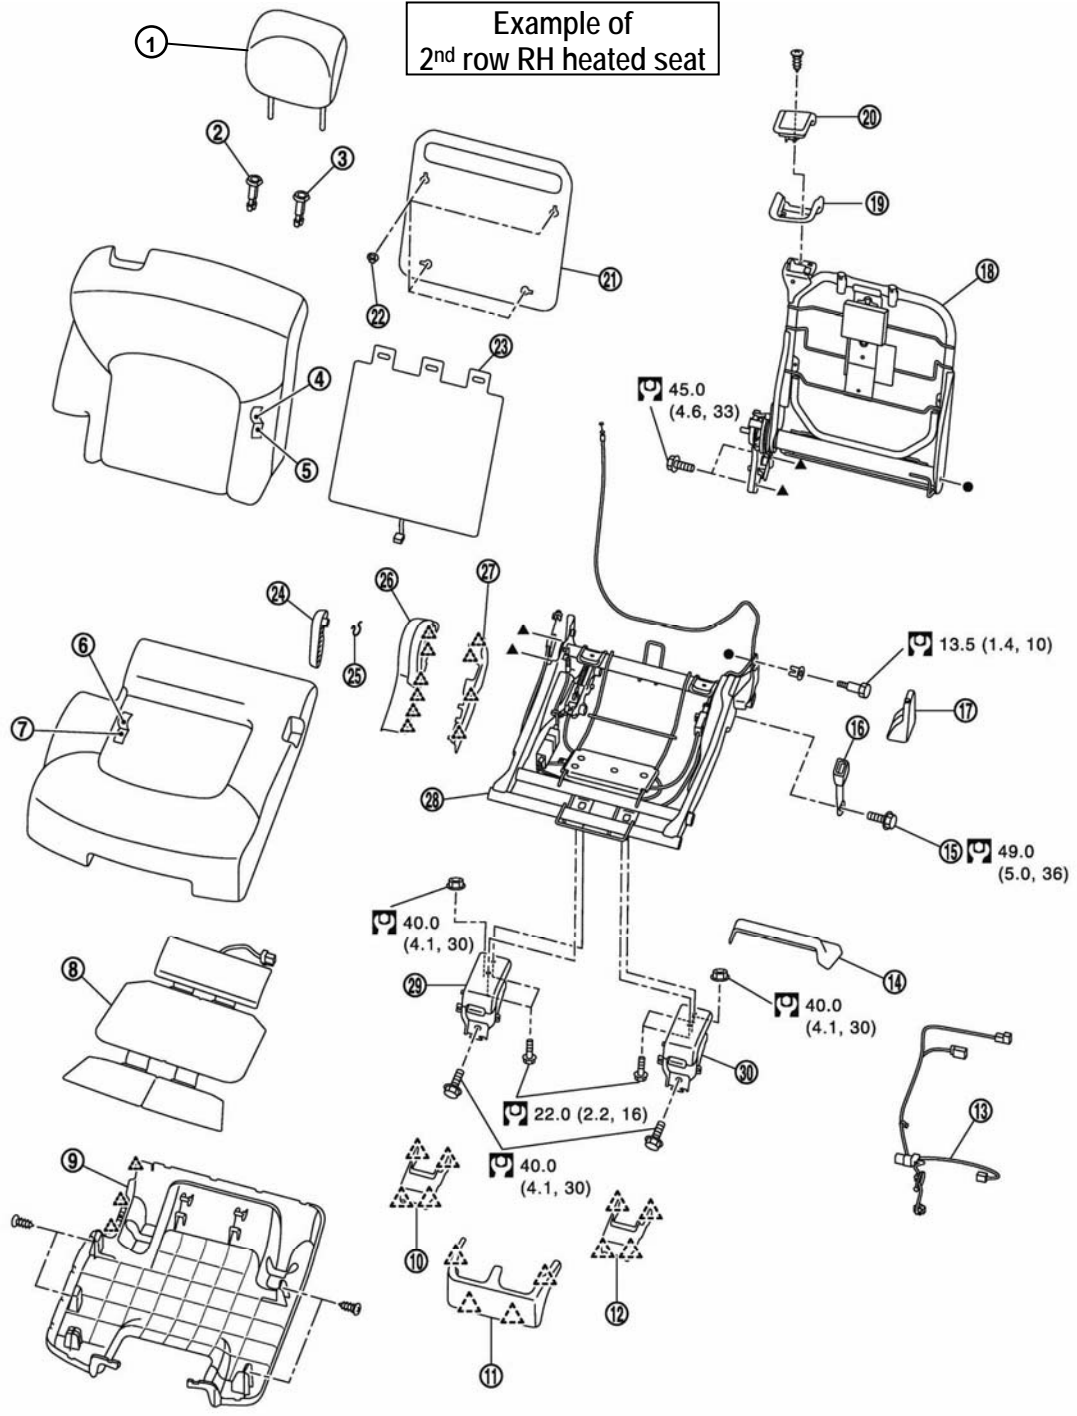
Example of
2nd row RH heated seat

- | | | |

| 1. Headrest RH | 2. Headrest holder (free) | 3. Headrest holder (locked) |
| 4. Seatback trim | 5. Seatback pad | 6. Seat cushion trim |
| 7. Seat cushion pad | 8. Seat cushion heater unit* | 9. Seat cushion under cover |
| 10. Seat cushion hinge cover RH | 11. Seat hinge cover RH | 12. Seat cushion hinge cover LH |
| 13. Seat harness assembly | 14. Seat cushion carpet | 15. Seat belt buckle anchor bolt |
| 16. Seat belt buckle | 17. Reclining inner cover (outside) | 18. Seatback frame |
| 19. Seat control lever escutcheon | 20. Rear seat lever assembly | 21. Seatback board |
| 22. Seatback board clip | 23. Seatback heater unit* | 24. Reclining lever knob |
| 25. Snap ring | 26. Reclining device outer cover (outside) | 27. Reclining device outer cover (inside) |
| 28. Seat cushion frame | 29. Seat hinge assembly RH | 30. Seat hinge assembly LH |

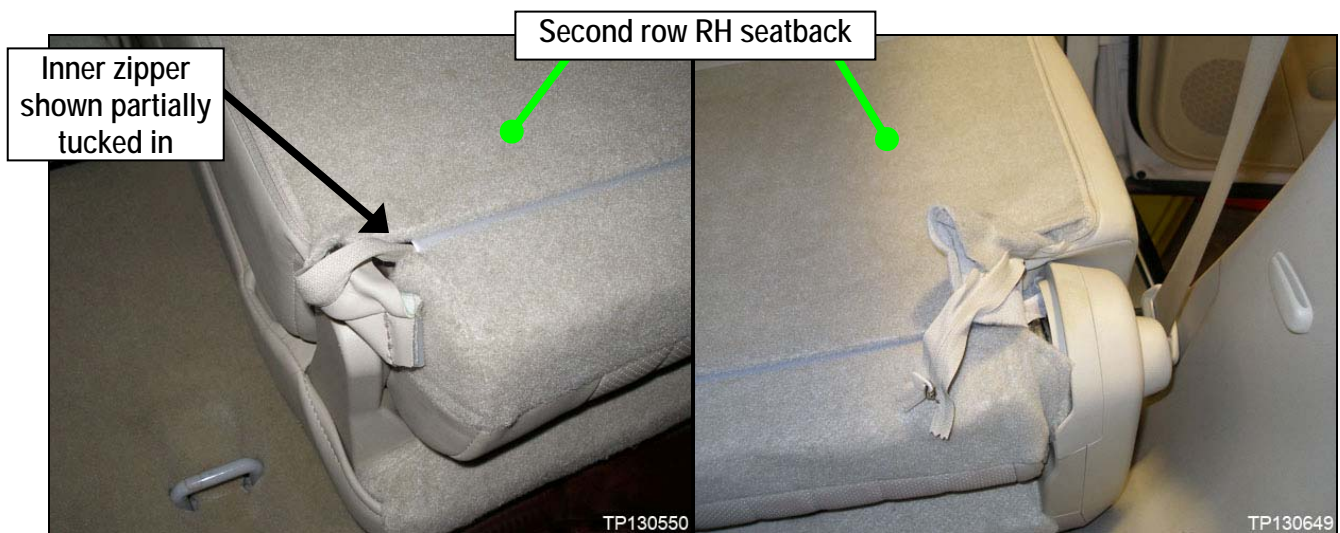
Figure 1

1. Unzip the inner and outer seatback zippers.
 - The ends of both zippers are tucked within the seat trim.

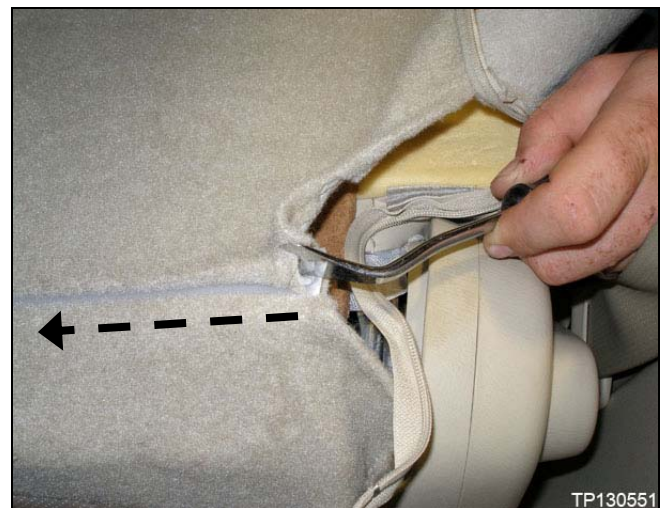
Figure 3

2. Unclip the full length of the bottom portion of the seatback trim with a suitable tool, and then peel it up and out of the way.

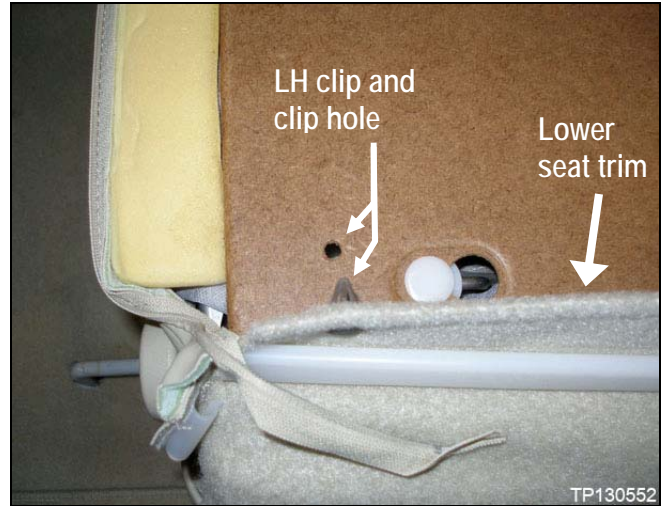
Figure 4

3. Unsnap both clips (one on each side), and then peel down the lower portion of the seat trim.

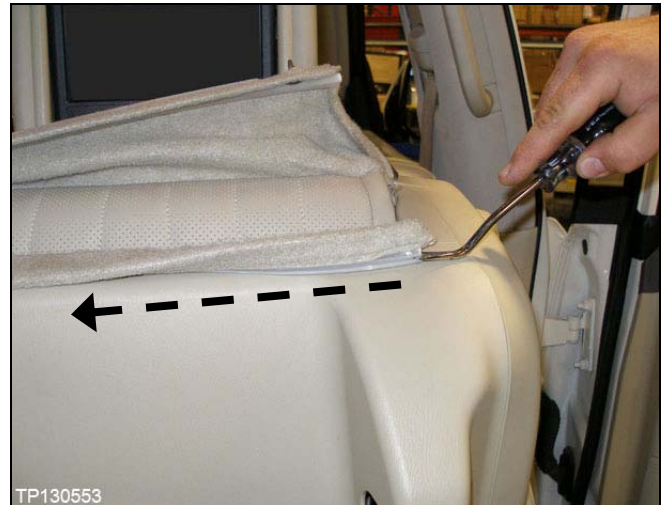
Figure 5

4. Similar to step 2, unclip the full length of the seat cushion trim, and then peel it down and out of the way.

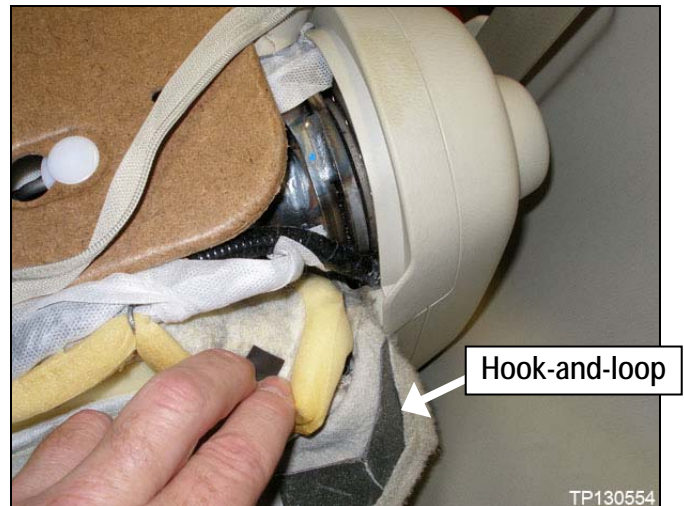
Figure 6

5. Unfasten the lower cushion where secured by hook-and-loop (or "Velcro" type) fasteners by peeling them apart.

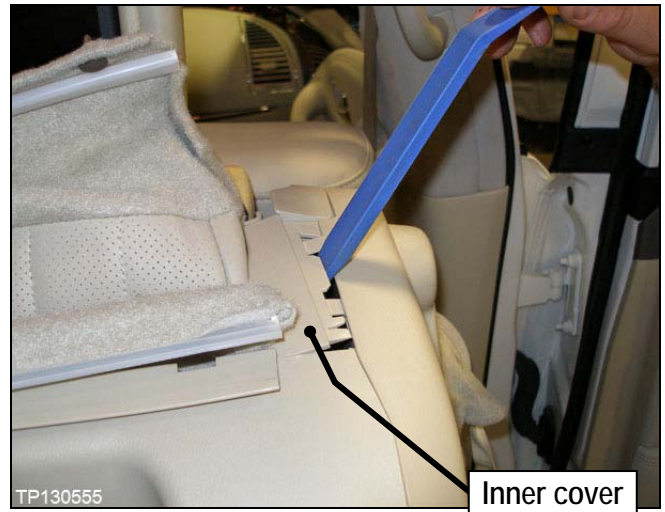
Figure 7

6. Unsnap the rear clips of the "reclining device outer cover inner" (or inner cover).

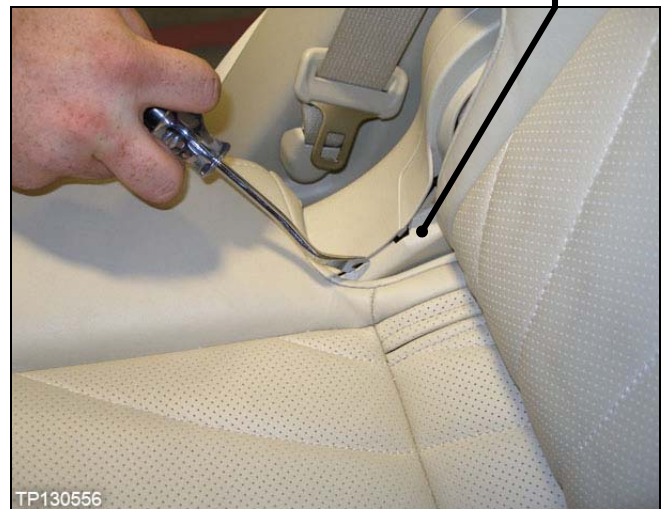
Figure 8

7. Unsnap the top clips of the inner cover.

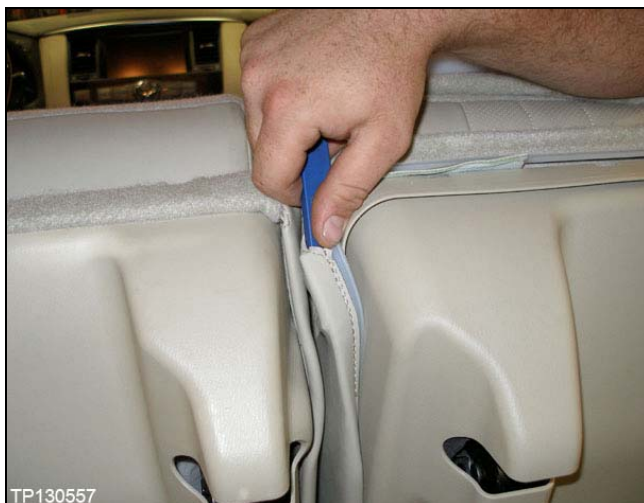
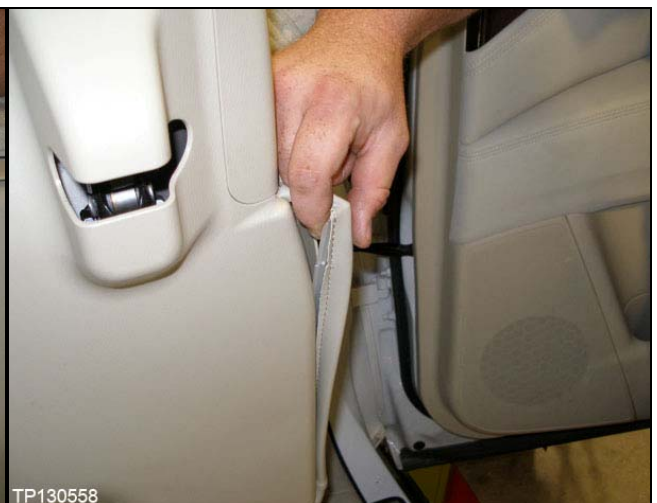
8. Similar to step 2 and 4, unclip the lengths of the seat cushion trim on each side, and then peel them out of their grooves.

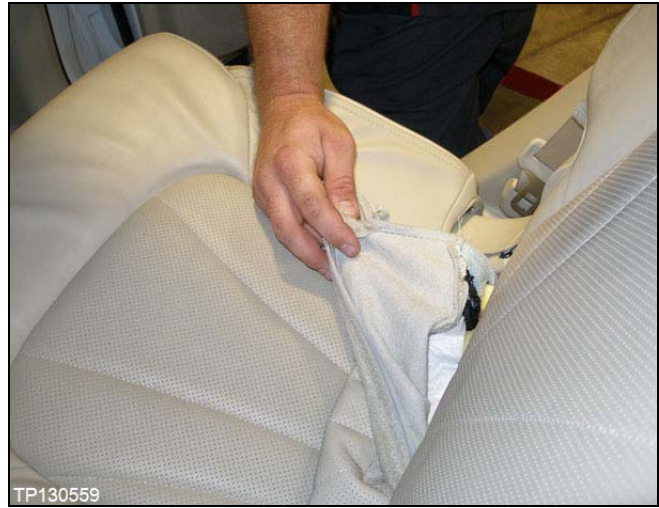
Figure 11

9. Carefully peel back the seat cushion trim and pad toward the front of the seat.

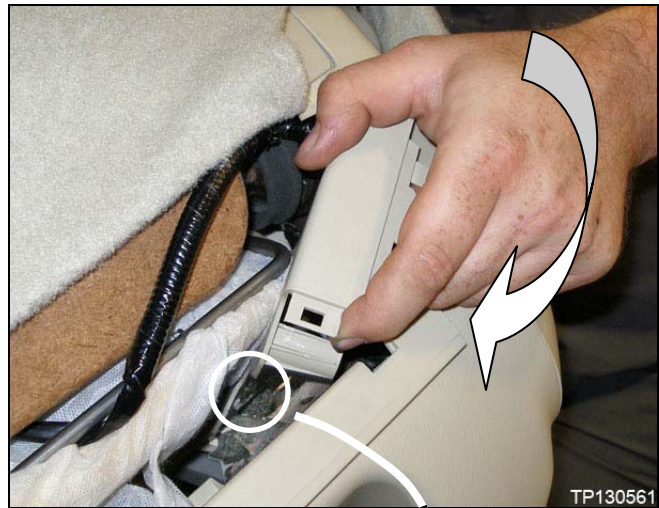
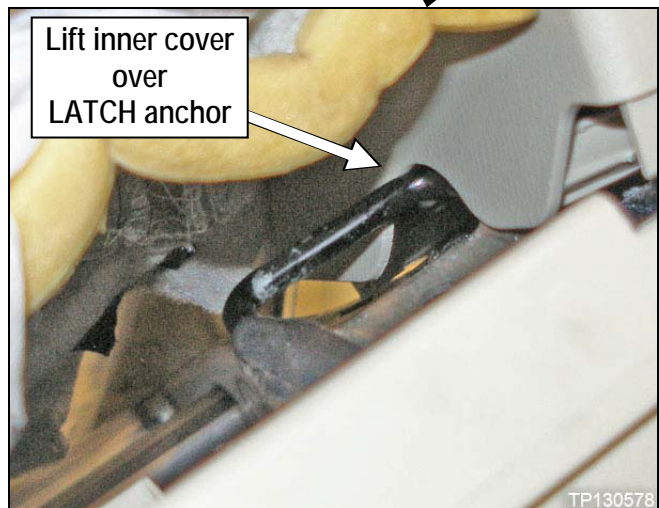
10. With the inner cover already detached, remove it by rotating clockwise and downward, and then removing from the backside of the seat (see Figure 12 and 13).

- The inner cover will need to be lifted above the LATCH anchor while rotating.

NOTE: This inner cover will not be reused and will be replaced by one with a new design (see **PARTS INFORMATION**).

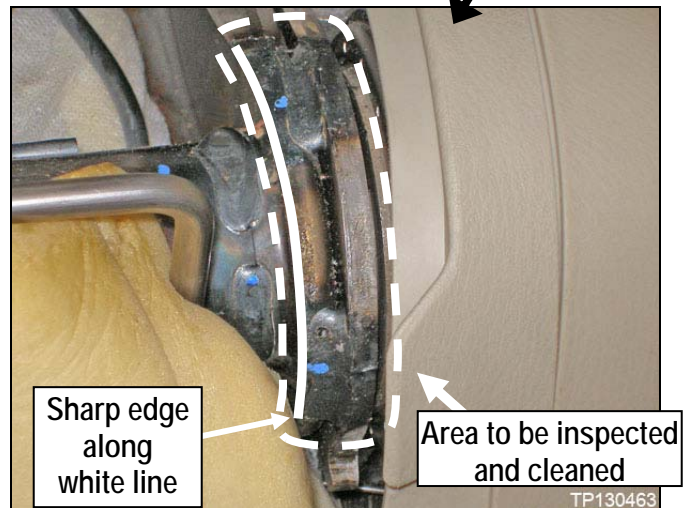
Figure 15

11. Inspect for and remove all weld spatter in the area where noted in Figure 15.

12. Smooth off the chiseled areas and sharp edge with suitable sandpaper, and then clean off the area shown in Figure 15.

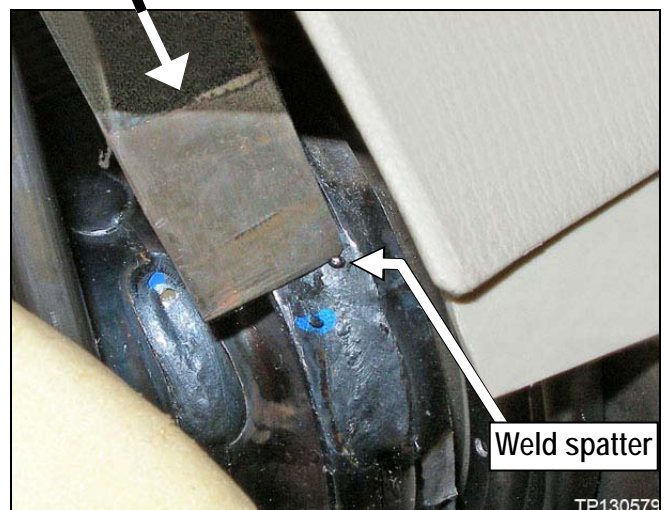
Figure 16

- Using a suitable hammer and chisel as shown in Figure 16, carefully chip off all spatter.
 - Do NOT chisel in an angle or direction other than shown in Figure 16.

CAUTION: Do NOT use a grinding type tool as the removed material may get into the reclining device.

Direction of chiseling

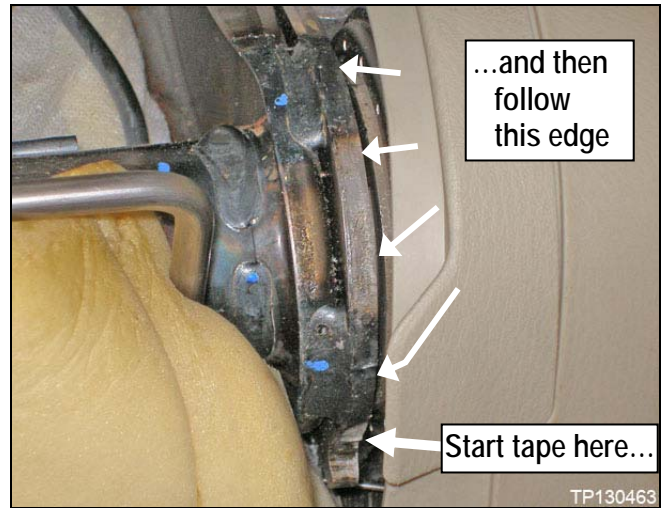
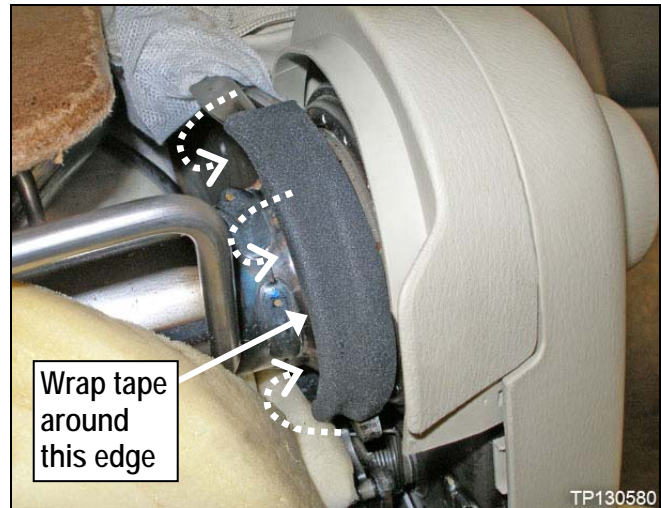
13. Apply a piece of 25 mm x 100 mm (1 inch x 4 inch) tape where shown in Figure 17 and 18.

- Use the tape listed in **PARTS INFORMATION**.
- Make sure to wrap the tape around the edge as shown in Figure 18.

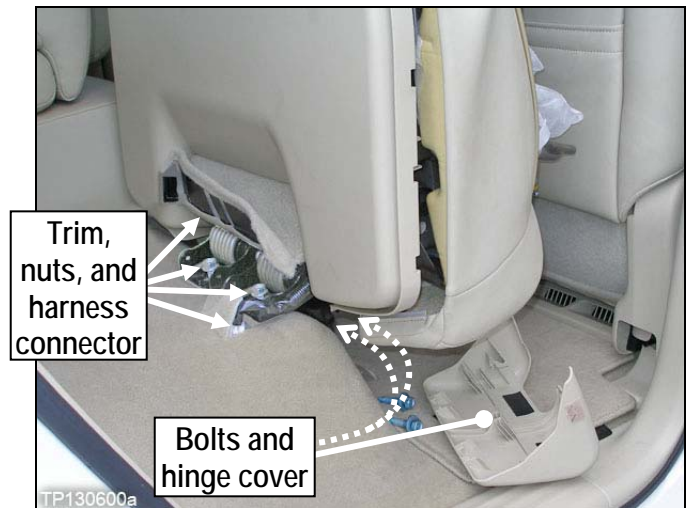
Figure 19

1. Remove the seat:

- Remove the hinge cover, and then remove the two bolts behind it.
 - Raise the seat, lift the trim, and then disconnect the seat harness.
 - Remove the two nuts, and then remove the seat.
- Perform seat repairs on a clean surface such as a work bench with suitable covering.

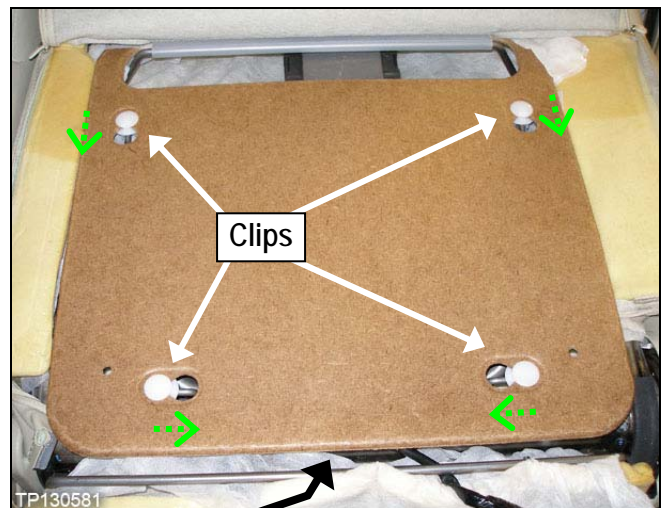
Figure 20

- Slide the four clips to line them up with the holes, and then move the seatback board out of the way.
- Disconnect the seat harness from the seatback heater unit's electrical connector (hidden behind the seatback board).

Seatback heater unit connector

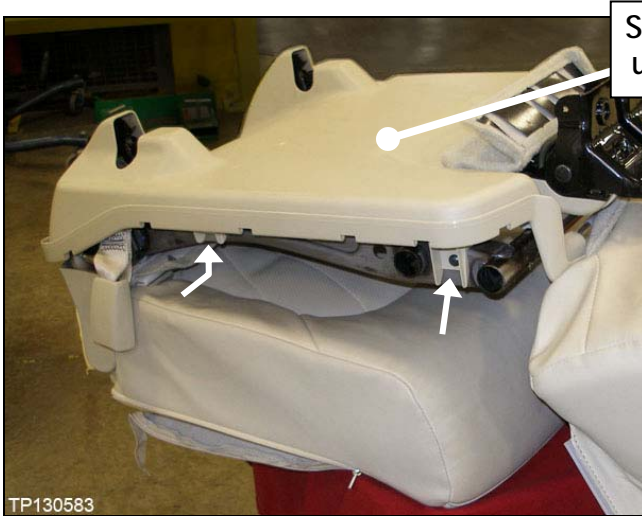
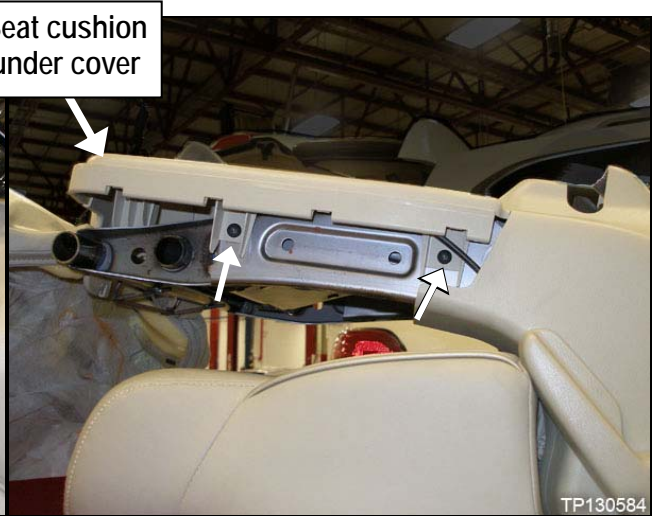
6. Remove the four screws (two on each side) holding the seat cushion under cover.

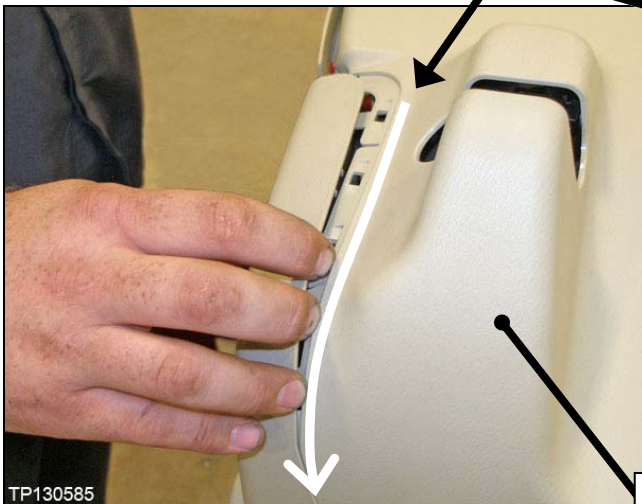
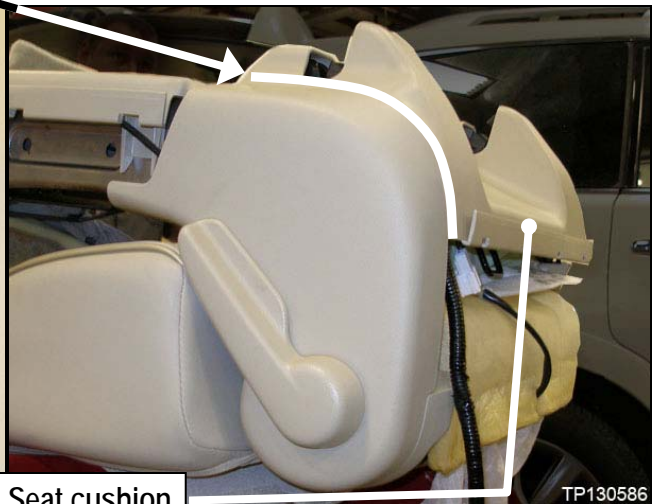
7. Unsnap both outer reclining covers from the seat cushion under cover as shown below, and then carefully remove the seat cushion under cover.

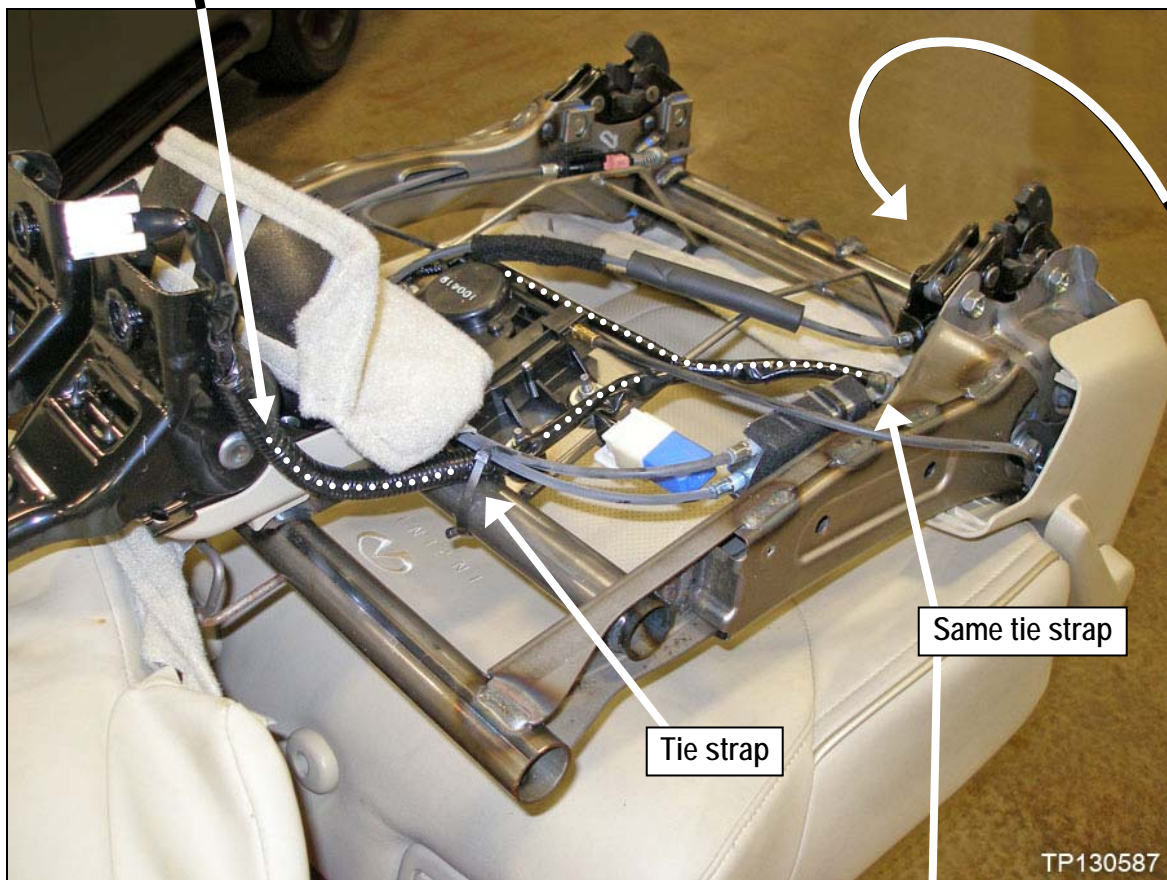
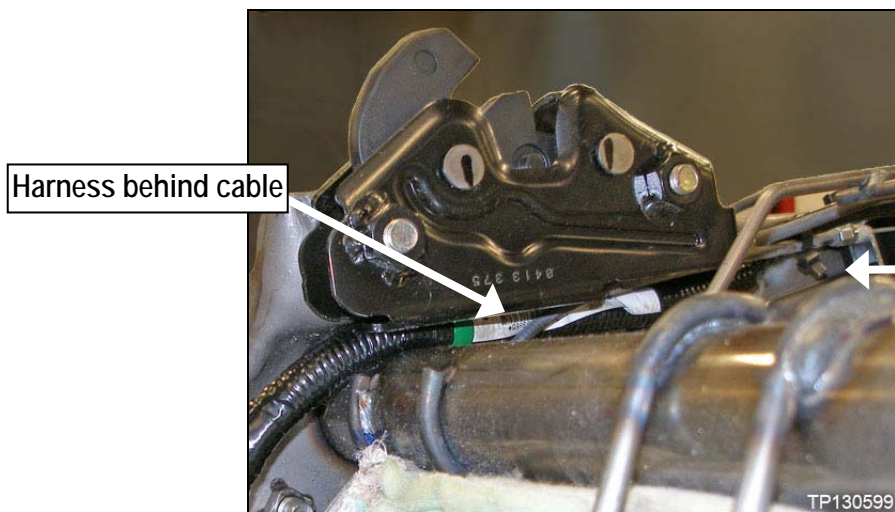
8. First, note the routing and securing of the seat harness, and then remove it.

9. Route and secure (with two tie straps) the new seat harness the same way as the old seat harness.
10. Reassemble the seat cushion in reverse order of disassembly as given under **If Needed: Replace Seat Harness**, and then go to page 8, step 15.
