SERVICE BULLETIN

Classification:	Reference:	Date:
BT13-002b	NTB13-005b	January 24, 2014

2013 - 2014 ALTIMA SEDAN; WIND, ROAD, OR RATTLE NOISE AT FOLDING DOOR MIRROR AREA

APPLIED VEHICLE: 2013 -2014 Altima Sedan (L33) with folding door mirrors **only**

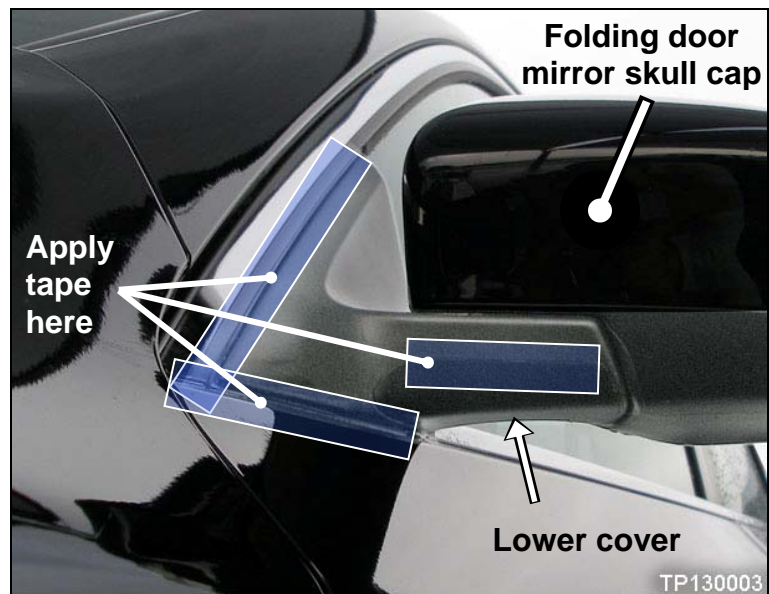
Figure 1

NOTE: The noises reduce during a road test after applying "painter's tape" or suitable covering where noted in Figure 1.

- The rattle noise is coming from the lower cover due to loose fit.

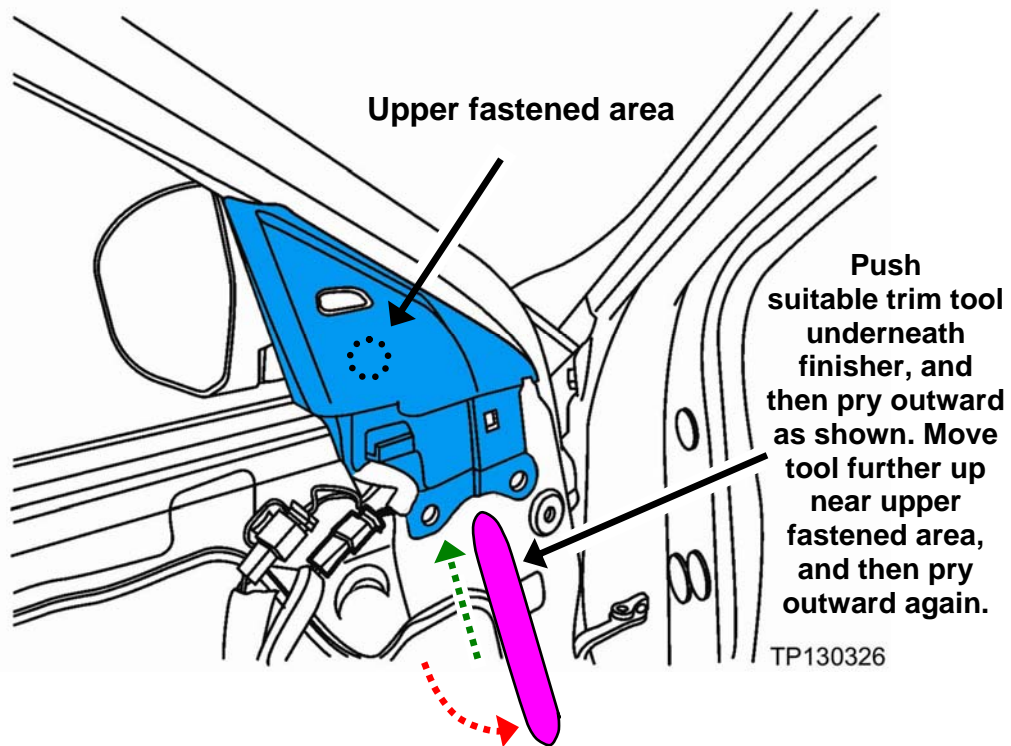
Figure 2

- The mirror(s) should be removed for both wind/road noise and rattle noise repairs.
1. Remove the folding door mirror from the door where the noise is heard.
 - Refer to the **L DRIVER CONTROLS > MR Mirrors** section of the ESM.
 - Make sure your hands are clean before starting this repair.
 - When removing the door mirror corner finisher, make sure to remove it as noted below.

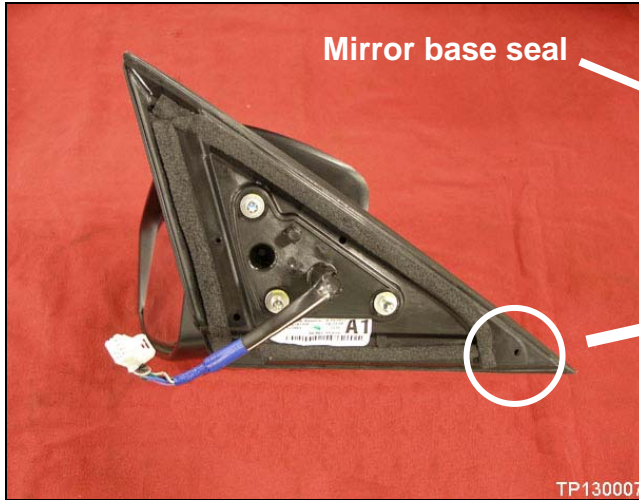
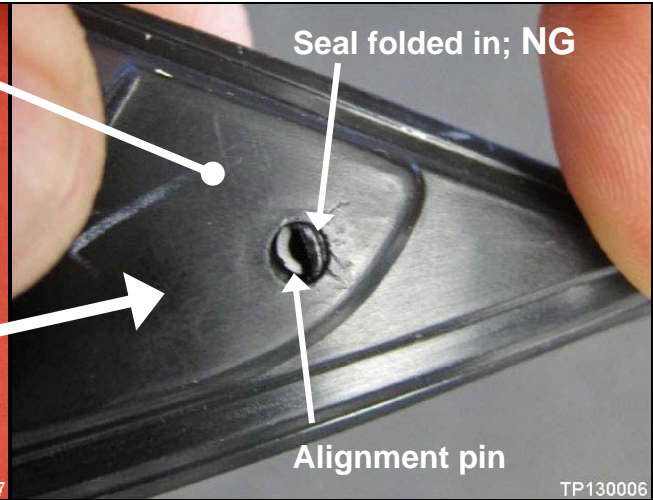
2. Visually inspect the folding door mirror's fastening hardware and foam strips for looseness, damage, etc.
 - If NG, repair / replace as necessary.
3. If the folding door mirror inspects OK, note the relation between the alignment pin and its pin hole (see Figure 3 and 4).

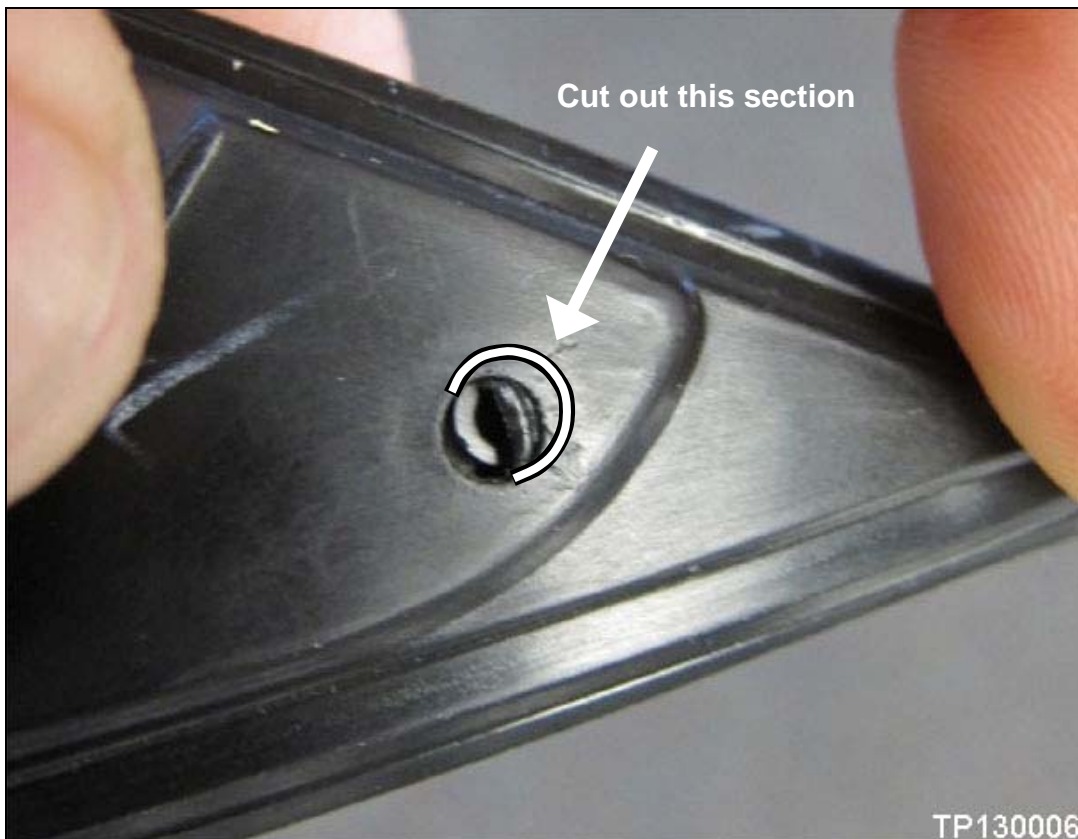
Figure 5; Example

4. Pull back the seal from the door mirror, and then open up the pin hole larger as needed to allow the pin to fit through.

5. Reinstall the seal, make sure the pin fits through and the seal fits flush and aligned to the folding door mirror.
 - This will allow the folding door mirror to fit flush and seal properly to the door.
6. Using a pocket screwdriver or other suitable tool, remove the lower cover (see Figure 6).

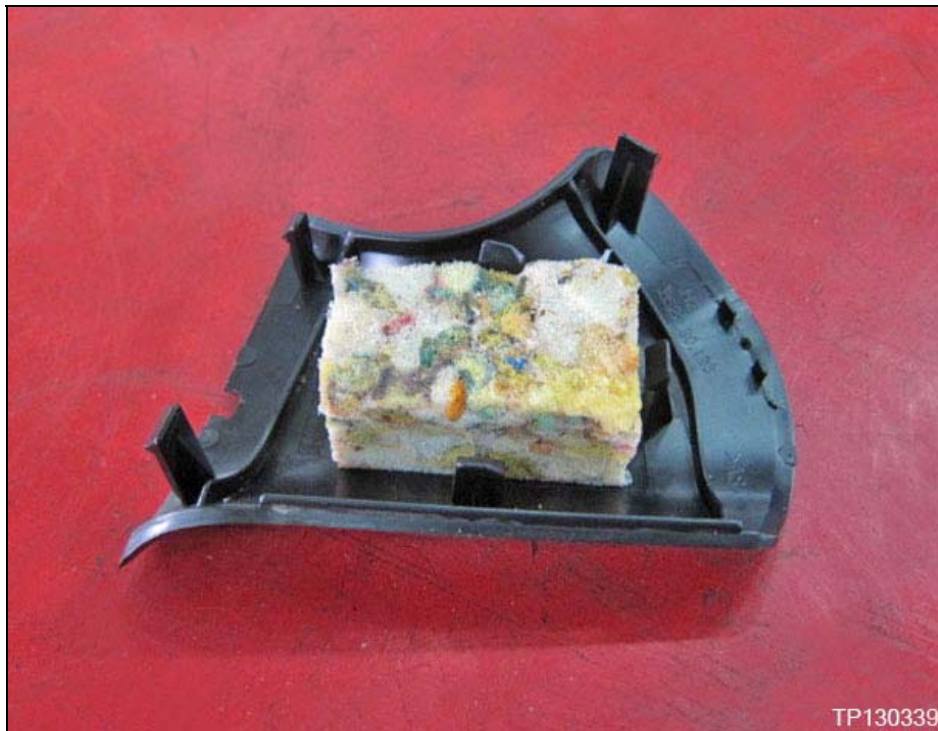
Figure 7

7. Put a piece of foam (see **PARTS INFORMATION**) between the lower cover and the folding door mirror, and then reinstall the lower cover.
 - The foam in **PARTS INFORMATION** has an adhesive backing.
 - The foam will need to be cut to size: 25 mm H x 20 mm W x 40 mm L (approx. 1 inch H x $\frac{3}{4}$ inch W x 1 $\frac{1}{2}$ inches L)

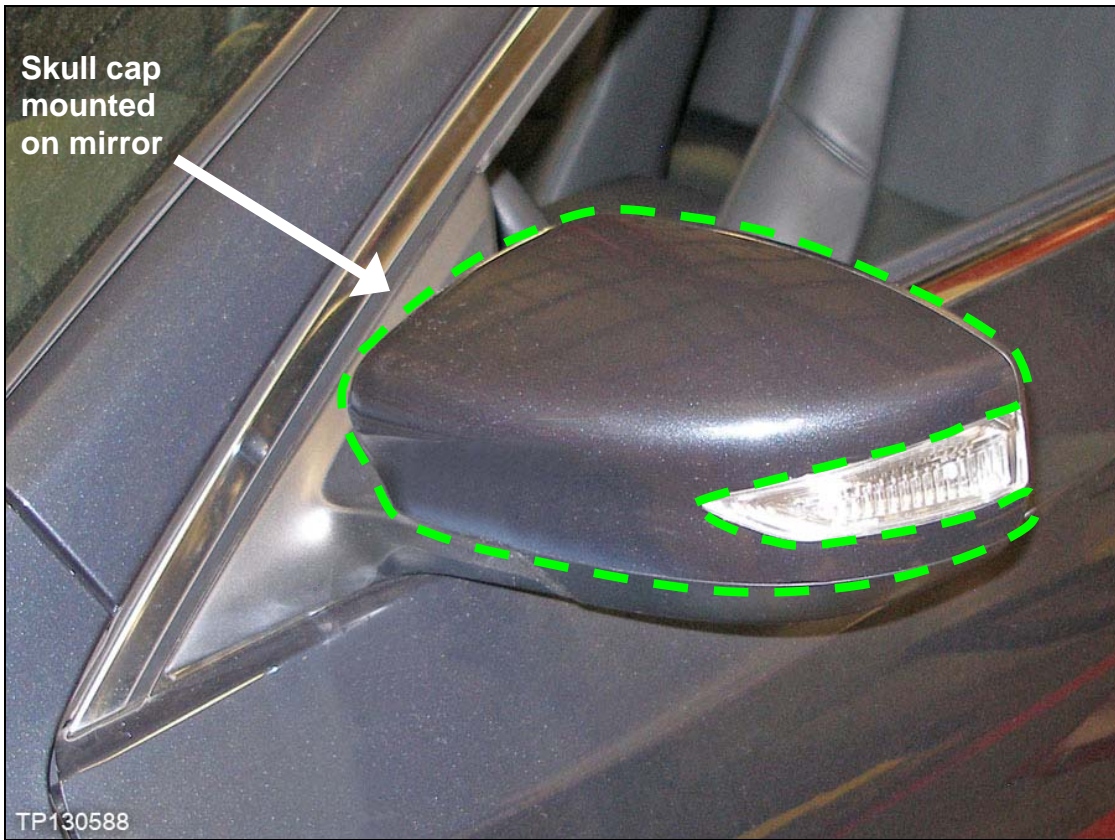
Figure 8; mirror with skull cap

8. Reinstall the folding door mirror.
 - Refer to the **L DRIVER CONTROLS > MR Mirrors** section of the ESM.
9. Verify the repair.
 - a. If the incident is resolved, repairs are complete.
 - b. If clearly determined this service procedure did NOT resolve the issue and the issue is still caused by the mirror assembly(ies), replace the mirror assembly(ies) and skull cap.
 - When removing, **DO NOT DISTURB** the mirror assembly. Leave the complete assembly in the exact same condition as it was during after-repairs testing. The mirror(s) being replaced will be collected by Nissan for further testing/investigation.
