BT14-021b

February 19, 2015

2014-2015 Q50 AND Q50 HYBRID; STRONG ODOR INSIDE VEHICLE

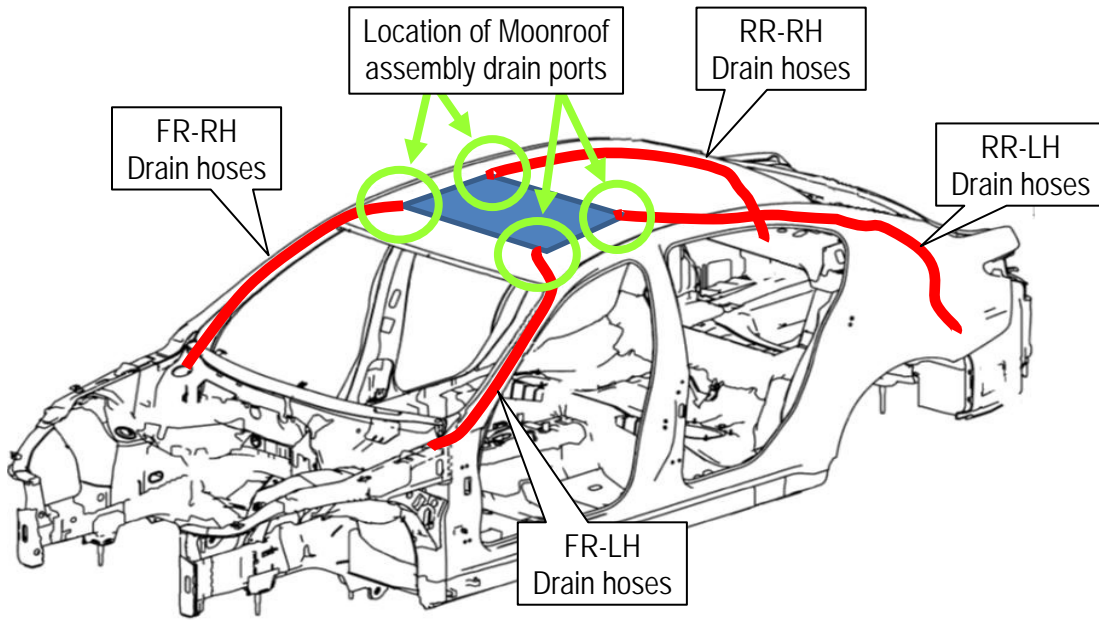
Figure 1 shows the hoses that will be replaced in the following procedure.

4. Disconnect all four Moonroof drain hoses (Figure 1) one at a time from the Moonroof assembly drain ports and blow compressed air into them to remove any residual water and/or debris.

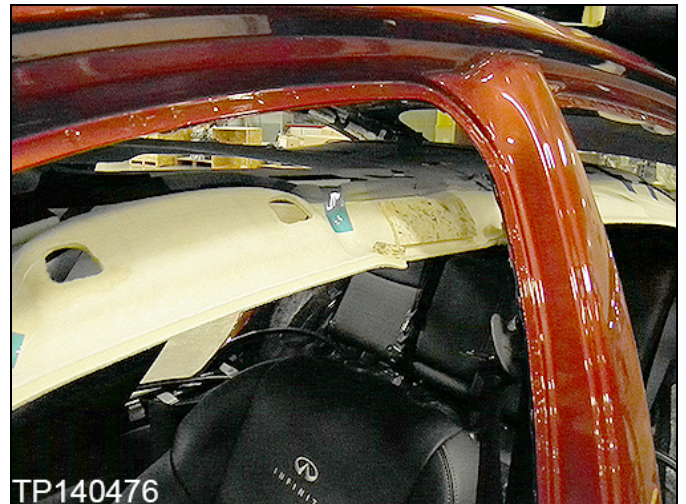
Figure 2

3. Lower the headlining, but do not remove it from vehicle.

- Rest the headlining on top of the seats (Figure 2).

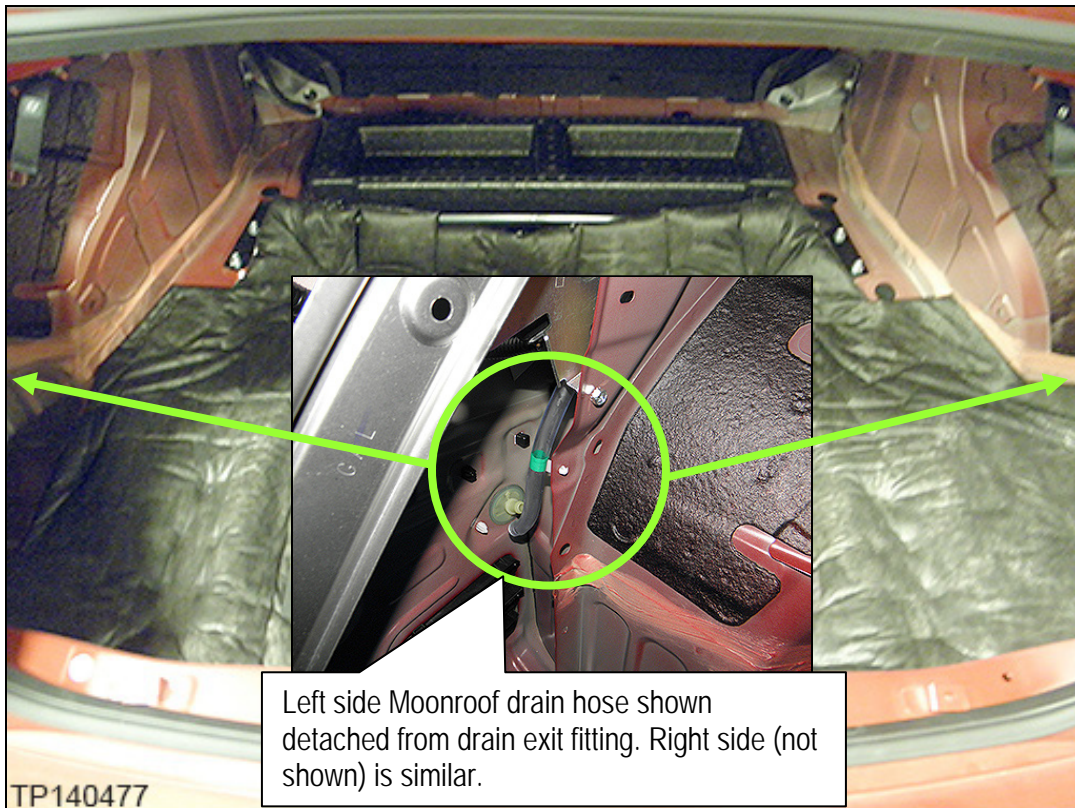
Figure 3

6. Disconnect the Moonroof drain hoses from the trunk side exit fittings (Figure 3) and then proceed to step 9.

Left side Moonroof drain hose shown detached from drain exit fitting. Right side (not shown) is similar.

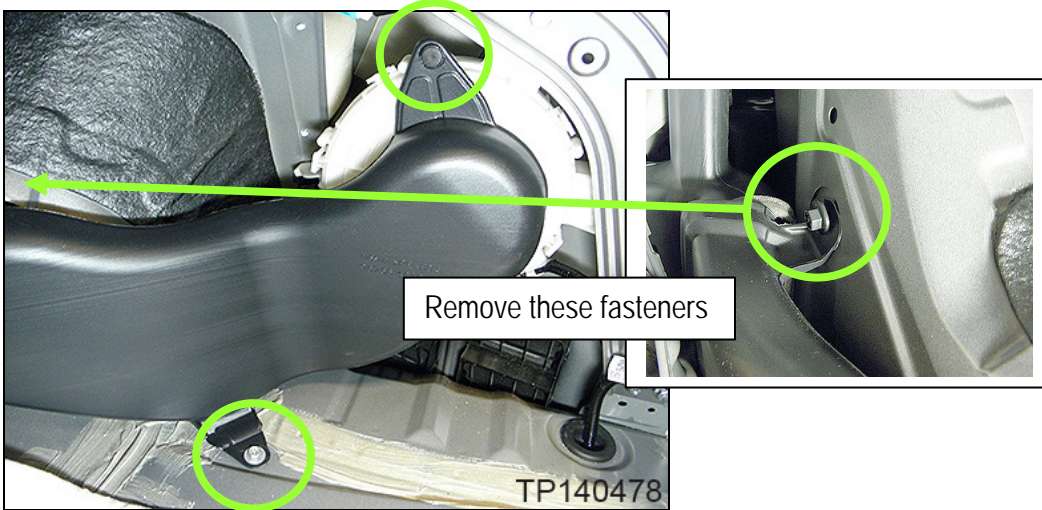
Figure 4

7. For HEV vehicles only, remove the battery cooling fan duct attached on right side of trunk (Figure 4).

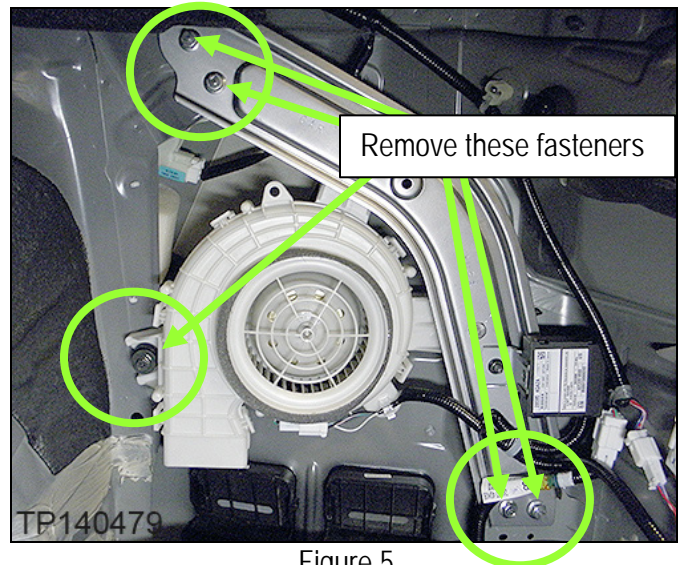
8. Remove the nuts and bolts shown in Figure 5 and then move the High Voltage battery cooling fan and bracket gently out of the way.

Reassembly Torque: 9.5 N·m (0.97 kg-m, 84 in-lb)

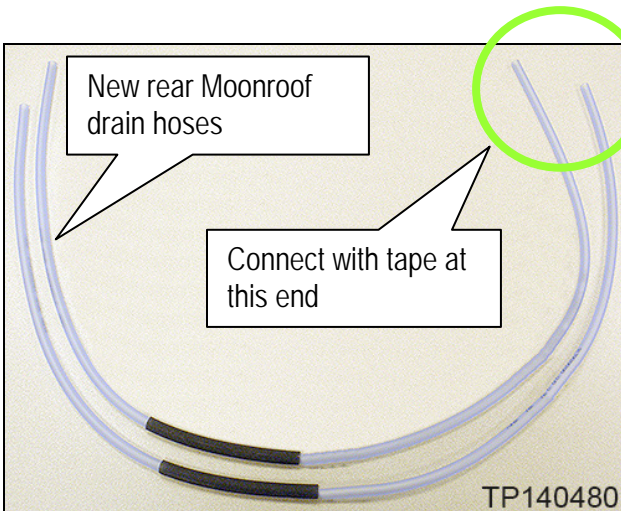
Figure 6

9. Tape a new rear Moonroof drain hose (Figure 6), from the Parts Information table, to the trunk end of the left and then right side Moonroof drain hoses as shown in Figure 7.

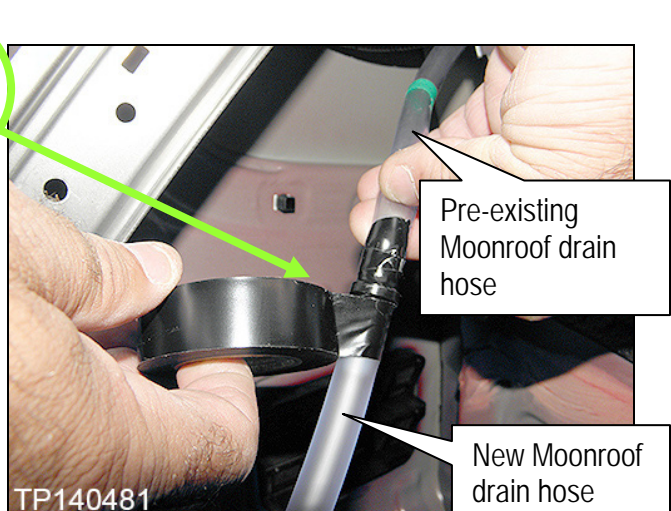
Figure 7

NOTE: This will allow the new hose to be drawn through the C-pillar/package shelf.

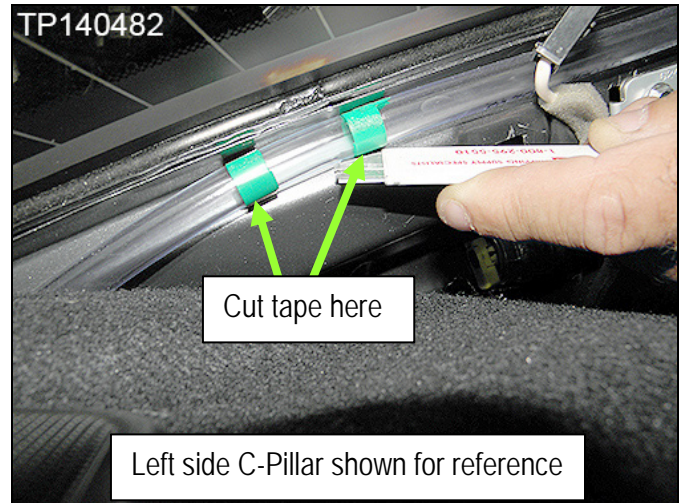
Figure 8

10. Cut the tape (left side is green, right side is black) of each clip that holds the rear drain hoses in place to the C-pillars and then remove the tape (Figure 8).

- There are two taped clips at each rear C-pillar.

NOTE: Do not remove the clips from body panel. If the clips are broken they may fall into the pillar panels, and cause noise.

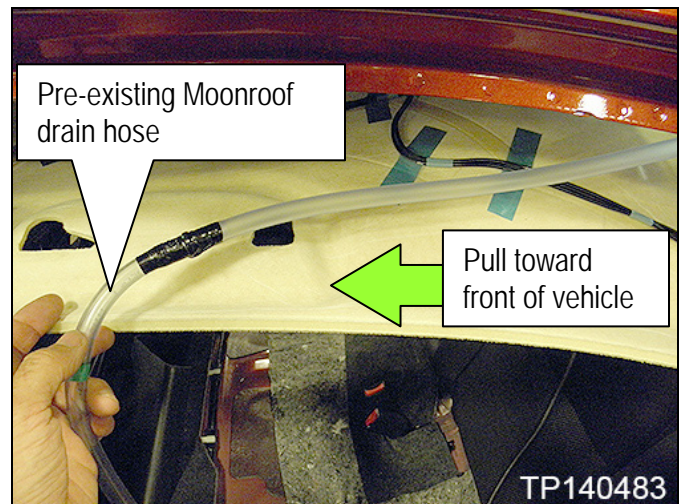
12. Gently pull the pre-existing rear Moonroof drain hoses from the Moonroof side to draw the new drain hoses connected to them into the vehicle.

NOTE: Figure 9 shown from driver's side rear door.

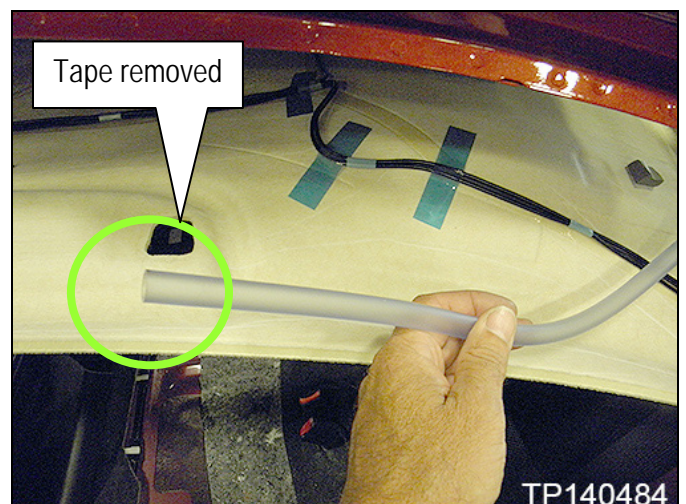
Figure 10

15. Tape the new hoses to the 2 body clips (4 total) on the left and right C-pillars that they were removed from in step 10 (example shown in Figure 18).

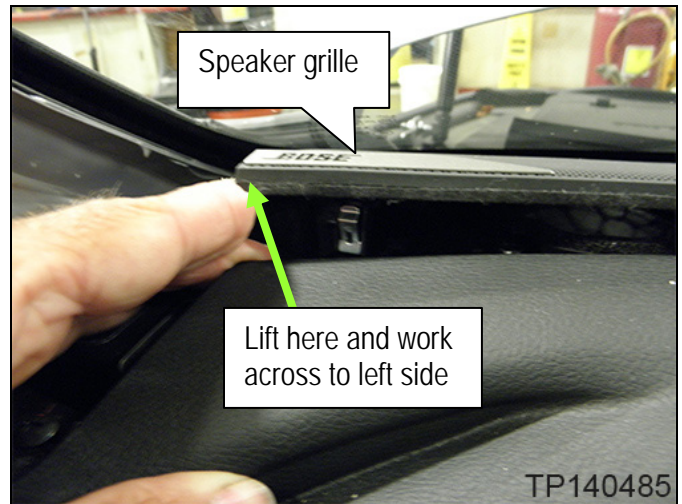
Figure 11

1. Detach the front speaker grille.
 - Lift the left side of the front speaker grille and work from left to right to unsnap speaker grille.

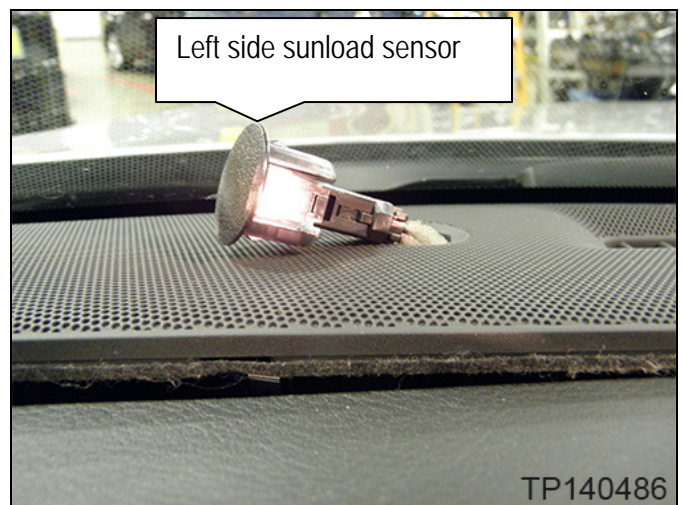
Figure 12

2. Disconnect both left and right sunload sensors and then remove the front speaker grille.

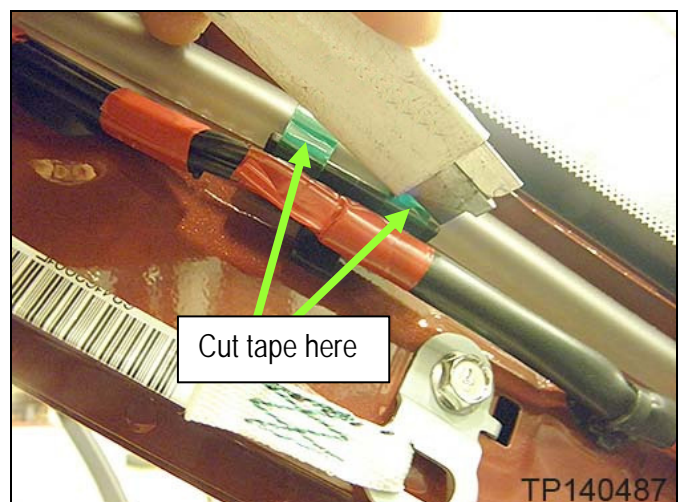
Figure 13

3. Cut the tape (left side is green, right side is black) of each clip that holds the front drain hoses in place.
 - There are 4 clips at each front A-pillar.

NOTE: Do not remove the clips from body panel. If the clips are broken they may fall into the pillar panels and cause noise.

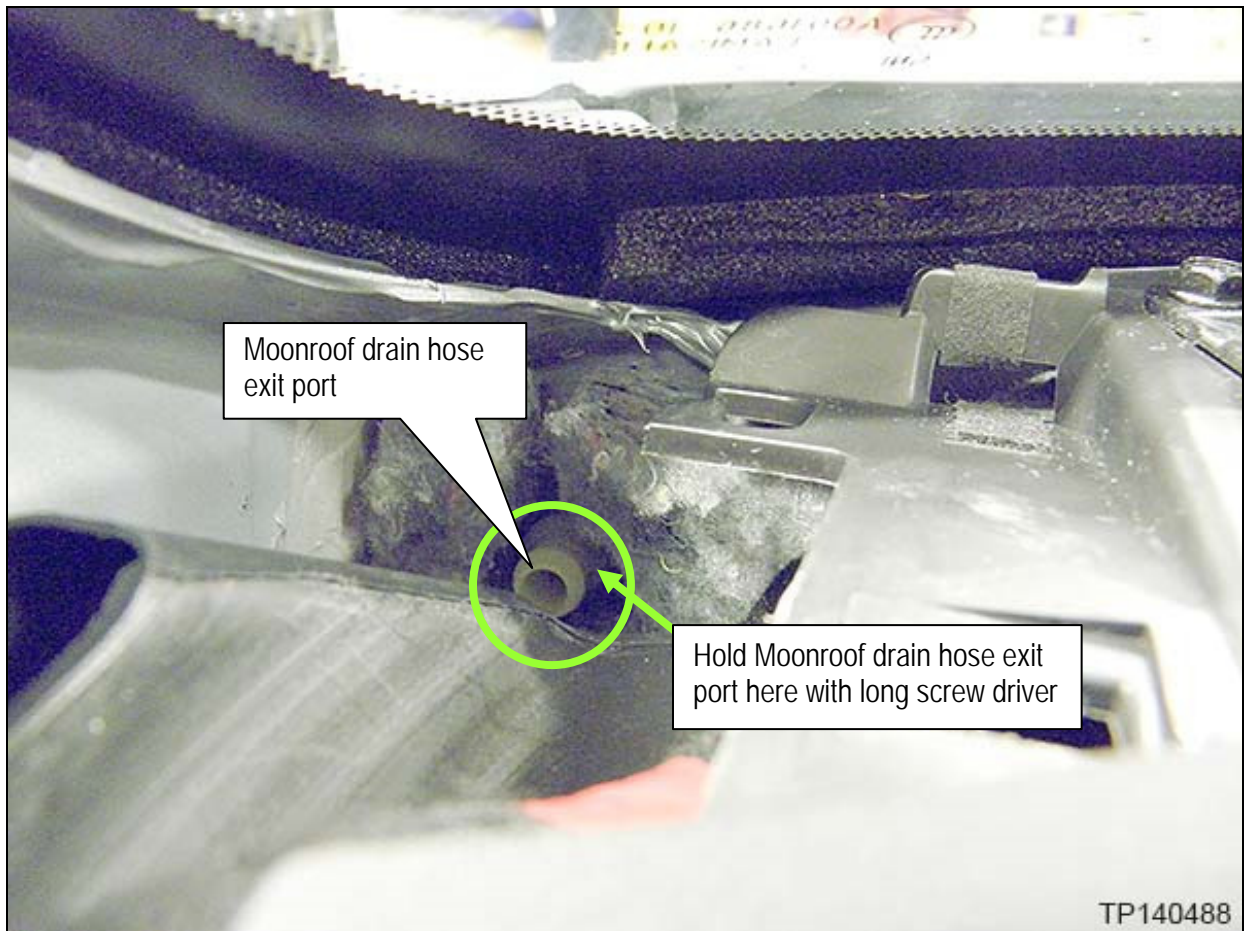
Figure 14

4. Disconnect the left side Moonroof drain hose from the drain hose exit port with long curved needle nose pliers, and then remove the front Moonroof drain hose from the vehicle.

IMPORTANT: When removing the Moonroof drain hose from the exit port, hold the drain hose exit port in place with a long screw driver to prevent it from being detached from the bulkhead.

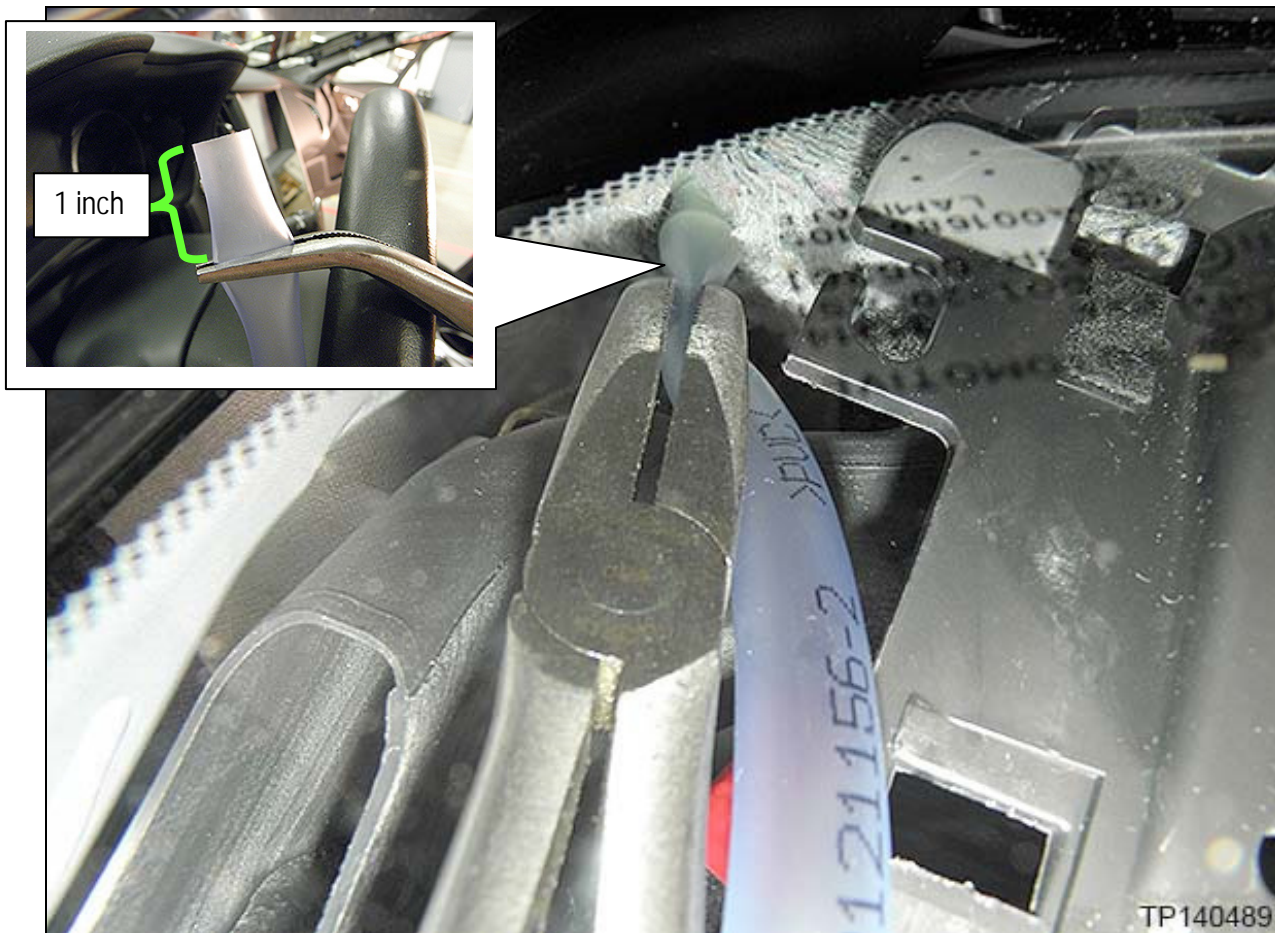
Figure 15

- Grab the end of the new Moonroof drain hose 1 inch from the end with long curved needle nose pliers.

NOTE: The end of the Moonroof drain hose with the **foam wrap** on it is the Moonroof Assembly side.

- Attach the new left front Moonroof drain hose, from the Parts Information table, to the left drain hose exit fitting and then to the left side Moonroof Assembly drain port.

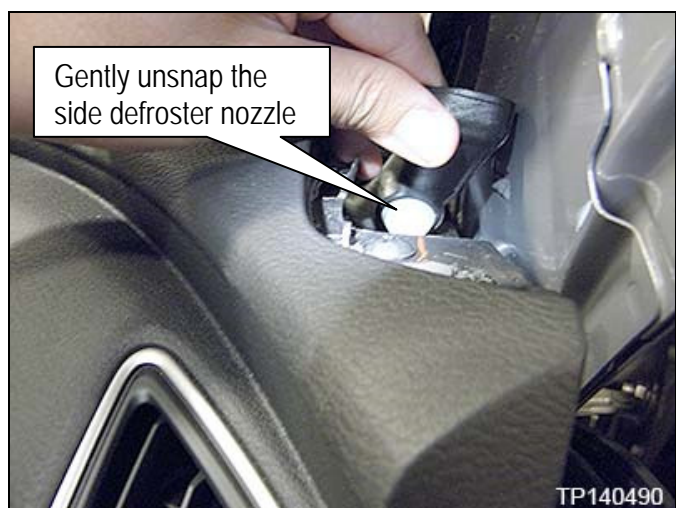
Figure 16

- Unsnap the passenger side defroster nozzle and move to the side to gain access to the right side Moonroof drain hose exit port (Figure 16).

NOTE: When removing the Moonroof drain hose from the drain hose exit port, hold the drain hose exit port in place with a long screw driver to prevent it from being detached from the bulkhead.

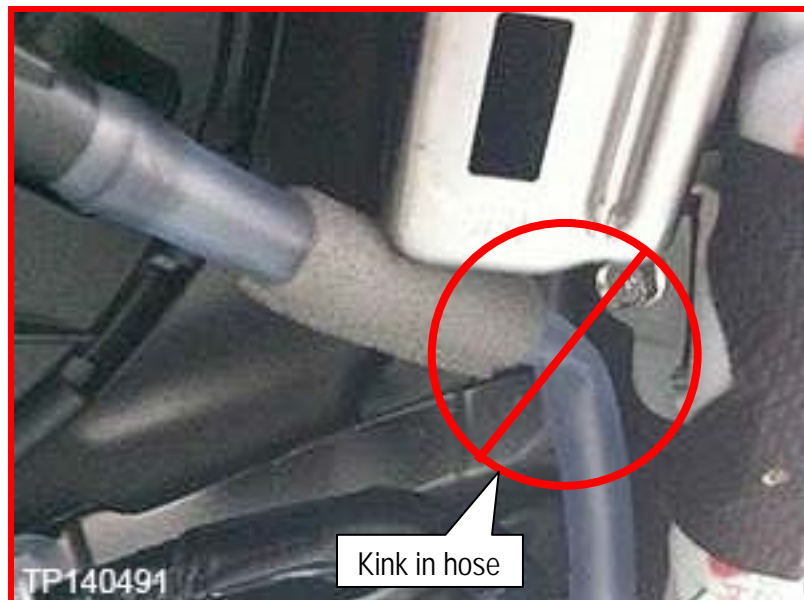
Figure 17

10. Before taping the Moonroof drain hoses in place, center the hose(s) over the clips so that the hose(s) do not kink and create a blockage (example of kink shown in Figure 17).

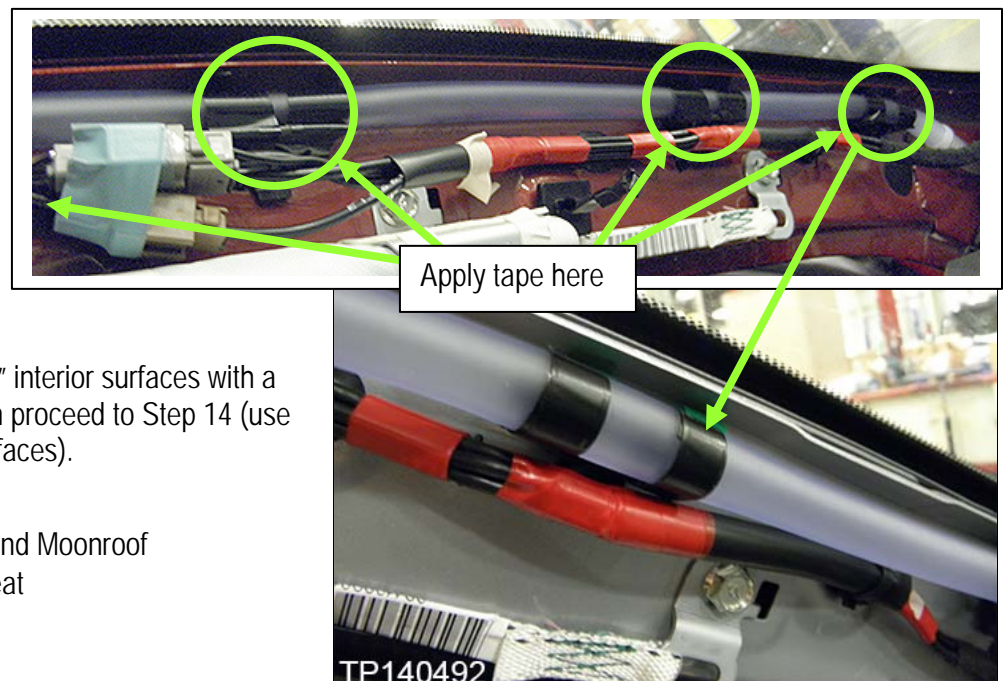
Figure 18

11. Tape the new hoses to the 4 body clips (8 total) on the left and right A-pillars that they were removed from in step 3 (Figure 18).

NOTE: Fourth clip(s) not shown.

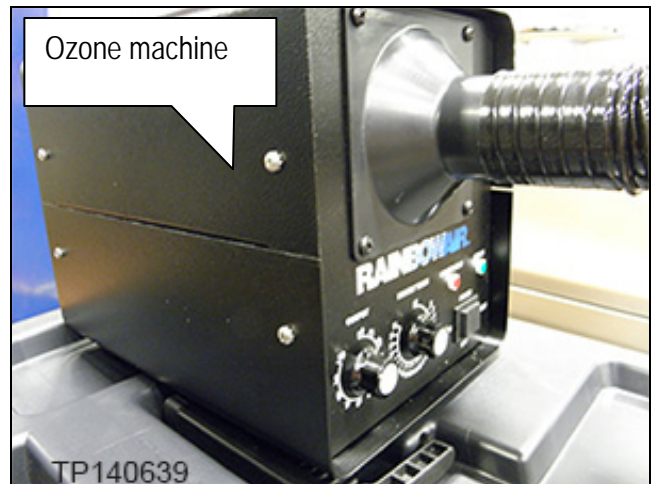
Figure 20

5. Remove the TechMate ozone machine (Rainbowair Activator 1000 - II Mobile Station, part number #188-5401-II MS), foam inserts (Figure 21) and ducting hose from its storage case.
6. Place the ozone machine on top of the storage case.
7. Fold down the rear seat arm rest, and then open the pass through access panel to the trunk that is located behind the arm rest.

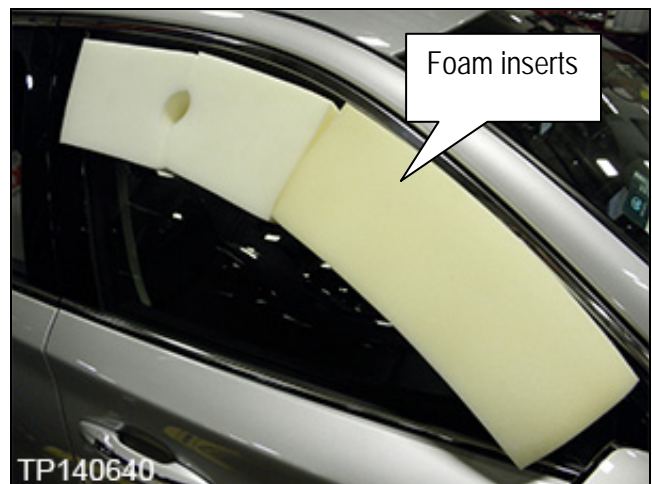
Figure 21

8. Close all windows, doors, and Moonroof.
9. Roll down either the passenger or driver's side window half way.
10. Insert the foam from kit (Shown in Figure 21) into chosen window, and then close window until snug fit is achieved.

NOTE: Confirm that any gaps in the foam are as small as possible. This will prevent ozone from escaping.

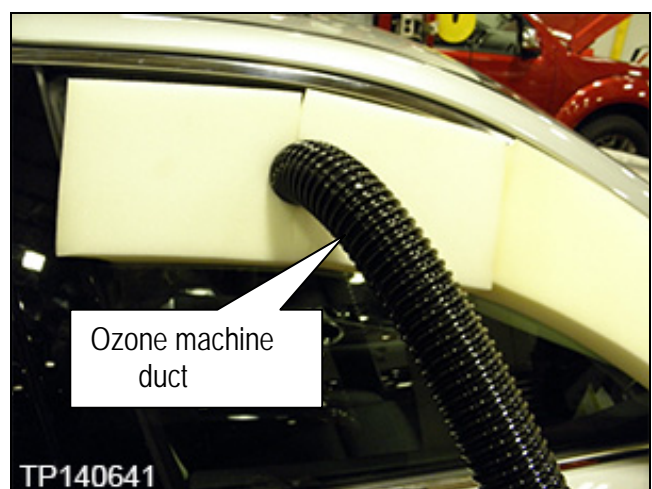
Figure 22

11. Connect the duct hose to the ozone machine and then the other end into the hole provided in the foam inserts.

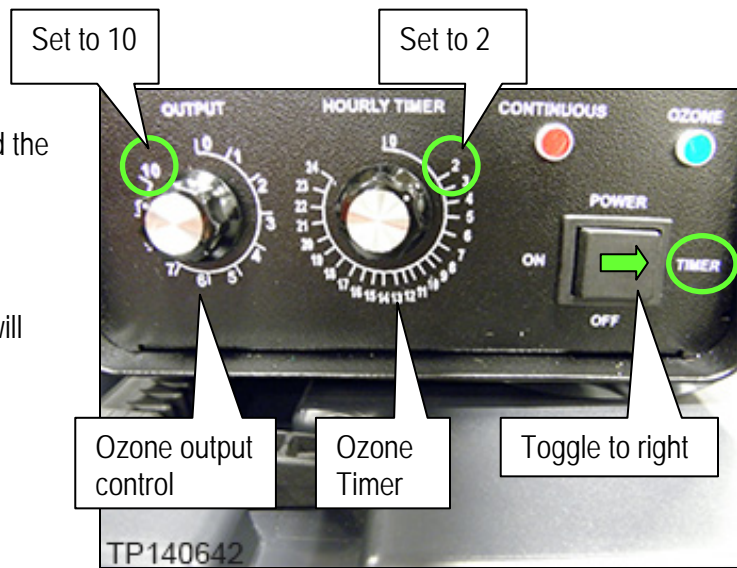
Figure 23

12. Set the ozone machine's **OUTPUT** to 10 and the **HOURLY TIMER** to 2.

13. Toggle the **POWER** switch to **TIMER**. This will start the flow of ozone.

After 2 hours the machine will shut off.
