SERVICE BULLETIN

Classification: EL15-004a	Reference: NTB15-022a	Date: April 28, 2015
------------------------------	--------------------------	-------------------------

NV200 AND NV200 TAXI; CRANK NO START BELOW FREEZING AFTER OVERNIGHT COLD SOAK AND DTC U1000 STORED

APPLIED VEHICLES: 2013-2015 NV200 (M20)
2014-2015 NV200 Taxi (M20)

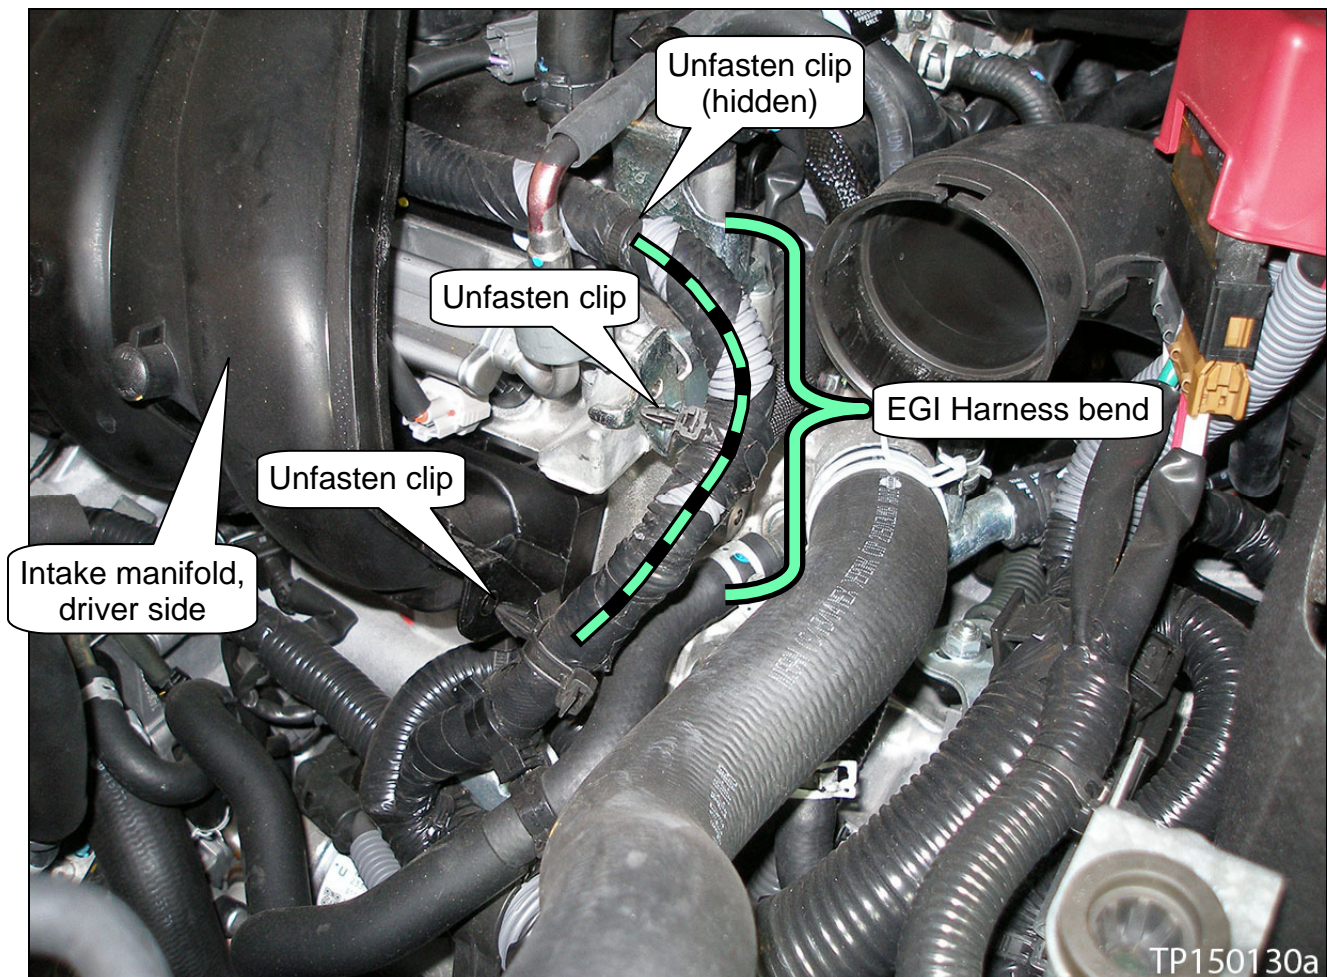
Figure 1

- Disconnect both battery cables, negative cable first.
 - Make sure to use suitable protection on the fenders and bumper fascia as needed.
- Remove the front air duct.
- Locate the bend in the EGI harness where shown in Figure 1.
- Unfasten the three (3) clips where shown in Figure 1.

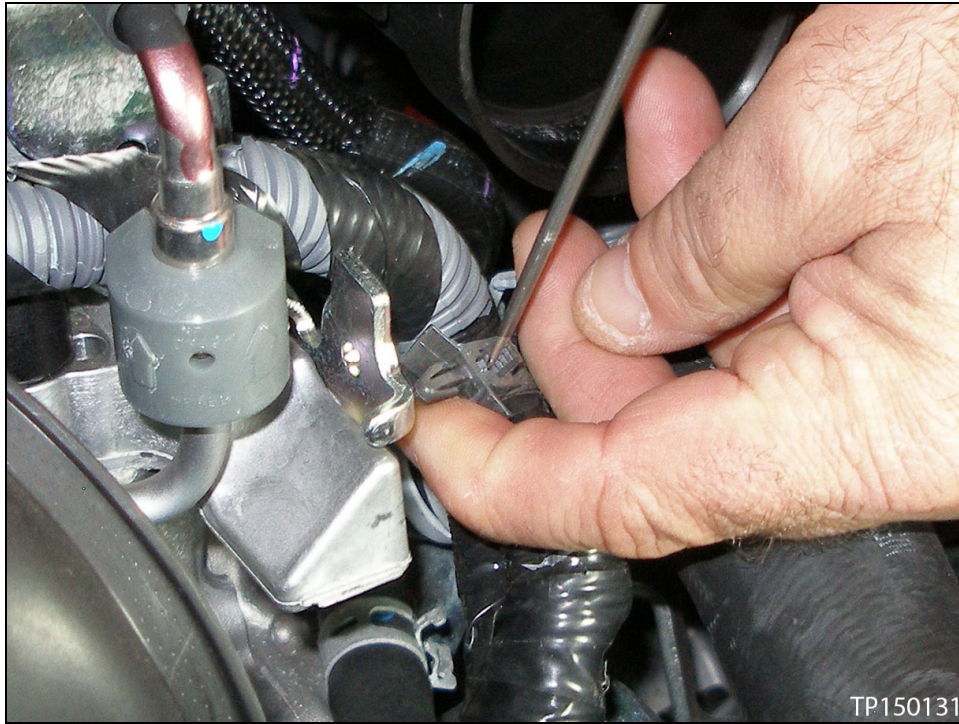
Figure 2

6. Remove the middle clip from the EGI harness where shown in Figure 2.

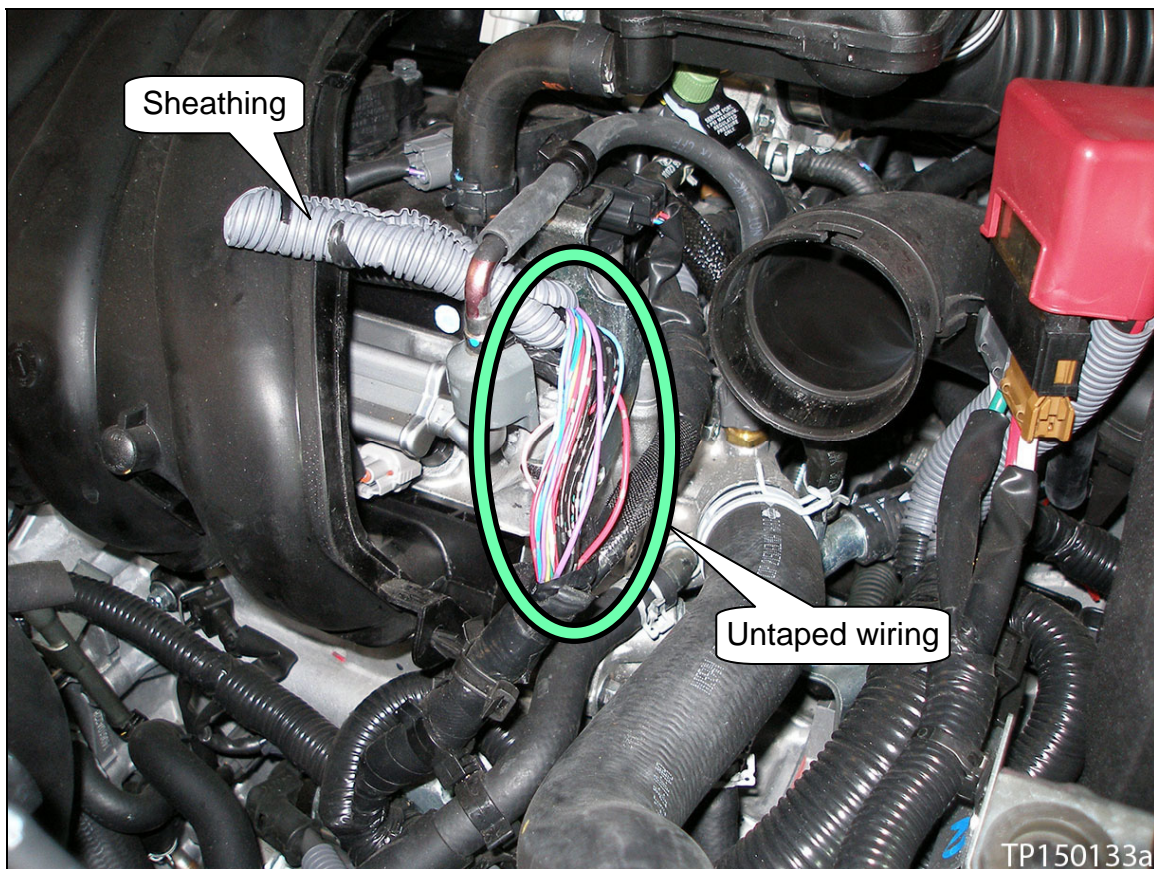
Figure 3

7. Untape the sheathing, and then pull back the sheathing out of the way (see Figure 3).
8. After pulling back the sheathing, untape the wiring (see Figure 3).

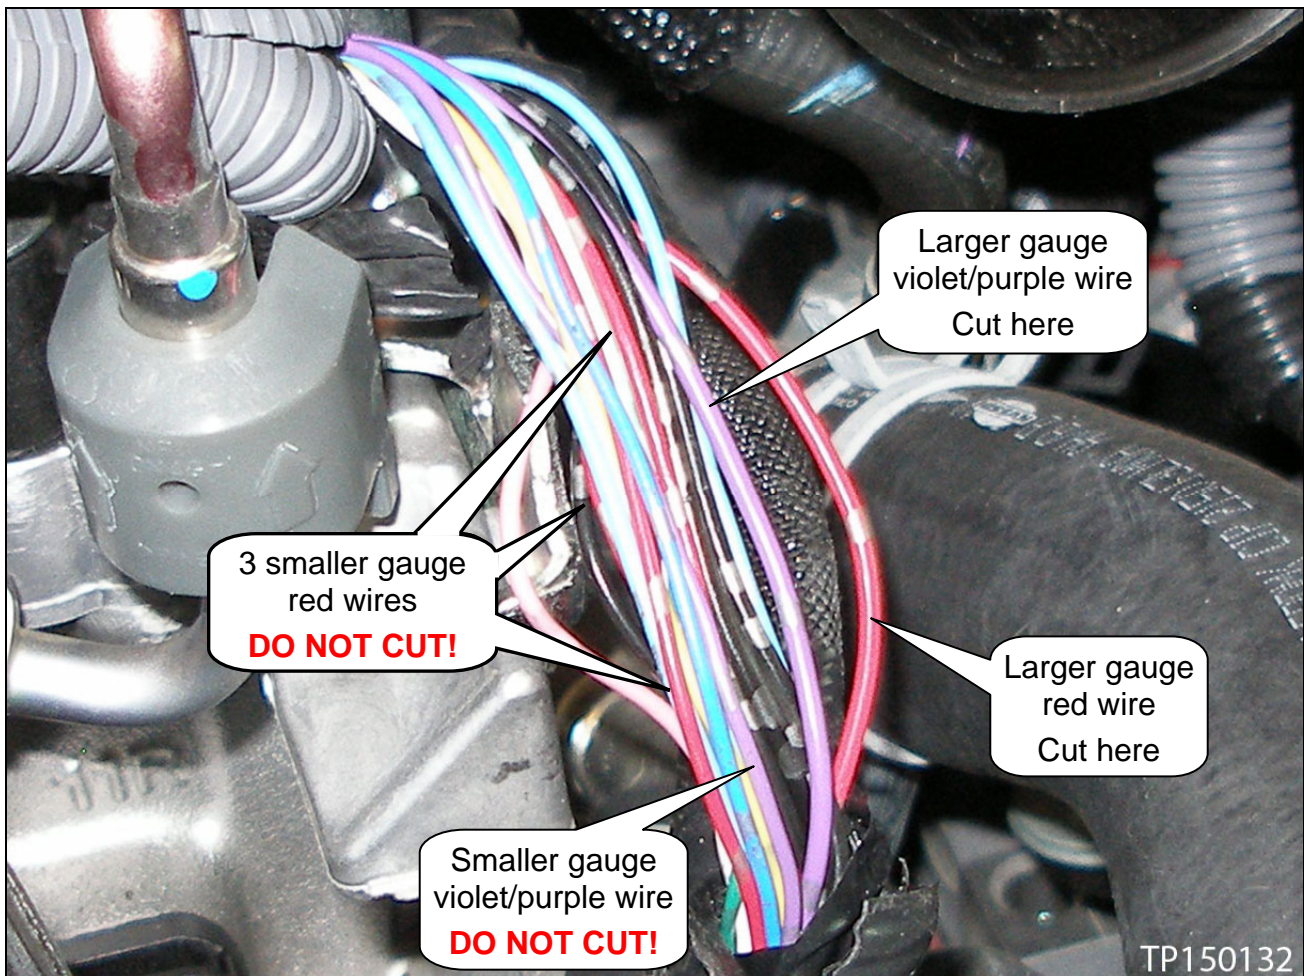
Figure 4

9. Locate and cut the thicker 16 Gauge/1.25 mm red wire (see Figure 4).

- Cut this wire further down the harness (see Figure 4). Leave enough length to install a piece of heat shrink tubing.

CAUTION: There are four (4) red wires in this section of the EGI harness. One is a thicker gauge (16 Gauge/1.25 mm) than the remaining three (3) wires. Make sure to cut the 16 gauge red wire.

10. Locate and cut the thicker 16 Gauge/1.25 mm violet/purple wire (see Figure 4).

- Cut this wire about in the middle of the exposed wiring (see Figure 4).

CAUTION: There are two (2) violet/purple wires in this section of the EGI harness. One is a thicker gauge (16 Gauge/1.25 mm) than the other violet/purple wire. Make sure to cut the 16 gauge violet/purple wire.

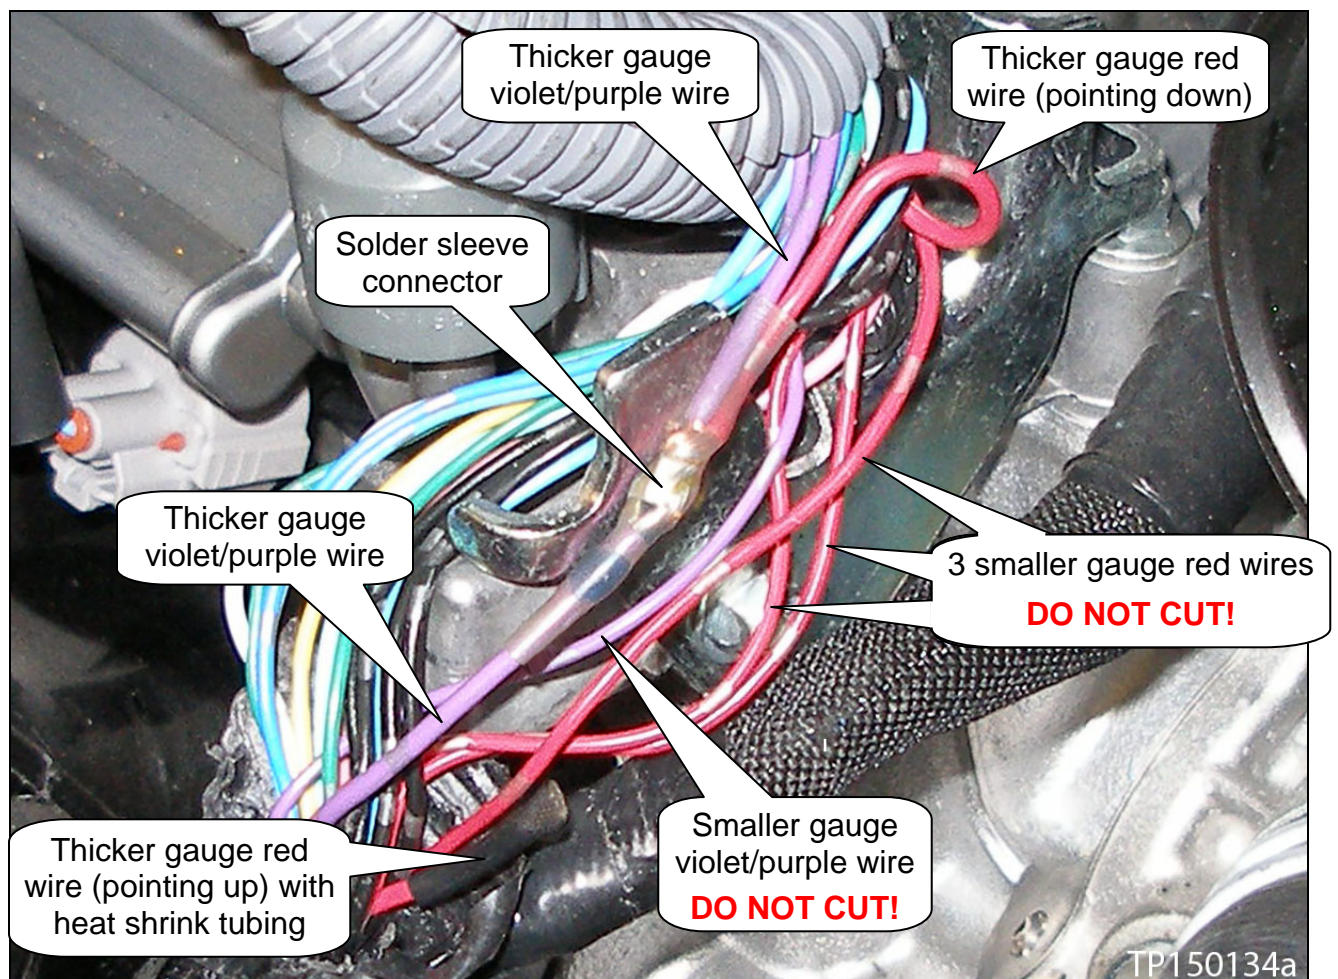
Figure 5

11. Connect/splice together the end of the red wire pointing down with both ends of the violet/purple wire with a “blue” solder sleeve connector (see **PARTS INFORMATION**).

- See Figure 5.
- Refer to NTB03-078 for solder sleeve connector installation procedure.

12. Place a one inch piece of heat shrink tubing on the red wire pointing up (see Figure 5).

- Leave about ½ inch of tubing past the end of the red wire.

13. Install the heat shrink tubing by applying heat with Flameless Heat Gun J-46538 or equivalent (see Figure 5).

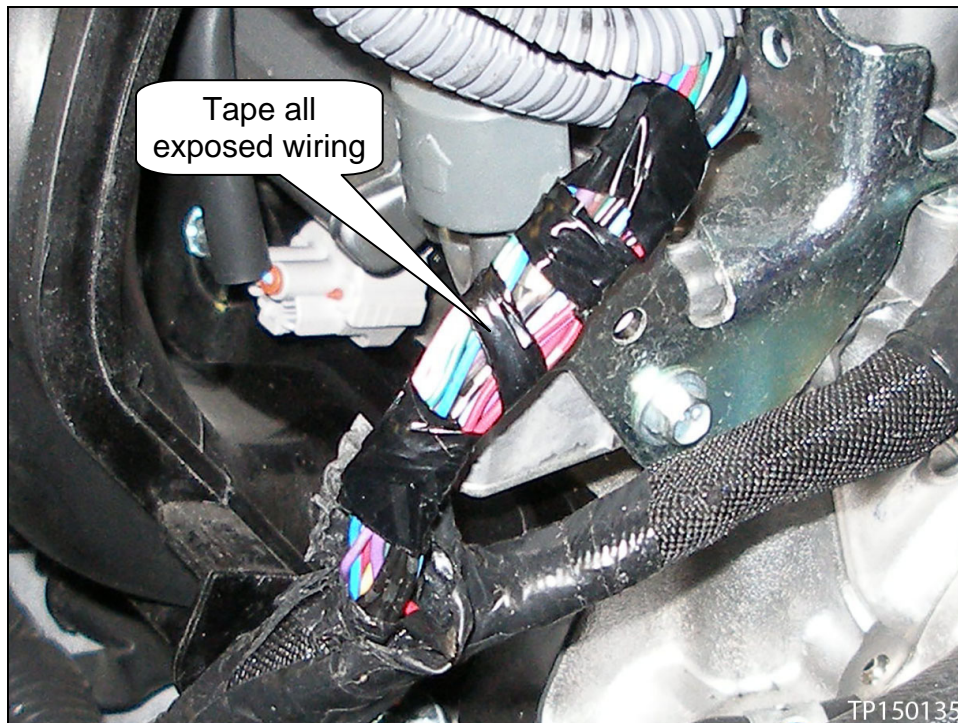
Figure 6

14. Wrap suitable electrical tape around all exposed wiring (see Figure 6).

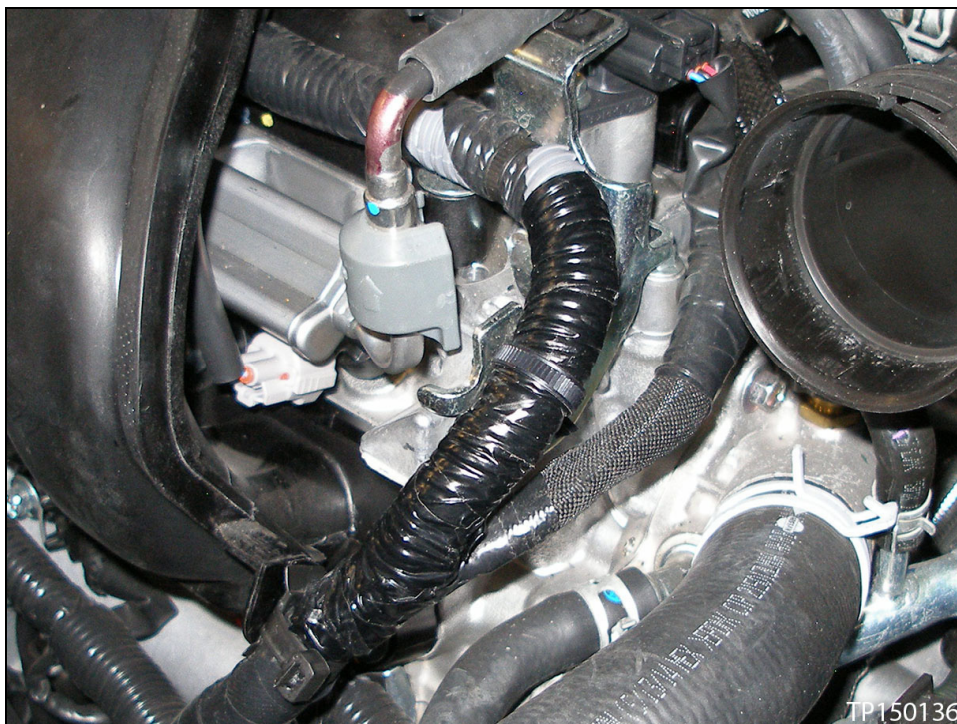
Figure 7

15. Fit the existing sheathing around the taped wiring, and then wrap suitable electrical tape around the sheathing from one end to the other (see Figure 7).
