ST15-009

ITB16-011

2013 JX AND 2014-2015 QX60; POWER STEERING NOISE HEARD INSIDE VEHICLE WITH WINDOWS CLOSED

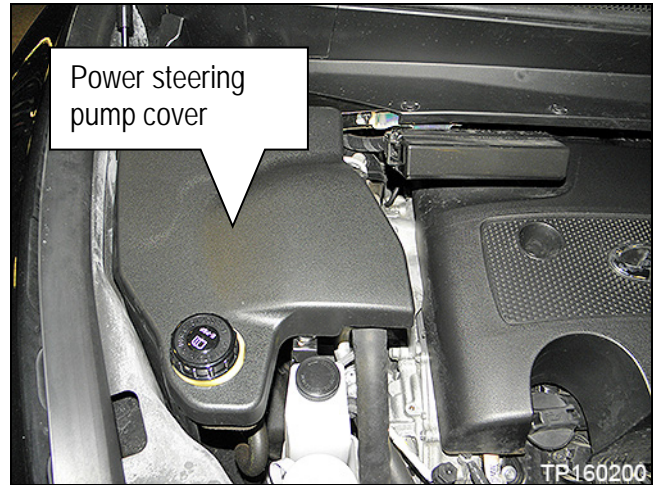
Figure 1

1. Remove the power steering pump cover to access the power steering pump motor housing.
 - Lift power steering pump cover vertically to detach two integral clips.

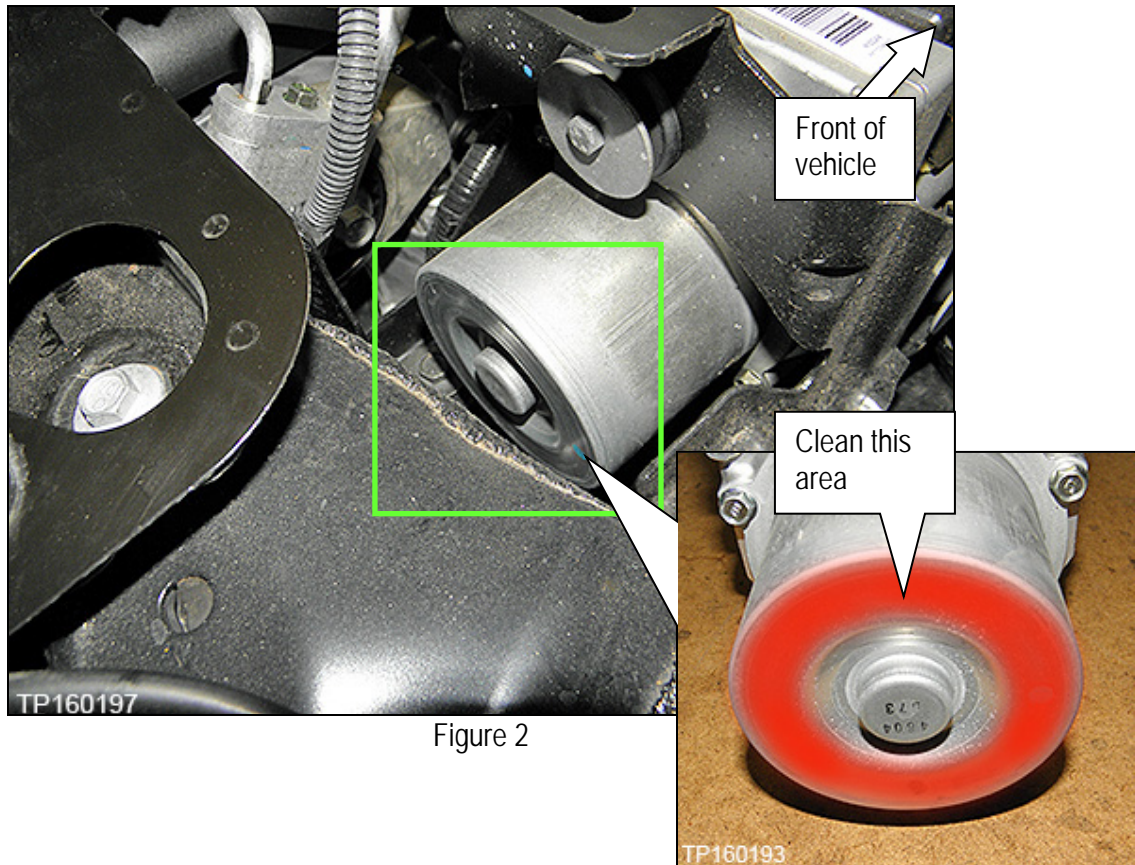
Figure 2

2. Clean the area where the adhesive will attach (Figure 2, highlighted in red).
 - Use 50% isopropyl alcohol and water, and a clean cloth.

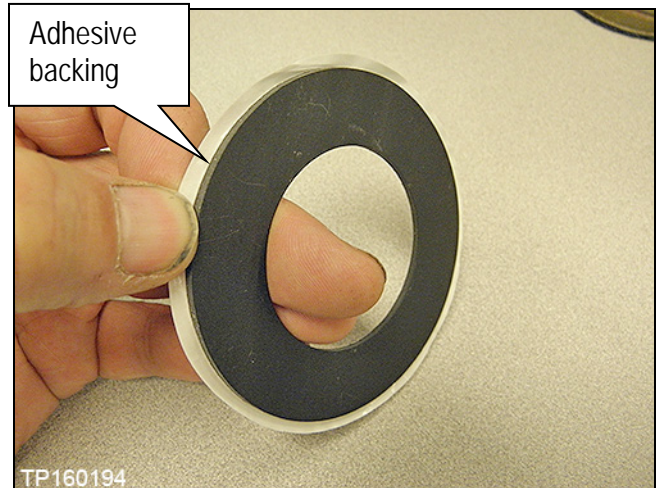
Figure 3

3. Remove the adhesive backing from the Insulator.

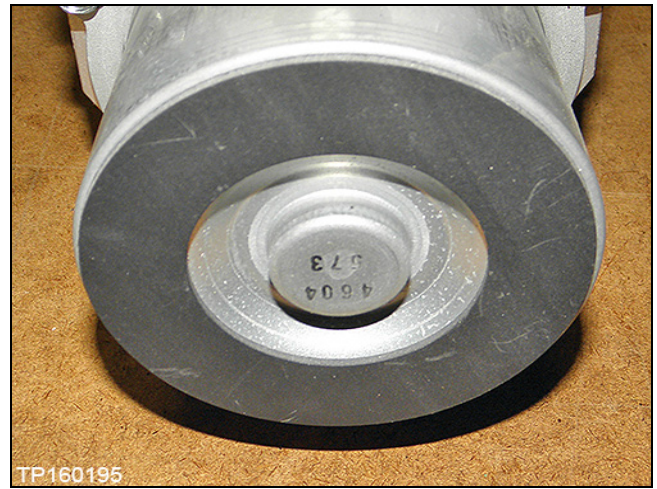
Figure 4

4. Attach the Insulator onto the end of the power steering pump motor housing (Figure 4).
