# Technical Service Bulletin

## 69 Front seat belt is twisted

69 21 65 2058455/4 May 17, 2021. Supersedes Technical Service Bulletin Group 69 number 20-51 dated May 11, 2020 for reasons listed below.

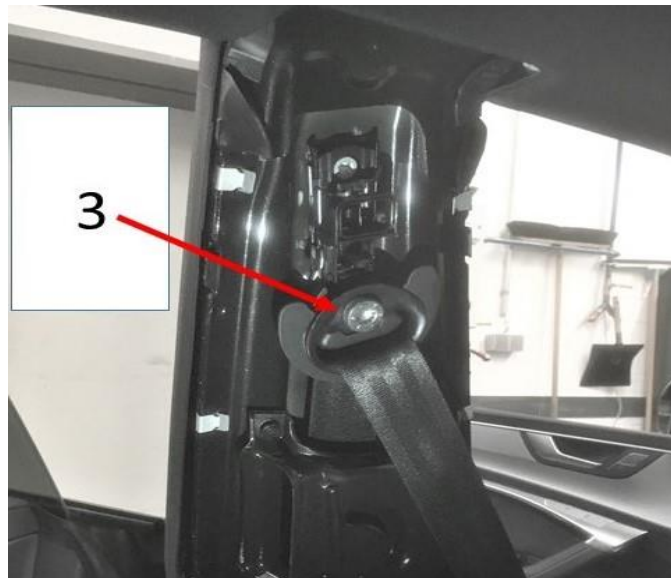
**Figure 1.** Seat belt deflector at height adjuster with B-Pillar trim removed.

1. Remove the upper B-Pillar trim on the affected side according to the repair manual.
2. Remove the bolt of the seat belt deflector (Figure 1, Pos. 3).

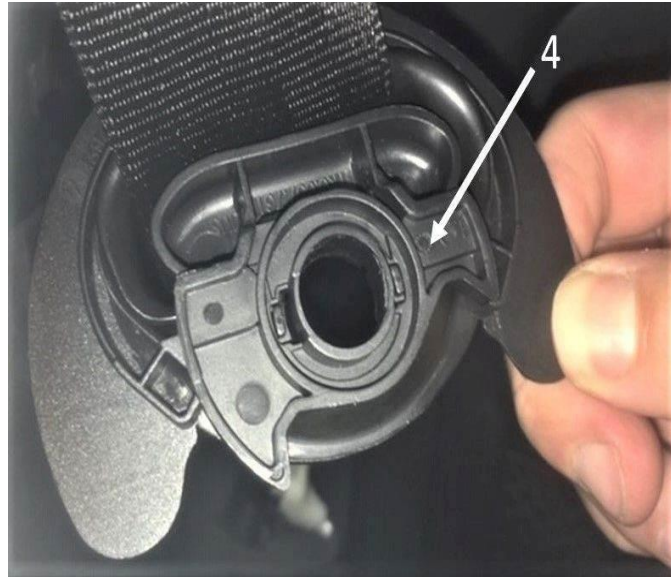
**Figure 2.** Backside of seat belt deflector. Deflector trim tabs engaged in old belt guide.

3. Use your thumb to remove the old belt guide (plastic part) from the steel deflector. Start by detaching the guide from the bolt hole, then press out the lower section covering the metal tab (Figures 2 -3).

5. Install the modified belt guide 4K8 857 799 on the front driver side and 4K8 857 800 on the front passenger side (Figure 2, Pos. 4).
6. Start installing the modified seat belt guide at the deflector metal tab (Figure 5).

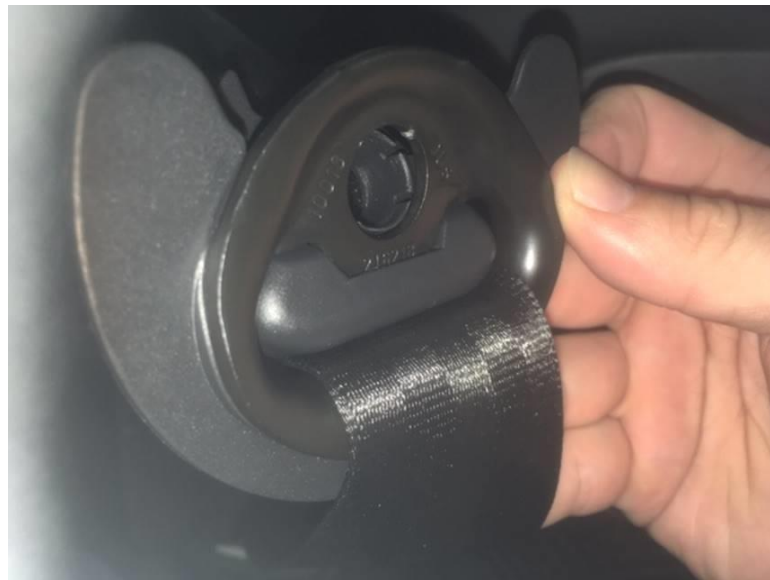
**Figure 3.** Removing old seat belt guide starting at the bolt hole.

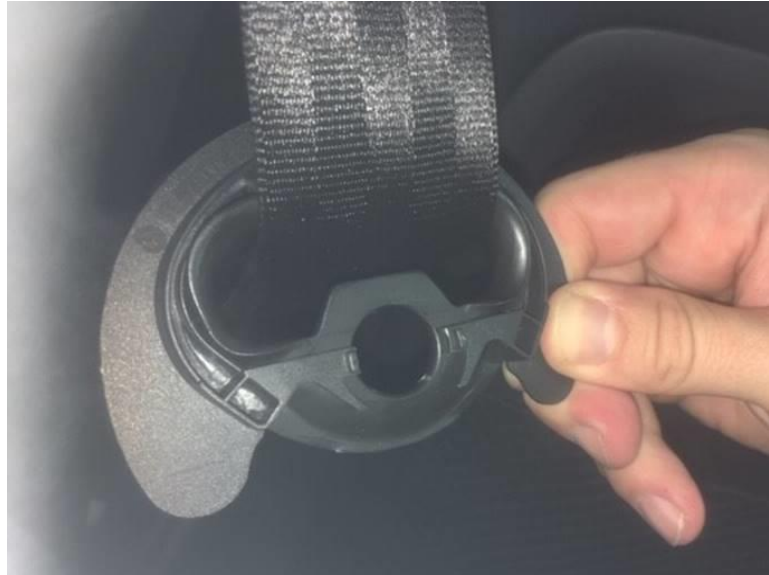
**Figure 4.** Old seat belt guide removed. Seat belt twist corrected.

4. With the old belt guide removed, turn the seat belt webbing to remove the twist (Figure 4).

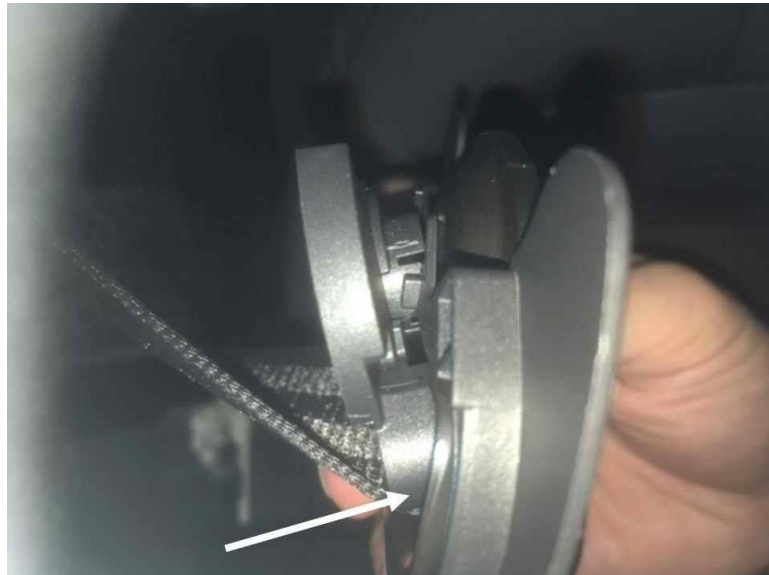
**Figure 5.** Installing modified seat belt guide starting with the metal tab on the bottom.

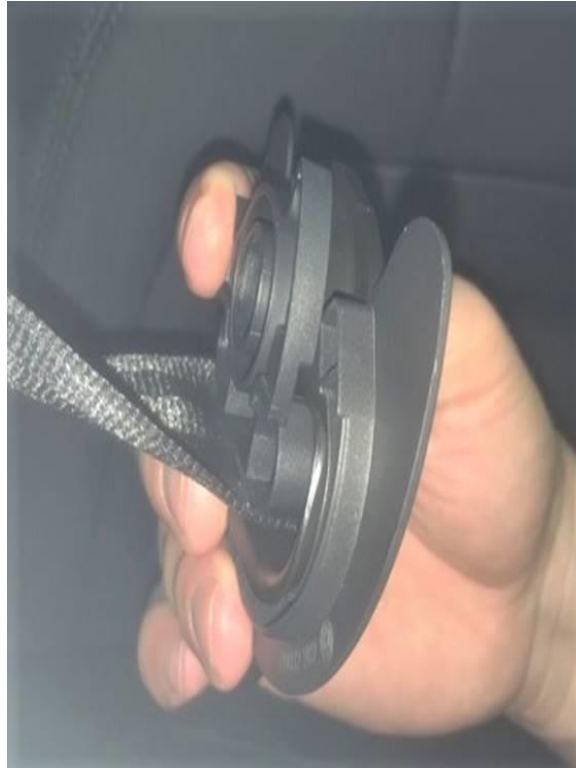
*Figure 6. Seat belt deflector with new guide installed.*

7. Push the new guide into the bolt hole until you can hear the plastic retainers snap into place (Figure 6).

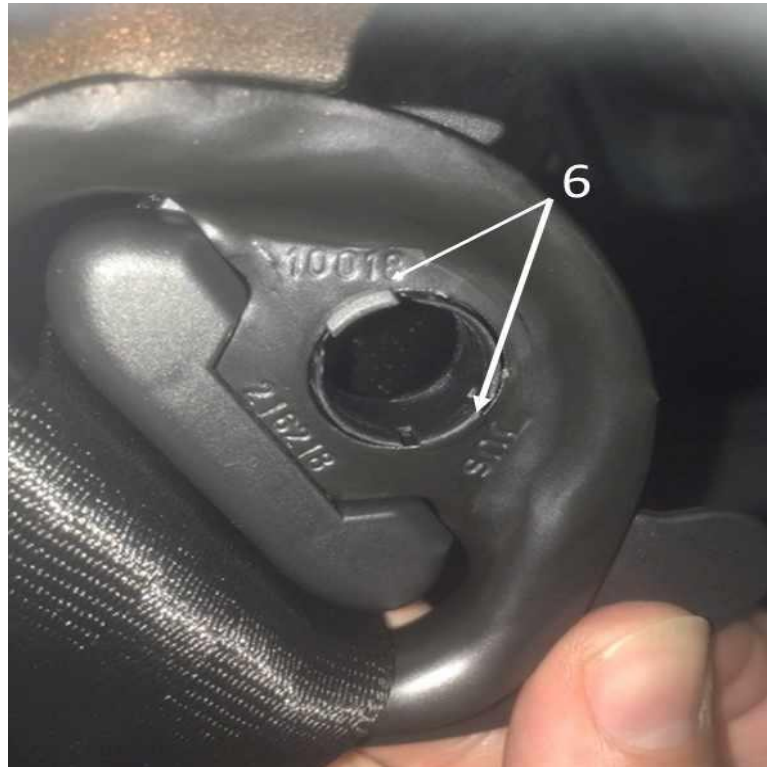
*Figure 7. Belt guide locking tabs correctly secured at bolt hole.*

8. Inspect the front of the deflector for proper installation of the guide locking tabs at the bolt hole (Figure 7, Pos. 6)

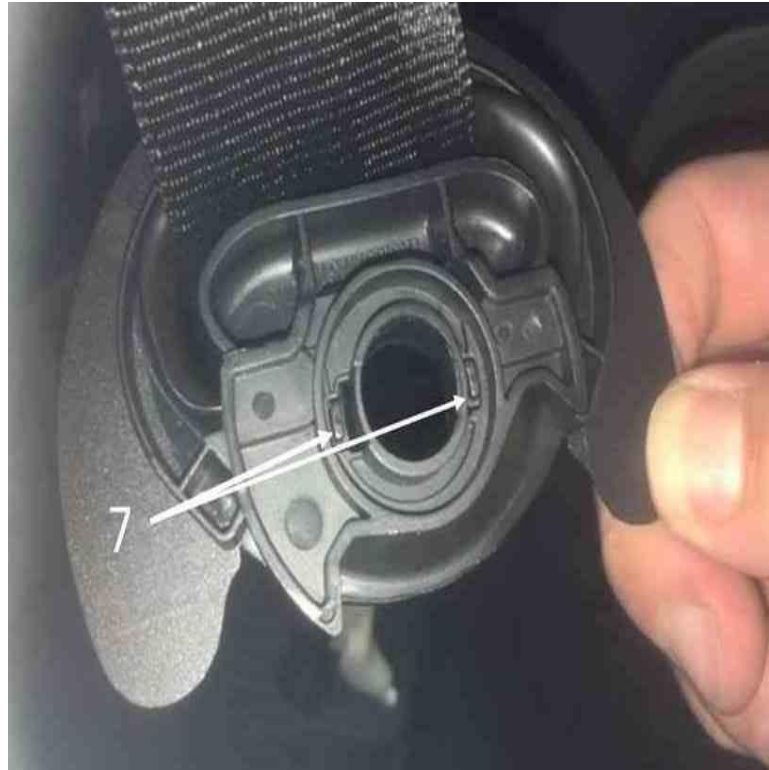
**Figure 8.** Seat belt deflector trim locking tabs properly secured to seat belt guide.

9. Inspect the back of the deflector for proper installation of the deflector trim locking tabs to seat belt guide (Figure 8, Pos. 7)
