GLOBAL SAFETY FIELD INVESTIGATIONS
DCS5766
URGENT - DISTRIBUTE IMMEDIATELY

Subject: N212329851 - Customer Satisfaction Program
Auxiliary Control Box Labels

Models: 2021 Chevrolet Silverado 4500 HD/5500HD/6500HD
Equipped with Provisions – Electrical Switch Bank (SEO) (RPO UEH)

N212329851 Auxiliary Control Box Labels

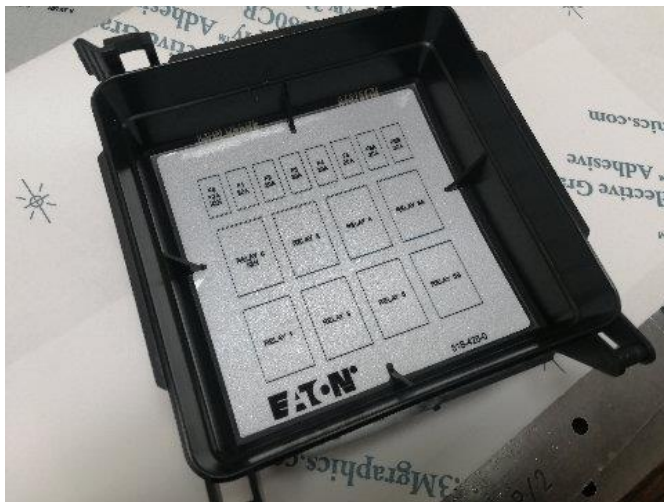
4. Install the fuse block cover label as shown. Carefully separate the label from the backing paper, do not touch the adhesive.

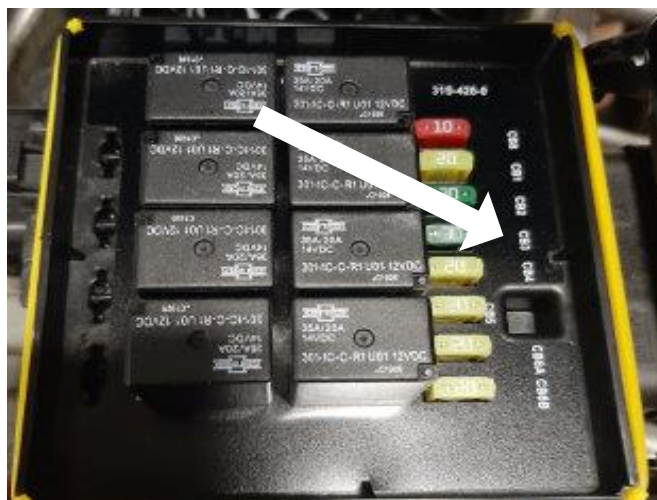
5774688

5. Clean the area of the fuse block that shows the CB values with isopropyl alcohol.

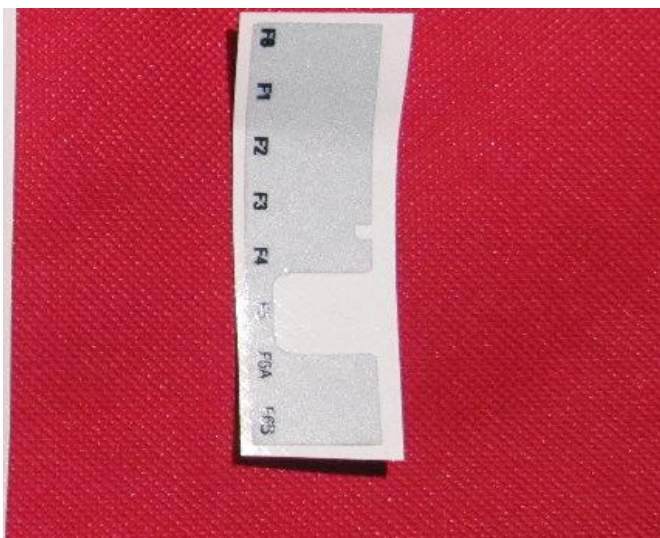
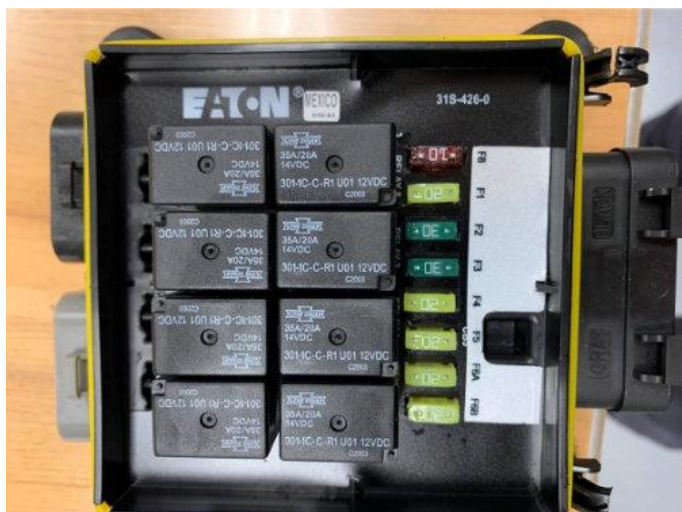
6. Install the fuse block label over the existing CB information. Carefully separate the label from the backing paper, do not touch the adhesive.
7. Close and latch the auxiliary power distribution block cover.
8. If necessary, reinstall the back-body panel carpet. Refer to *Front Seat Back Body Panel Carpet Replacement* in SI.
