SERVICE BULLETIN

Classification: EL16-017	Reference: NTB16-039	Date: April 11, 2016
-----------------------------	-------------------------	-------------------------

2015 PATHFINDER WITH 4WD; LOW POWER / STOP LAMPS STAY ON

APPLIED VEHICLE: 2015 Pathfinder (R52) 4WD with V6 engines only

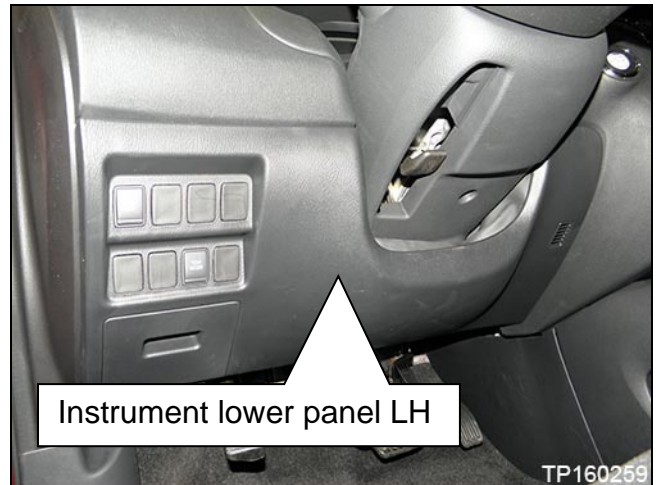
Figure 3

1. Remove instrument lower panel LH

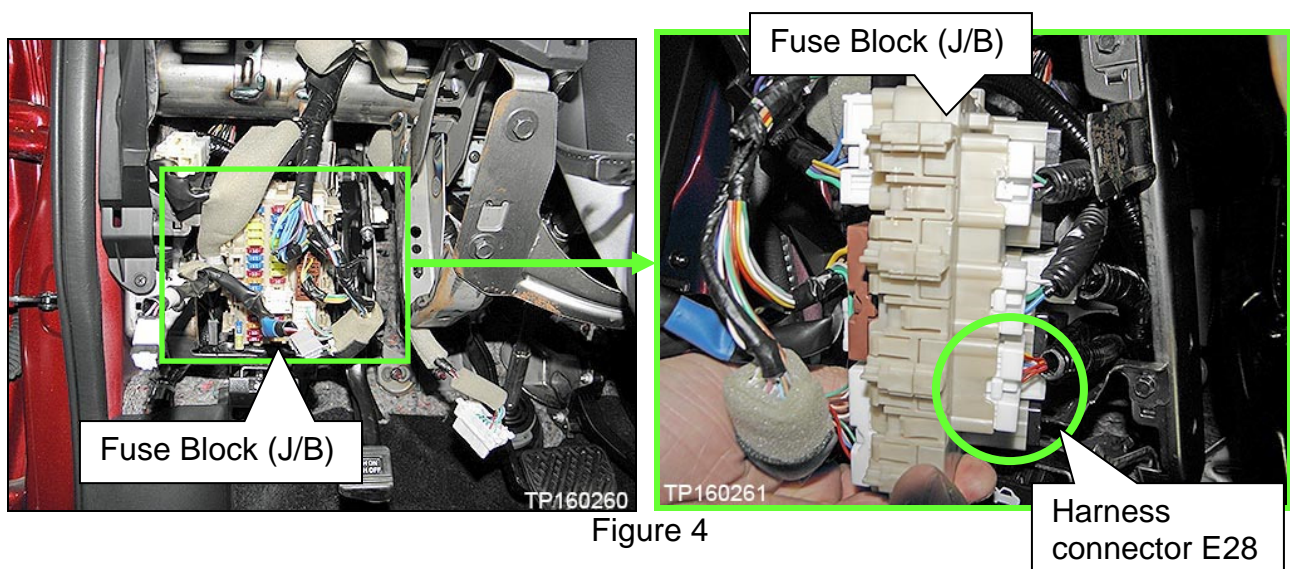
Figure 4

2. Disconnect harness connector E28, shown in Figure 4, from the back of Fuse Block (J/B).

NOTE: Fuse Block (J/B) is shown detached from support bracket. Harness connector E28 can be disconnected with Fuse Block (J/B) left in place.

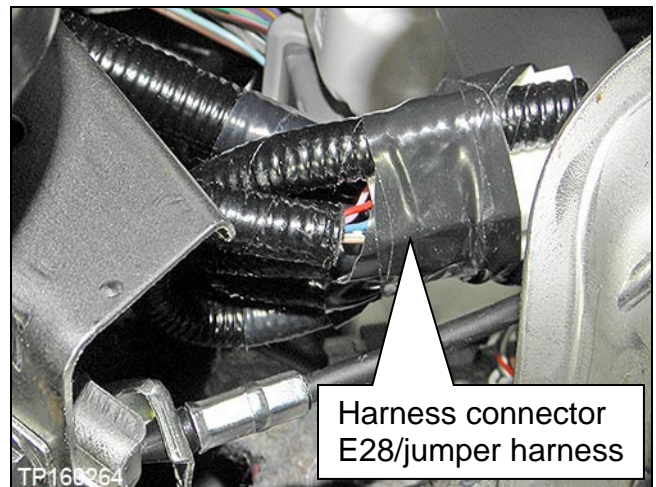
Figure 7

5. Tape harness connector E28/jumper harness to the main harness.

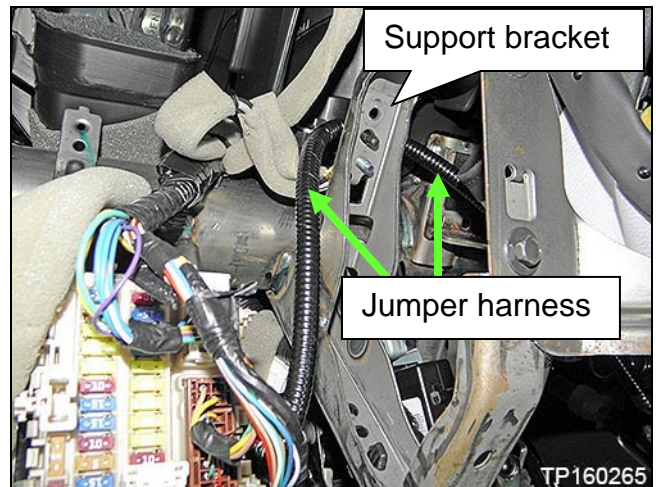
Figure 8

6. Route the jumper harness behind the support bracket as shown in Figure 8.

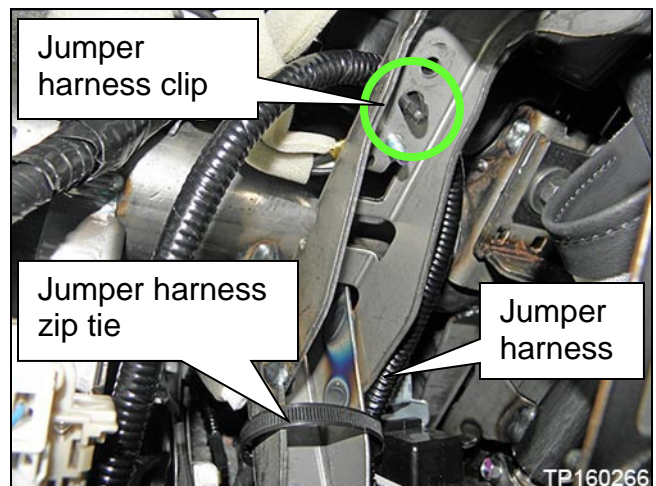
Figure 9

7. Clip the jumper harness to the support bracket (Figure 9).

8. Zip tie the jumper harness to the side of the support bracket (Figure 9).

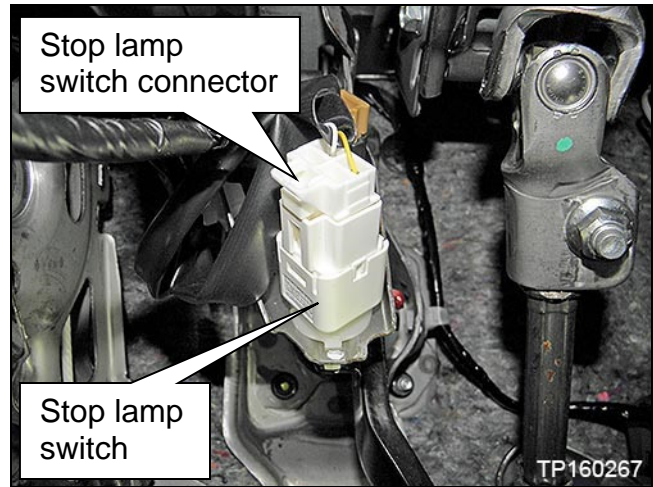
Figure 10

9. Locate the stop lamp switch connector and disconnect it from stop lamp switch.

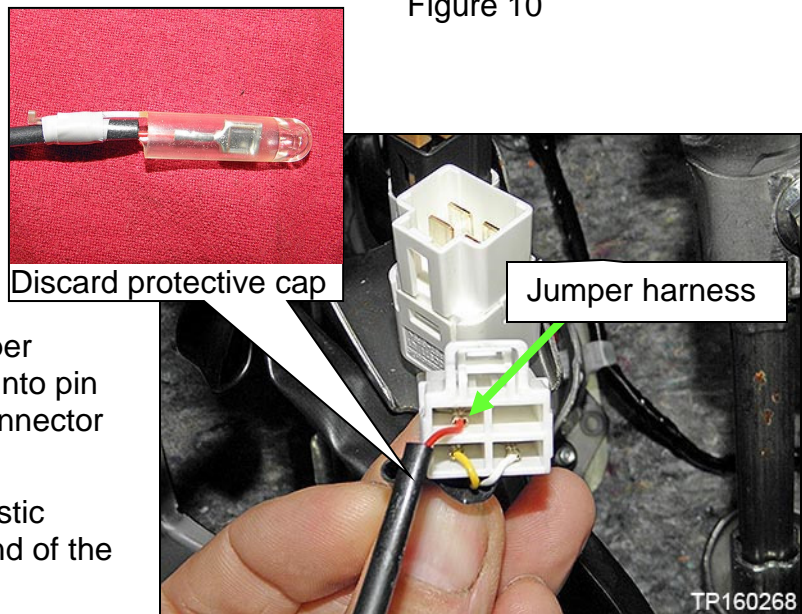
Figure 11

10. Insert the single wire of the jumper harness (part #: 24167-9PB1E) into pin No. 3 of the stop lamp switch connector in vehicle harness (Figure 11).

NOTE: Remove and discard plastic protective cap that covers the end of the single wire.

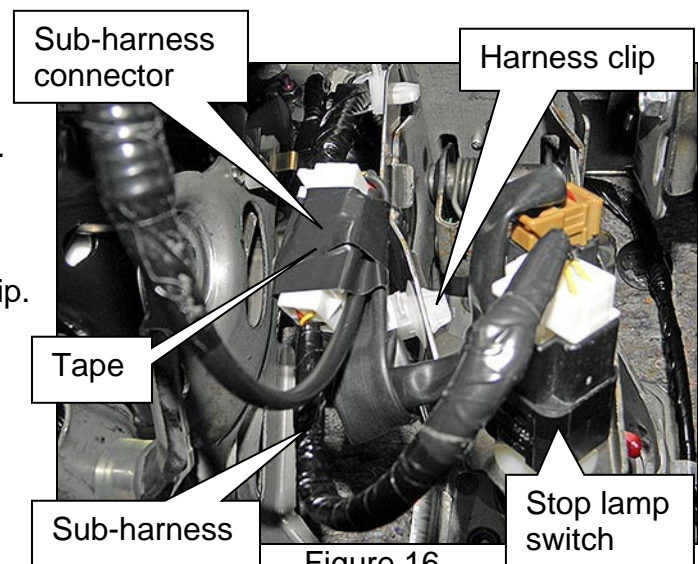
Figure 16

14. Unclip the stop lamp harness from the support bracket (Figure 16).

15. Tape the sub-harness connector to the adjacent stop lamp harness (Figure 16).

- Tape the harness so that the sub-harness is facing downward.
- Apply the tape above the harness clip.
