87-18-08 - Air Conditioning, Cleaning of the R1234yf Refrigerant Circuit (U.S. Only)

Technical Background

In cases where an air conditioning system component (such as a compressor or other system component) has failed and debris from the compressor or component is circulated throughout the refrigerant circuit, the refrigerant circuit must be cleaned of any and all debris or damage to the replacement components will result.

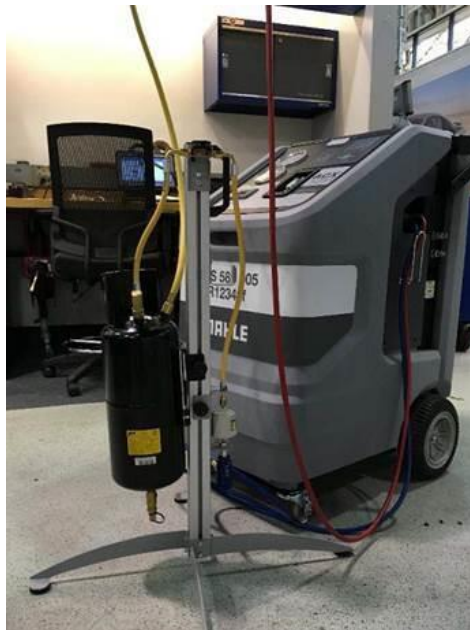
Figure 1. The VAS581005 Air Conditioning Service System with Flushing Device.

Use an approved R1234yf servicing machine and the R1234yf Flush Kit RTI360831840 (Figure 1).

Used for effective refrigerant handling and air conditioning circuit flushing after air conditioning component failure.

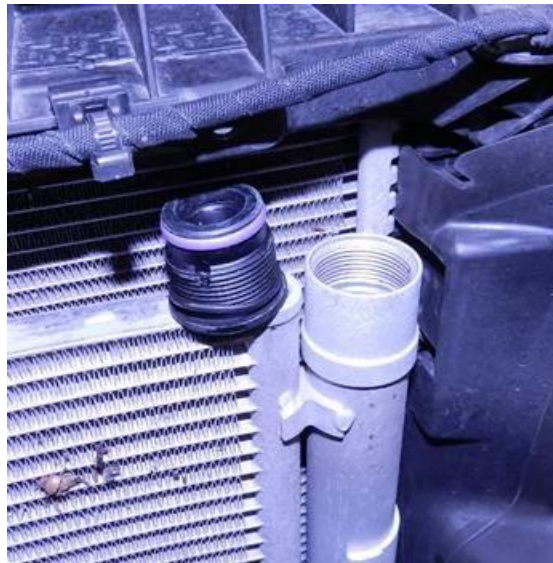
Figure 2. Location of the Receiver Drier

- 6. Remove receiver drier cartridge.
Reinstall cartridge cap with O-ring (Figure 2).

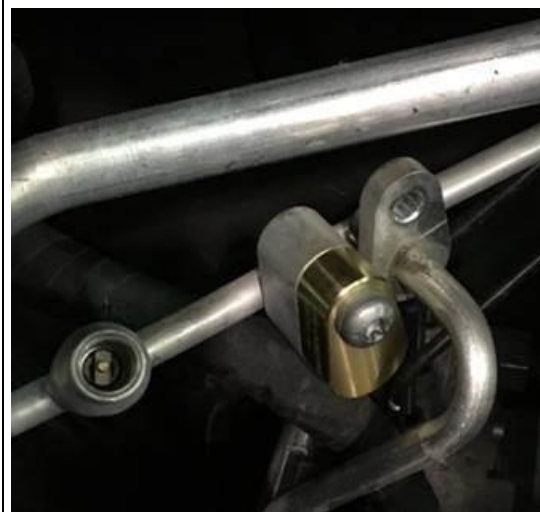
Figure 4a. Installation of high side rear A/C Line connection block adaptor VAS 6338/63

(Atlas Only) The rear A/C unit refrigerant lines must be disconnected and replaced with block off adaptors VAS 6338/5 and VAS 6338/63 before performing the front A/C unit flush procedure.

8. (Atlas Only) Disconnect rear refrigerant lines and install adaptors VAS 6338/5 and VAS 6338/63 as shown (Figure 4a, 4b).

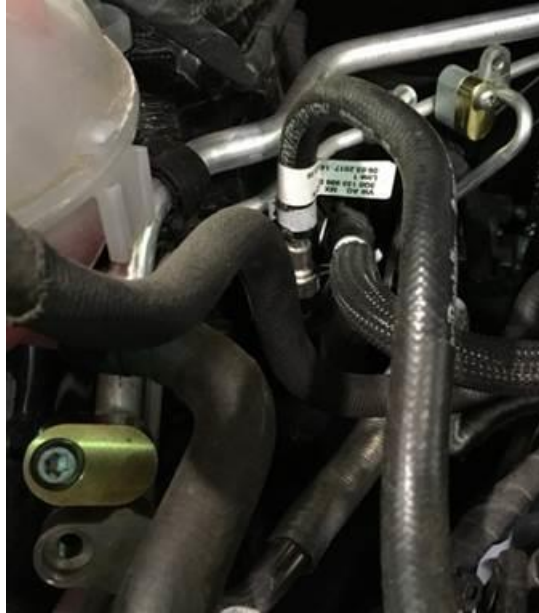
Figure 4b. Installation of Low side rear A/C Line connection block adaptor VAS 6338/5

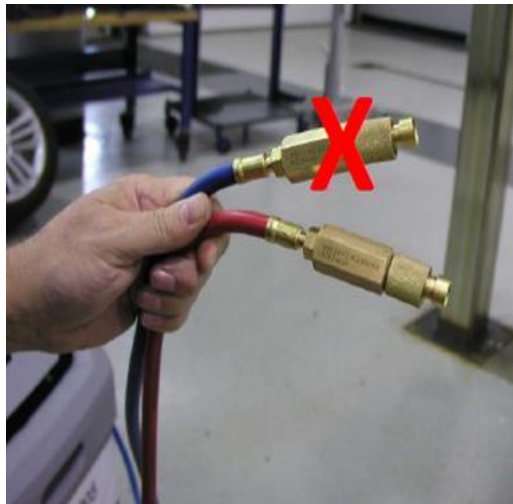
Figure 5. A.C hose adaptor 6338/44

9. Remove A/C Recovery machine high side coupler from hose.

Install flush adaptor VAS 6338/48 to high side A/C recovery machine hose (Figure 5).

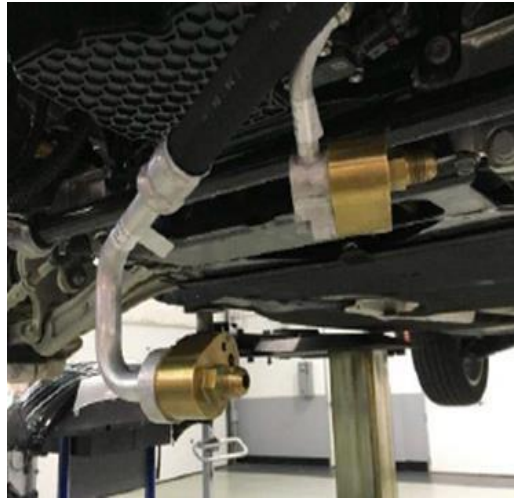
Figure 6. Installation of VAS 6338/3 and 6338/12.

- 10. Disconnect A/C compressor hoses from the compressor.
- Install flush adaptor VAS 6338/3 on the high side compressor hose.
- Install flush adaptor VAS 6338/12 on low side compressor hose (Figure 6).

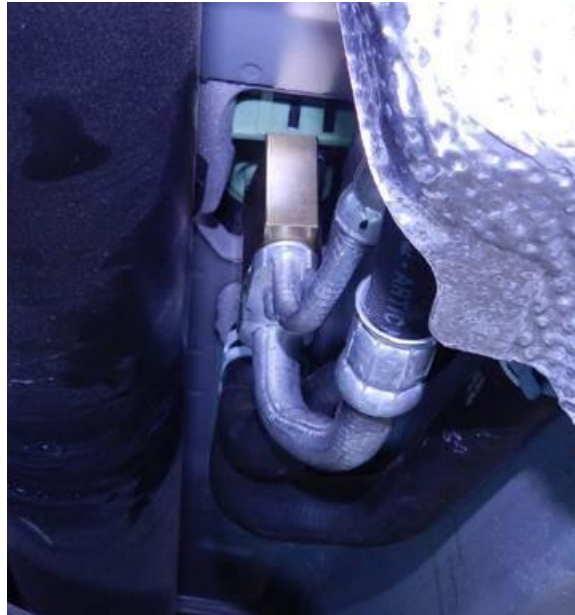
Figure 13. Location of rear air conditioning unit expansion valve.

23. Remove rear expansion valve and install VAS6338/38 as shown (Figure 13).

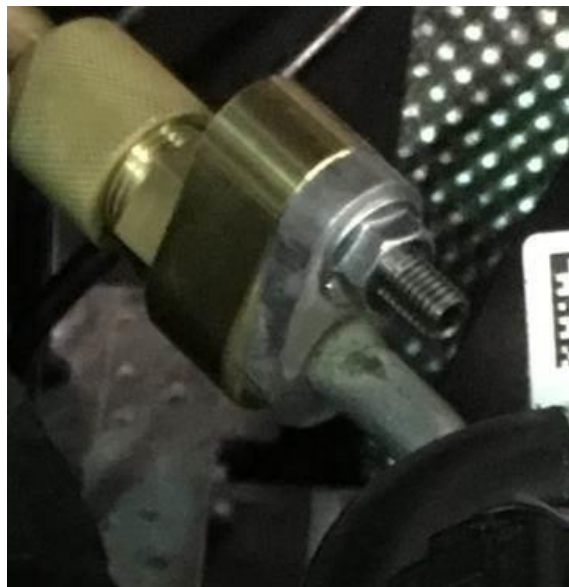
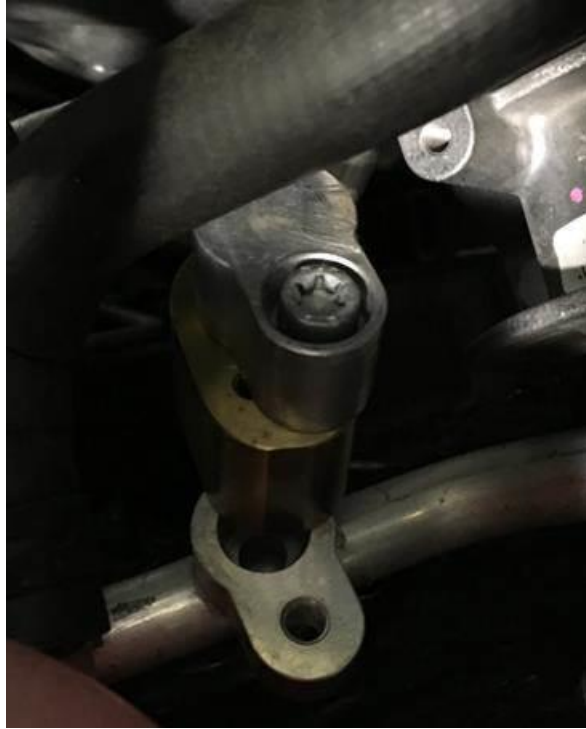
Figure 14. Location and connection of the adaptors for the rear unit A/C lines

24. Connect the VAS 6338/3 and VAS 6338/60 to the rear refrigerant A/C lines (Figure 14).

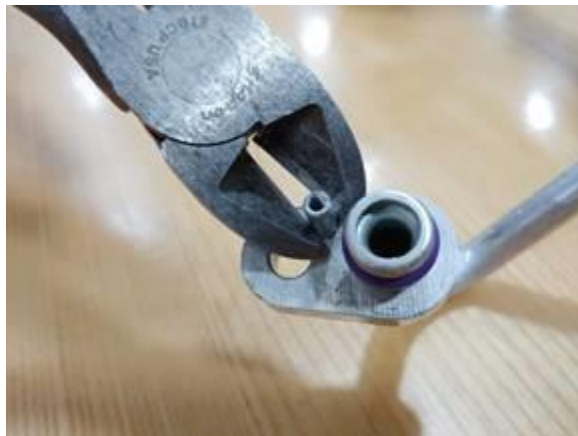
Figure 15. Removal of dowel pin.

Later models may have a dowel pin in the high pressure refrigerant line that does not allow the VAS 6338/60 to be installed. The pin must be temporarily removed to install the VAS 6338/60. DO NOT cut the pin flush with the refrigerant. Side cutters can be used to remove the pin and pliers to reinstall the pin (Figure 15 and 16).

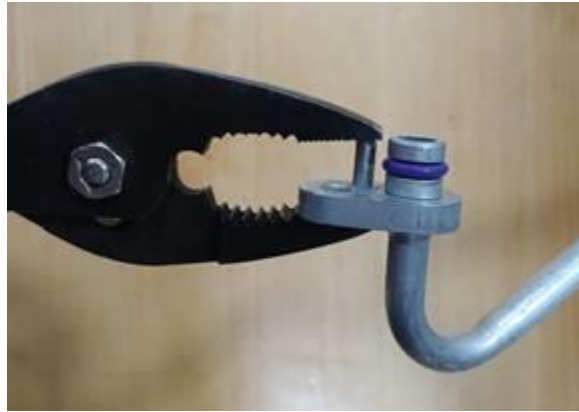
Figure 16. Installation of rear refrigerant line dowel pin.

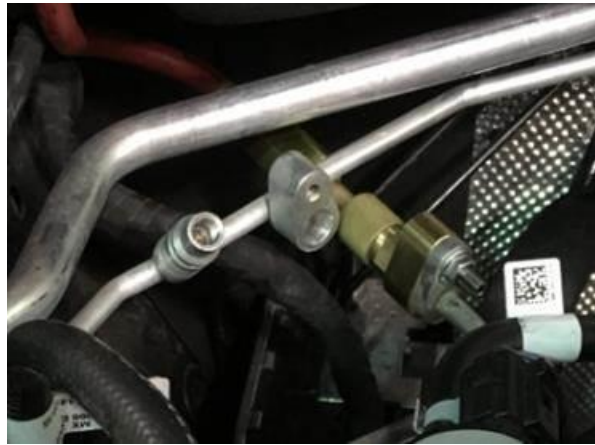
Figure 17. Attaching service station and flush hoses to rear A/C lines.

- 25. Connect the VAS 6338/48 to adaptor VAS 6338/60
- 26. Connect flush tank hose (Yellow) to the high side compressor hose adaptor VAS 6338/3. (Figure 17)

27. Perform an extended 3 cycle flush on the rear A/C unit.
