## Volvo Chassis - VN Models - Seat Lumbar Support Broken; Seat Back Replacement - Model Year 2018

## TSM-0001.11 Seat Back Replacement

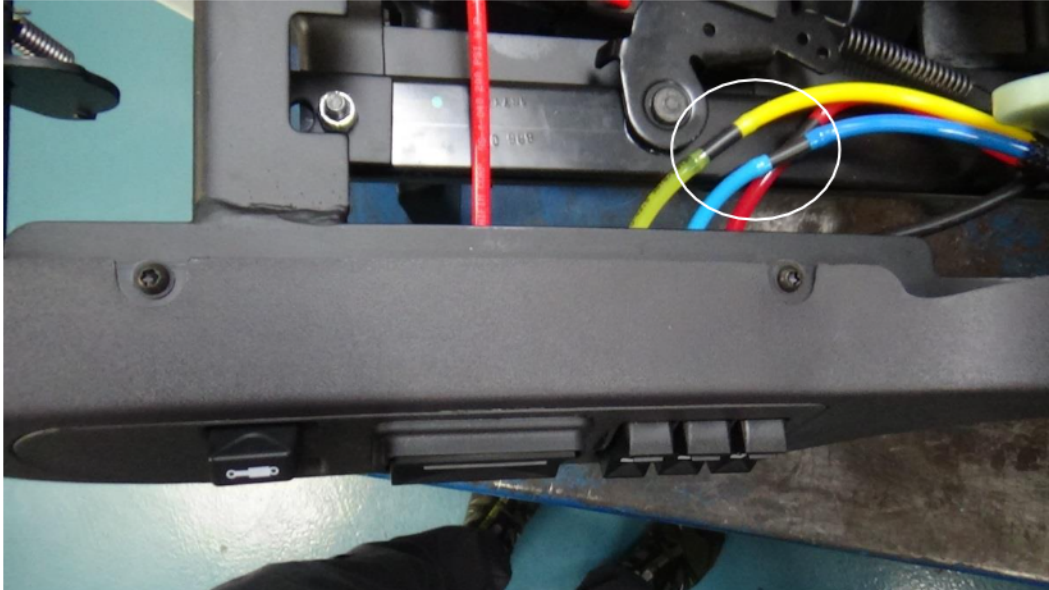
Figure 1: *Hose Connectors*

Disconnect the three colored hoses in Fig. 1 at their connection points by pulling on them. Also cut the two cable ties using the side cutters (Fig. 3).

Reconnect the three hoses from Fig. 1 and attach cable ties in the positions shown in Fig. 7. Make sure that the hoses are tight enough and out of the way so that it does not get caught on the cushion adjuster

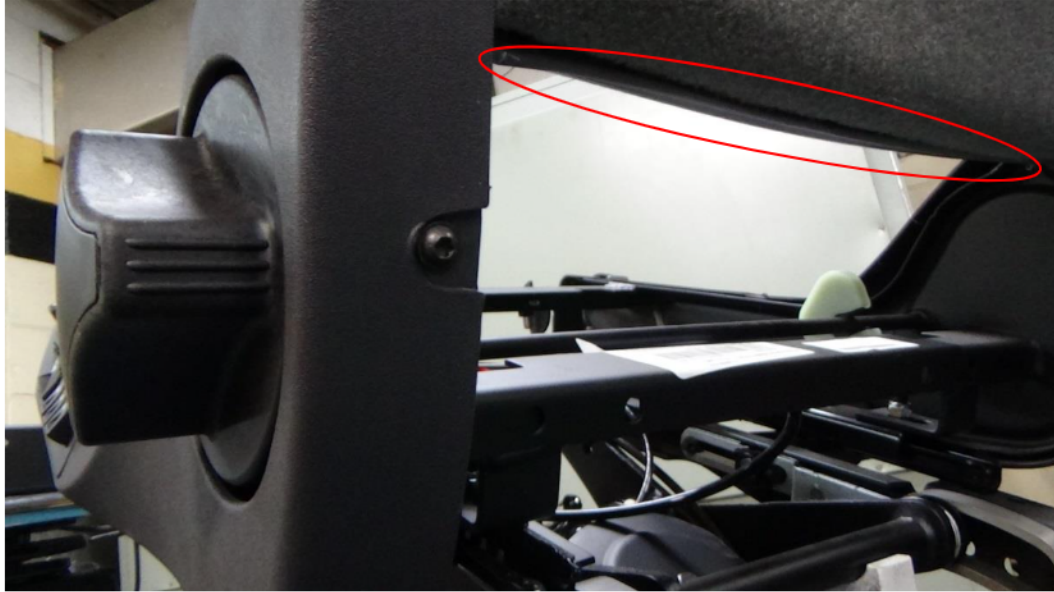
Figure 2: *Back Rest J-Clip*

Unclip the back rest j-clip in Fig. 2 by folding the front part forward until the entire piece disconnects.

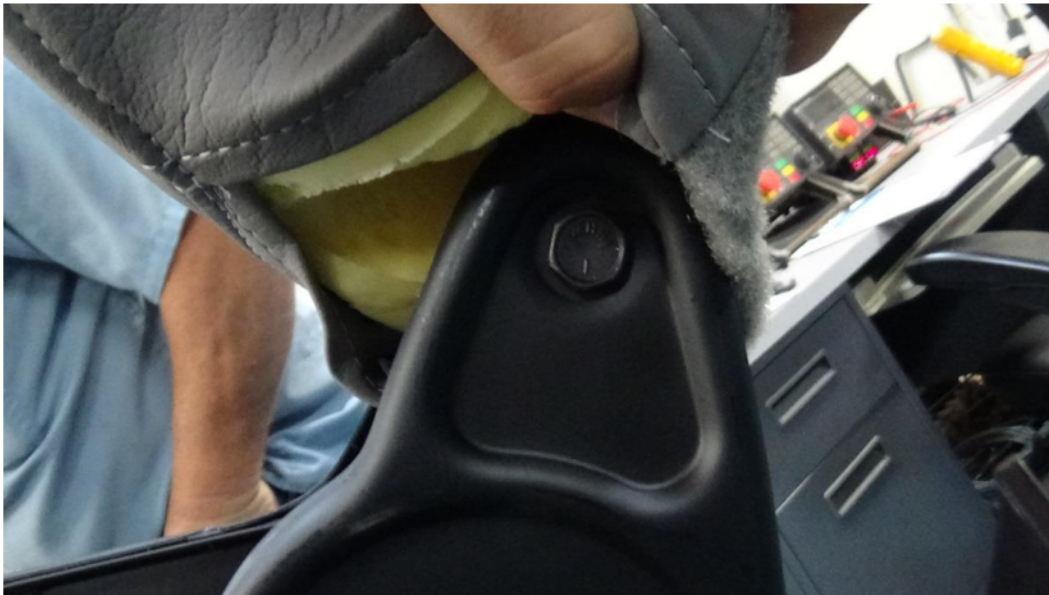
Figure 4: *Left Hand Outside Pivot Bolt*

To remove the seat back, remove the 9/16" bolt in Fig. 5 and the 9/16" bolt in Fig. 4 as well as the bolt on the right hand side in Fig. 6. Remove it using a 9/16"

wrench, holding the nut with a 9/16” wrench. The back rest will come off once that bolt is removed.

Line up the new back rest with the lower frame and attach the bolt from Fig. 5, torquing it to  $24\pm 2$  ft-lb. thread the bolt from Fig. 4 into the back plate assembly. Next, insert the bolt and nut in the right hand side frame in Fig. 6; torque it to 12-20 ft-lb.
