K436NAS1

TECHNICAL BULLETIN

Service Action: Luggage Compartment Lid Clash to Bumper

MODEL:	MODEL YEAR:	VIN:	ASSEMBLY PLANT:
XE (X760)	2016-2017	900120-966935	Solihull
XF (X260)	2016-2017	Y00001-Y41771	Castle Bromwich

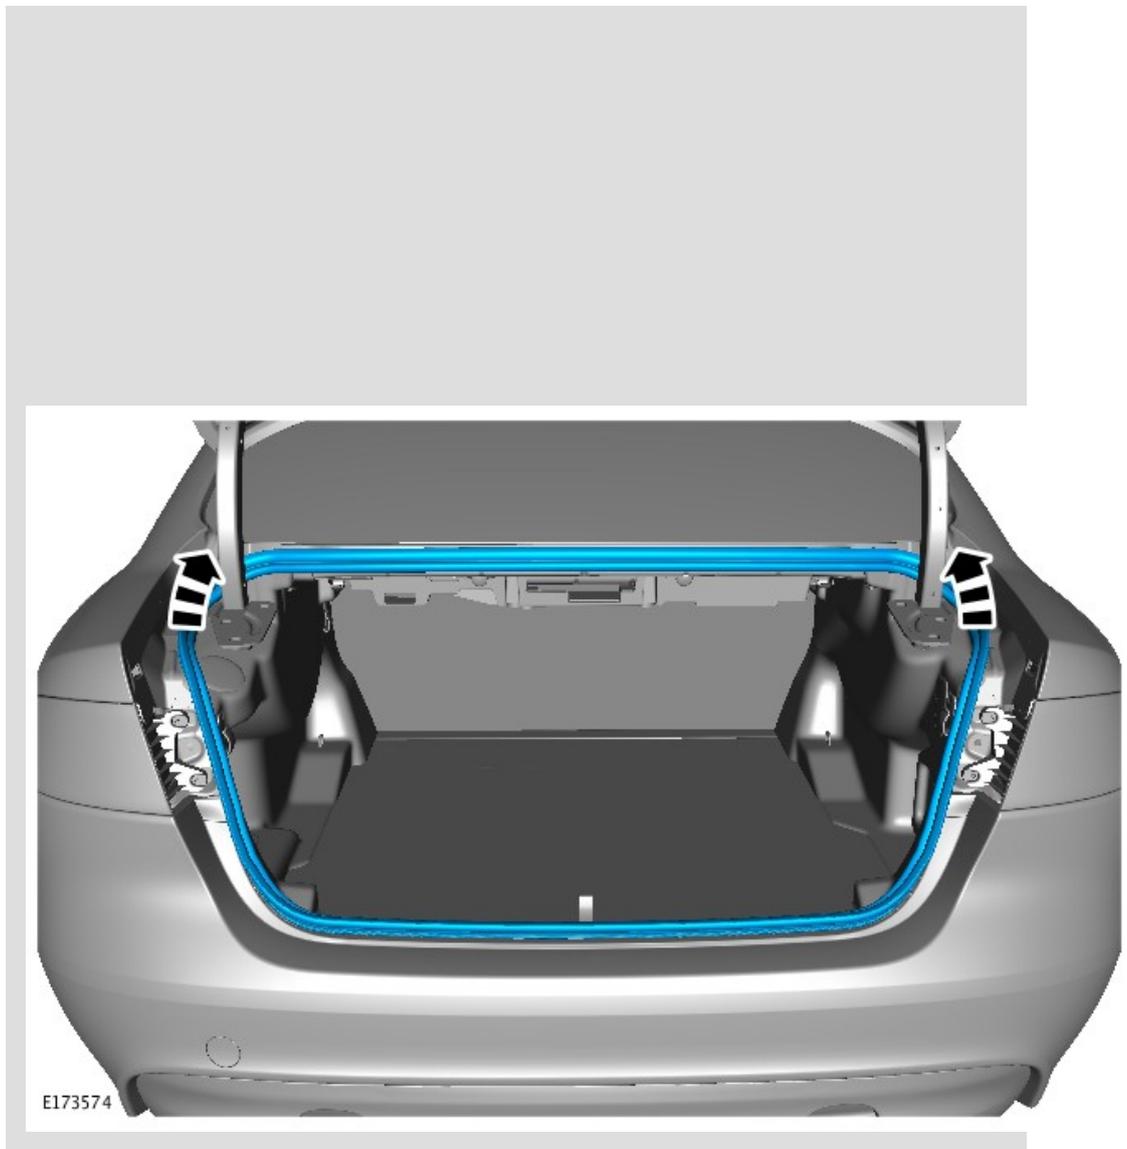
2

An issue has been identified on certain vehicles within the listed Affected Vehicle Range where the luggage compartment lid may foul the rear bumper cover when closing, resulting in paint damage to the bumper cover.

Remove and discard the rubber seal.
