SERVICE BULLETIN

Classification: RA21-002	Reference: NTB21-045	Date: May 25, 2021
-----------------------------	-------------------------	-----------------------

2013-2018 ALTIMA AND 2016-2018 MAXIMA; REAR SUSPENSION LOWER LINK

APPLIED VEHICLES: 2013-2018 Altima (L33)
2016-2018 Maxima (A36)

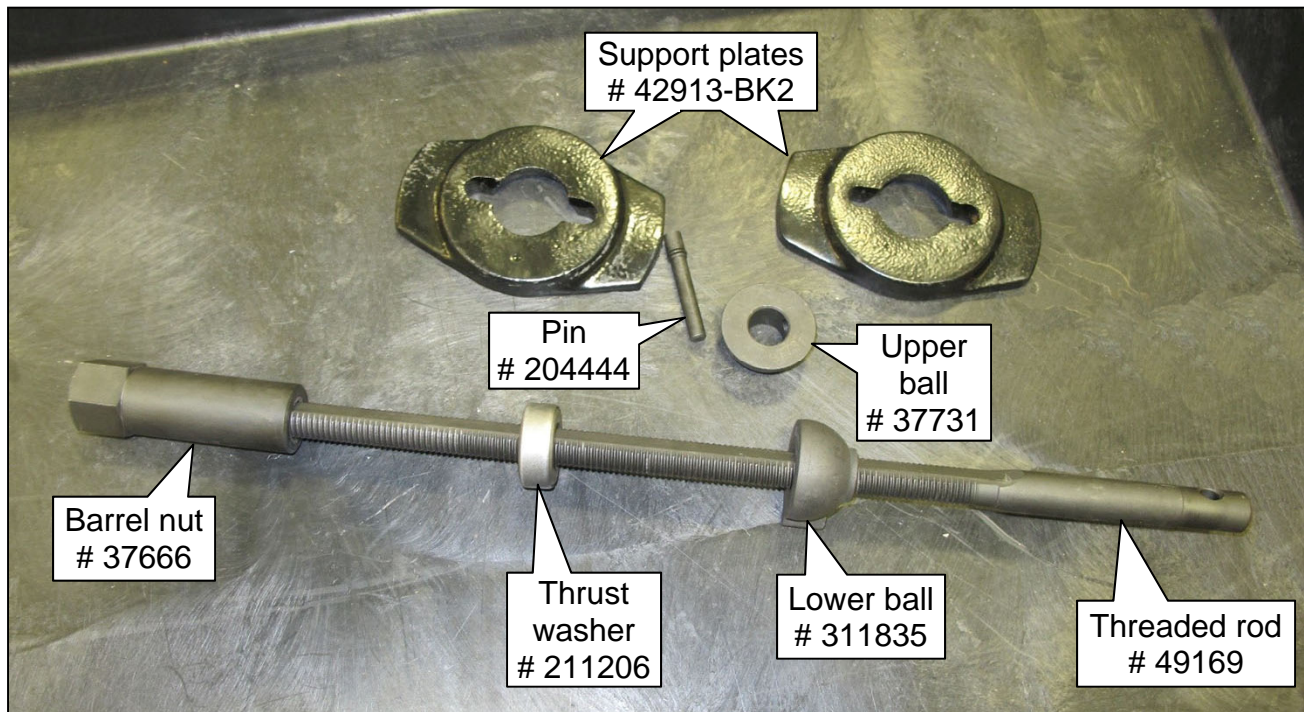
Figure 1

Each dealer has been shipped one Coil Spring Compressor, special tool J-52929.

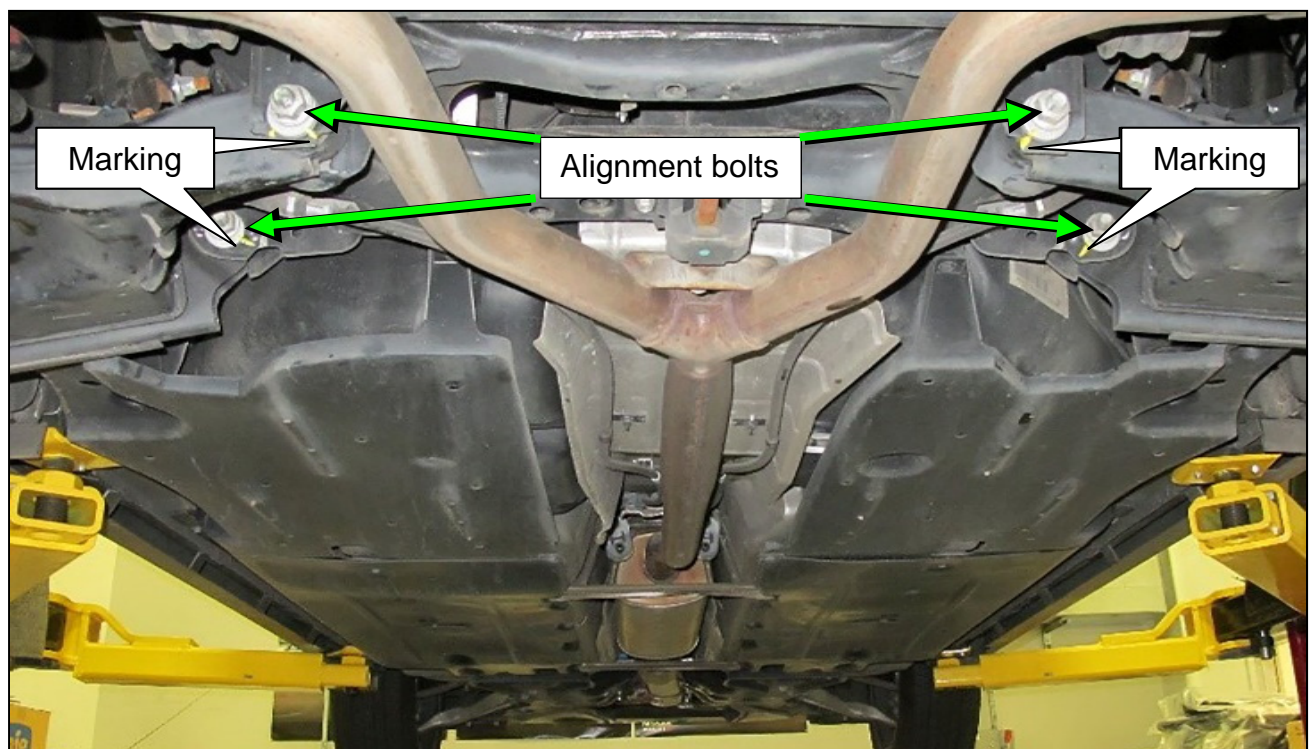
Figure 2

1. Place the vehicle on a lift and raise to a suitable height to remove both rear wheel and tire assemblies from the vehicle.
2. Mark the suspension alignment washer to the frame on all 4 rear lower link alignment bolts (see Figure 2).

HINT: Place the alignment bolts in their original locations, and then line up the marks when tightening to specified torque.

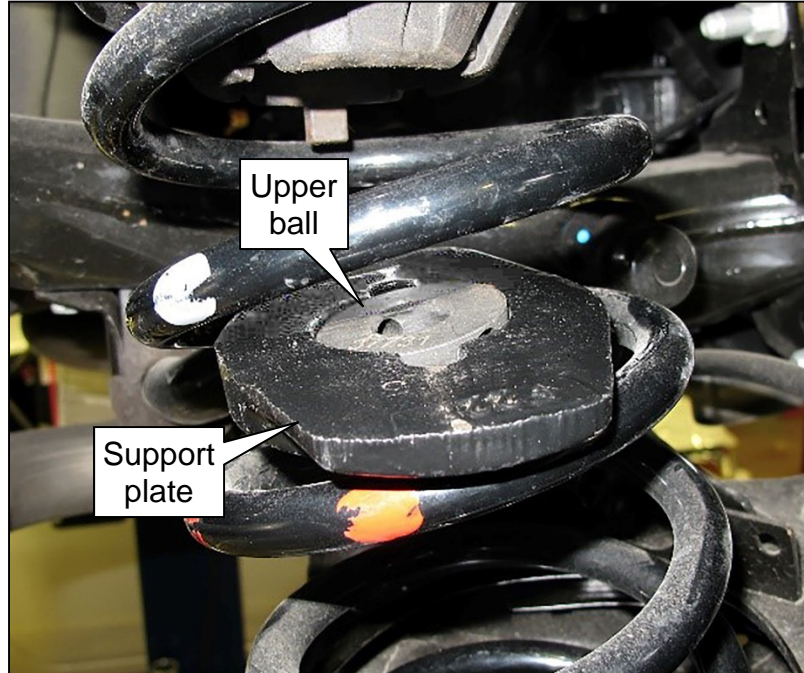
Figure 3

3. Install the upper ball in the cavity of a support plate of special tool J-52929, upper ball facing upward, and then place the support plate midway inside the coil spring.

HINT: The upper ball can be identified by its cross drilled pin hole.

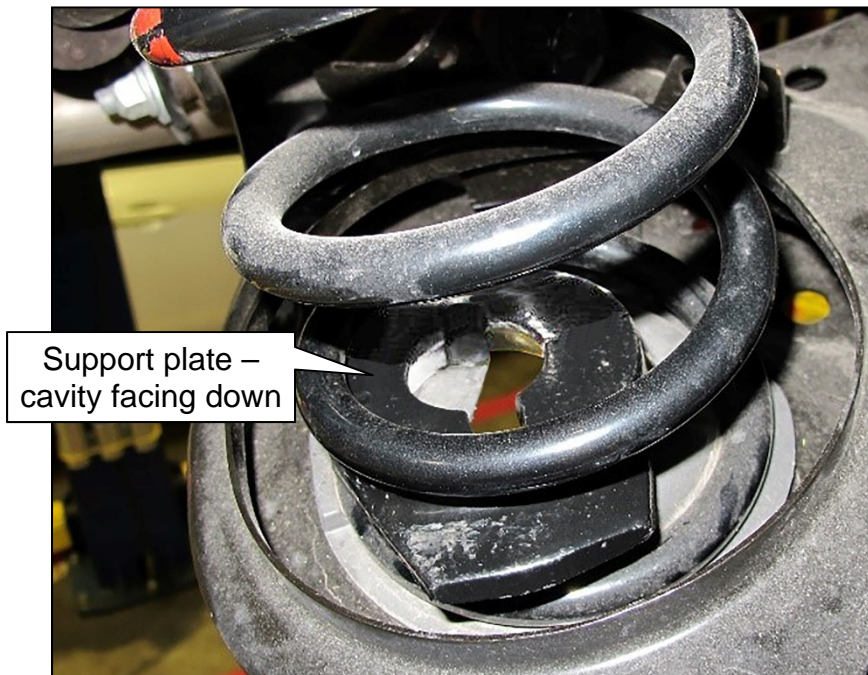
Figure 4

4. Install the other support plate, with the ball cavity facing down, as low as possible inside the coil spring.

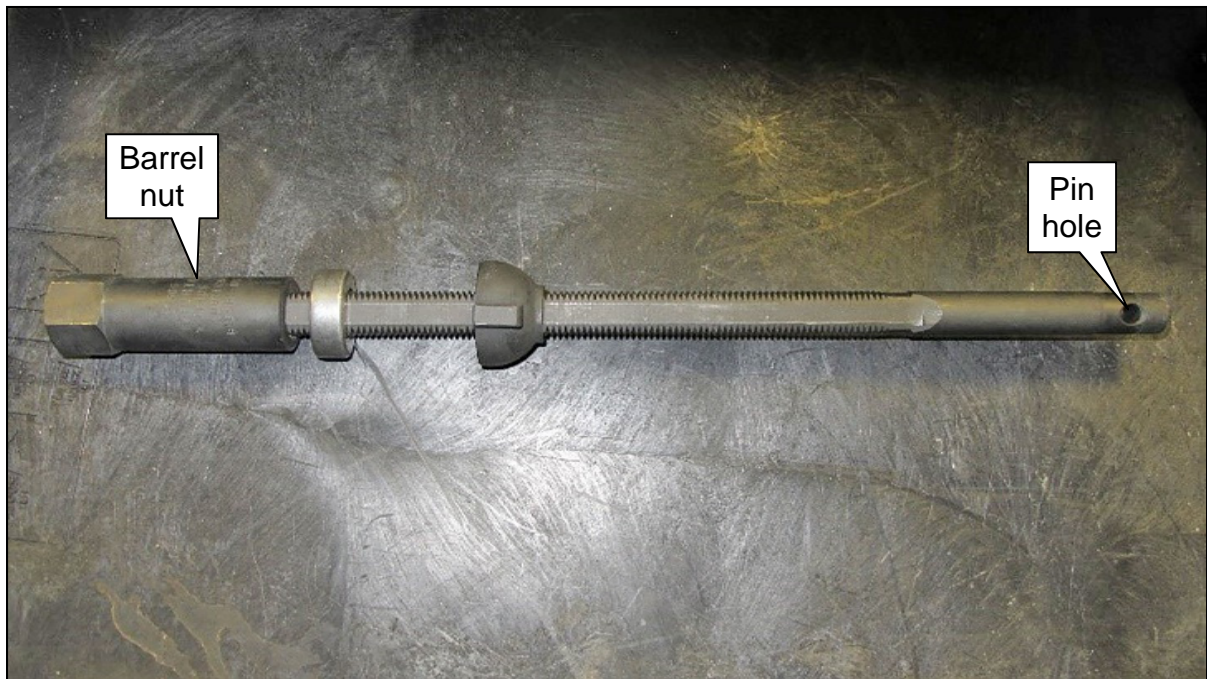
Figure 5

5. Assemble special tool J-52929 as shown in Figure 5.
 - To keep the pieces together, thread the barrel nut onto the threaded rod.

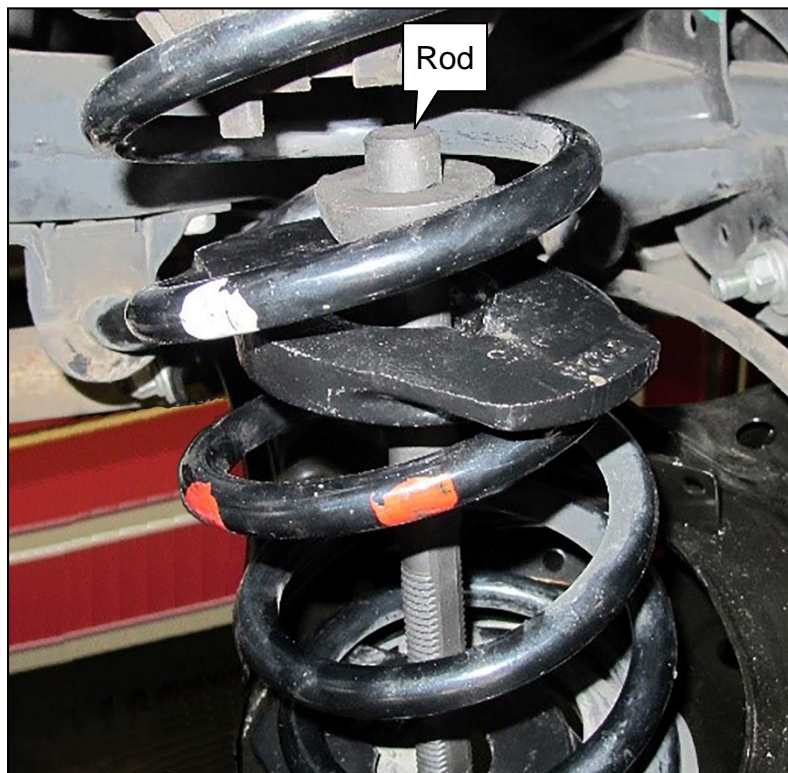
Figure 6

6. Install the assembled pieces, pin hole end first, from the bottom of the coil spring through both support plates and the upper ball.

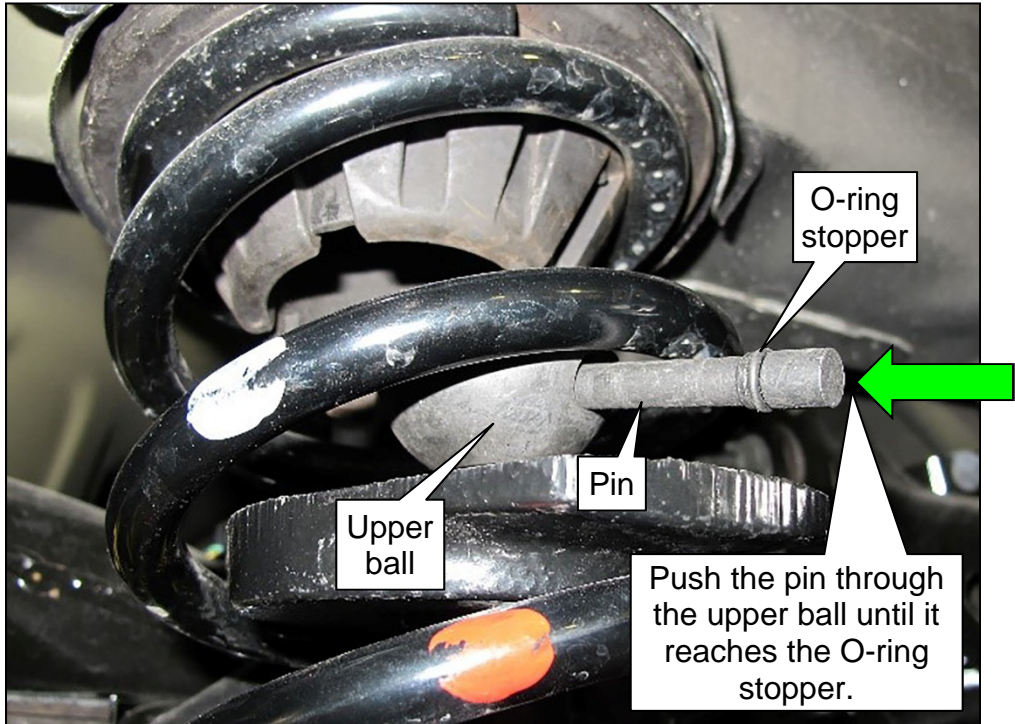
Figure 7

7. Install the pin of special tool J-52929 through the upper ball and threaded rod up to its O-ring stopper.

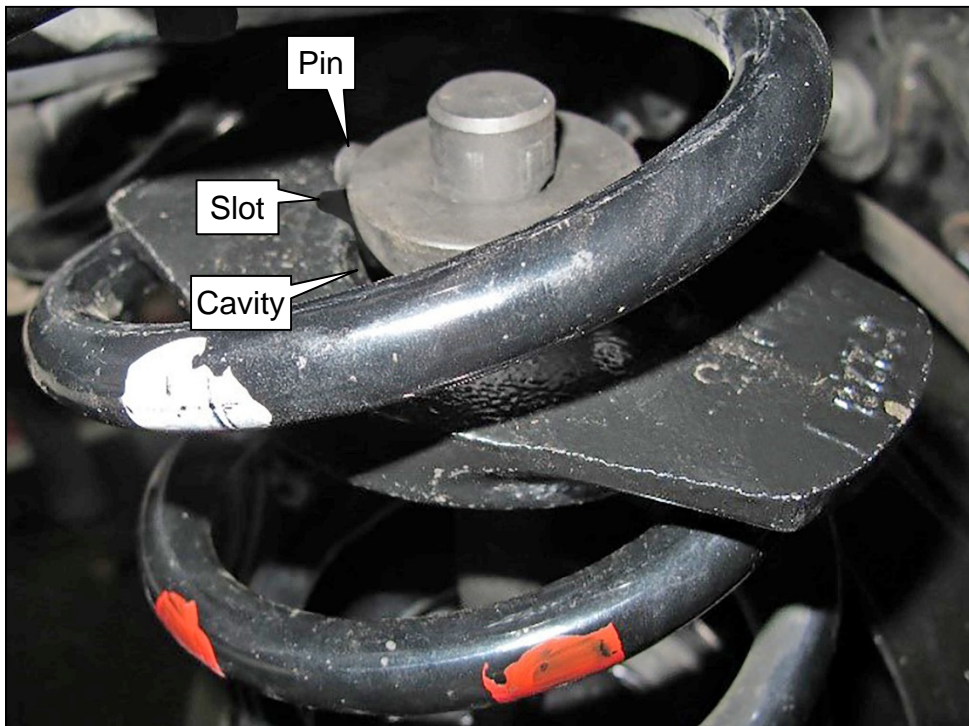
Figure 8

8. Align the upper ball into the upper support plate cavity so that the pin rests in the slots.

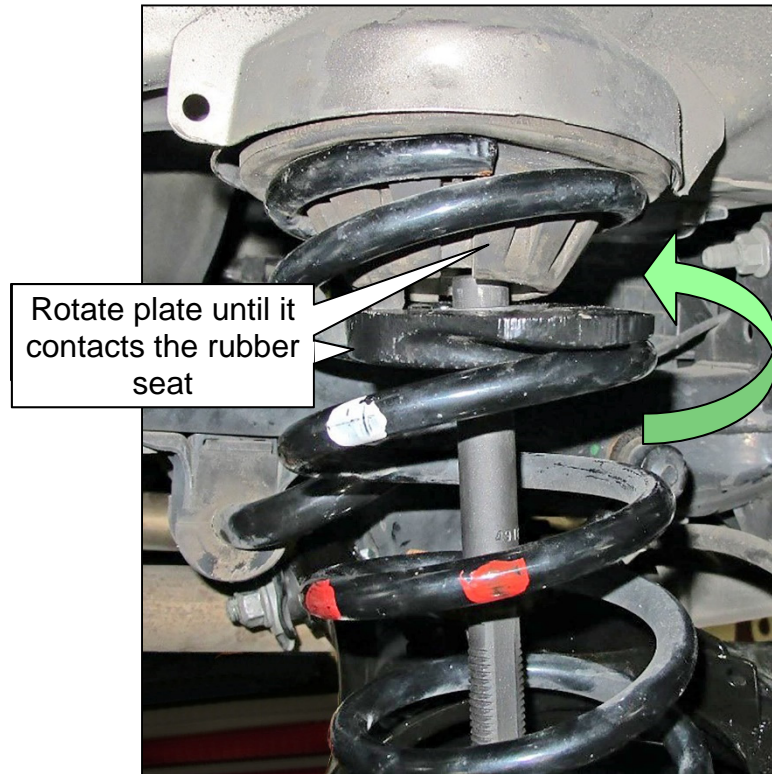
Figure 9

9. Rotate the threaded rod and upper support plate together, as an assembly, counterclockwise until the upper support plate contacts the upper rubber seat.

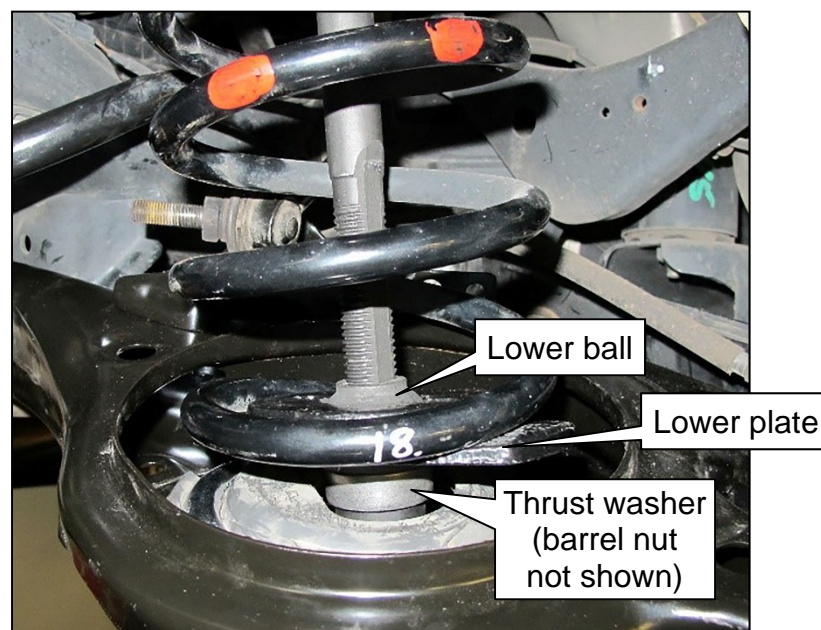
Figure 10

10. Slide the lower ball up the rod and into the lower support plate cavity, while aligning the lower ball's notch into one of the lower support plate's slots.
 - Make sure the lower plate stays as low on the coil spring as possible.
11. Thread the barrel nut up the threaded rod until the thrust washer makes contact with the lower ball (see Figure 10).

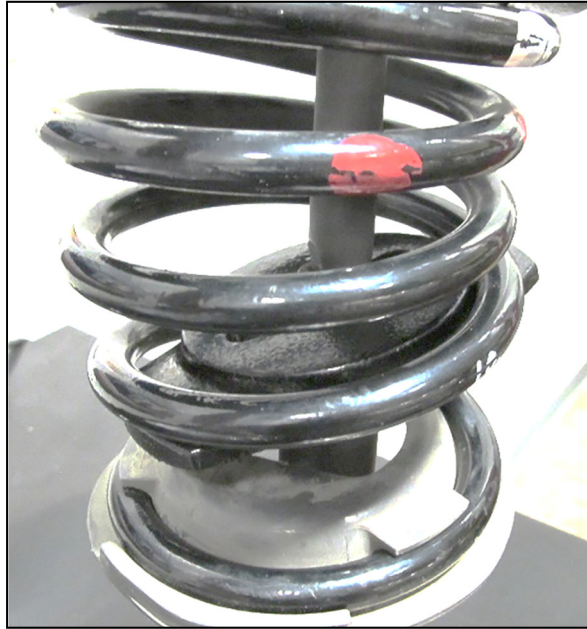
Figure 11

12. Compress the coil spring until the lower ball bottoms out on the threaded rod.
 - To compress the coil spring, use a wrench, deep socket, or other suitable tool to turn the barrel nut clockwise.

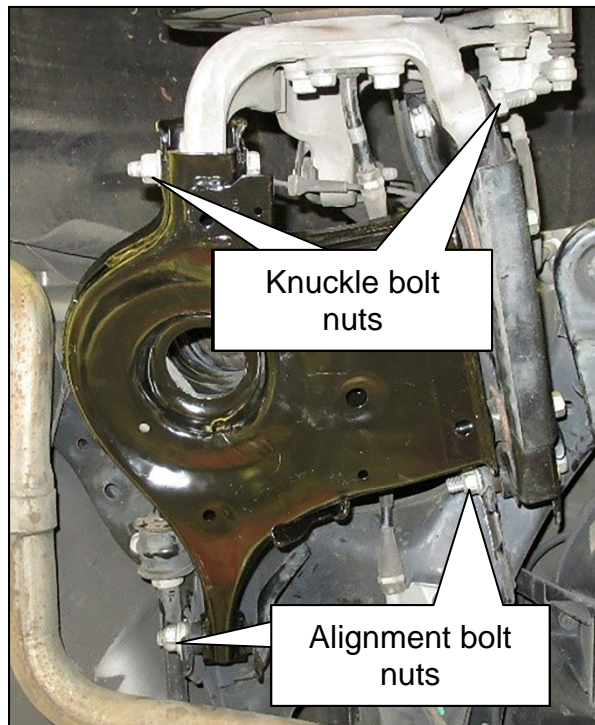
Figure 12

13. Remove the 2 knuckle bolt nuts and the 2 alignment bolt nuts, but do NOT remove the related bolts at this time.

NOTE: These nuts will not be reused and will be replaced with new ones.

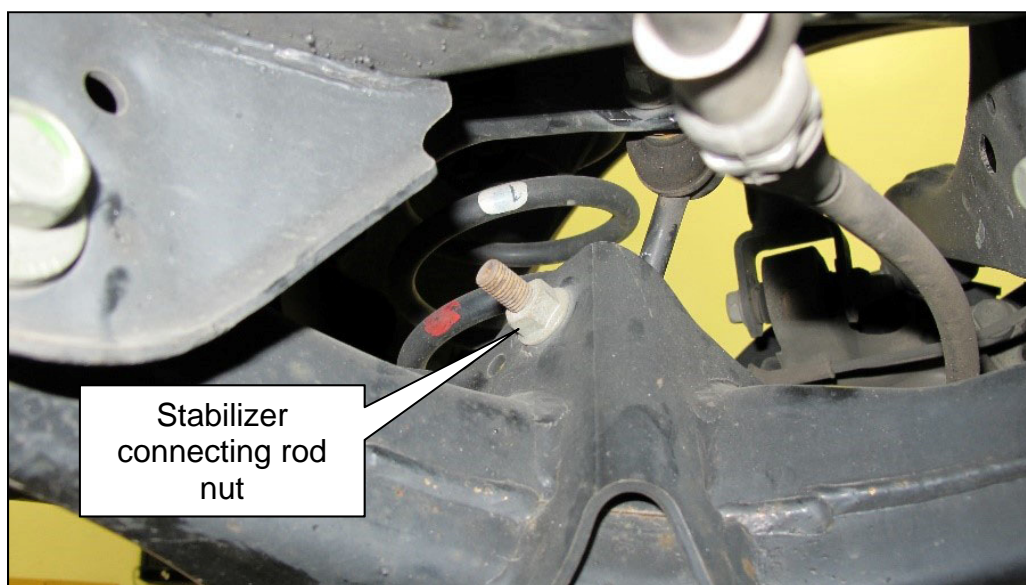
Figure 13

14. Remove the nut holding the rear stabilizer connecting rod to the rear lower link.

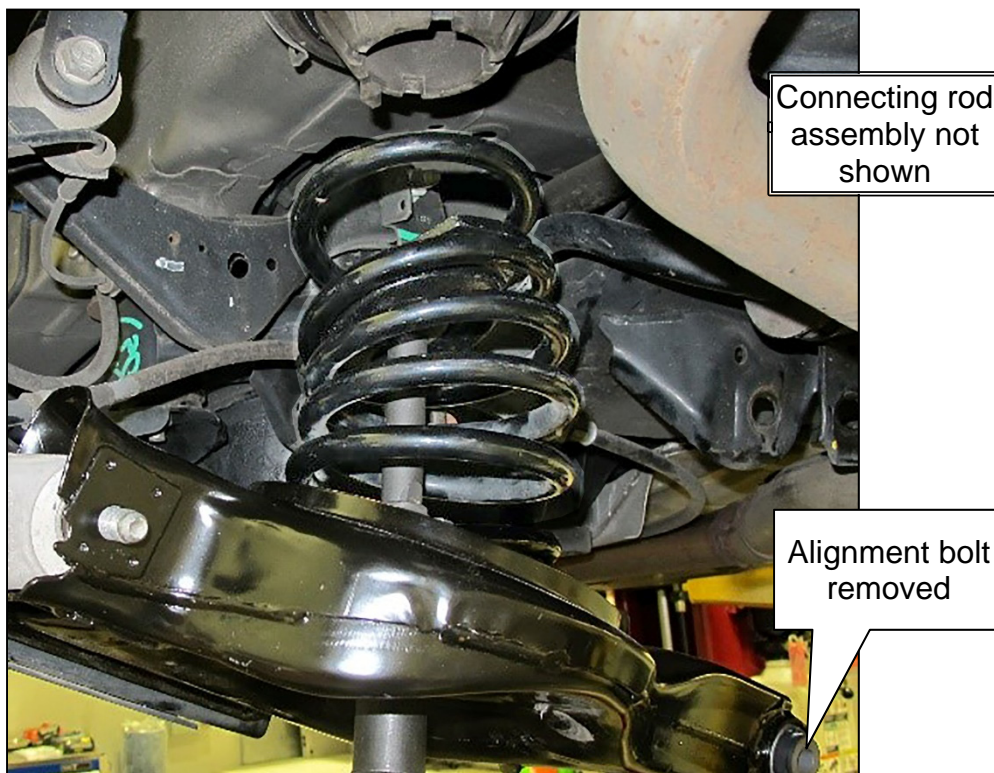
Figure 14

15. Remove the coil spring and special tool J-52929 as an assembly:
 - a. Remove both inside rear lower link (alignment) bolts.

HINT: Due to being marked earlier, these bolts need to go back to their original locations during reassembly.
 - b. Swing the rear lower link downward.
 - c. Remove the connecting rod assembly from the rear lower link.
 - d. Remove the coil spring and special tool J-52929 as an assembly.

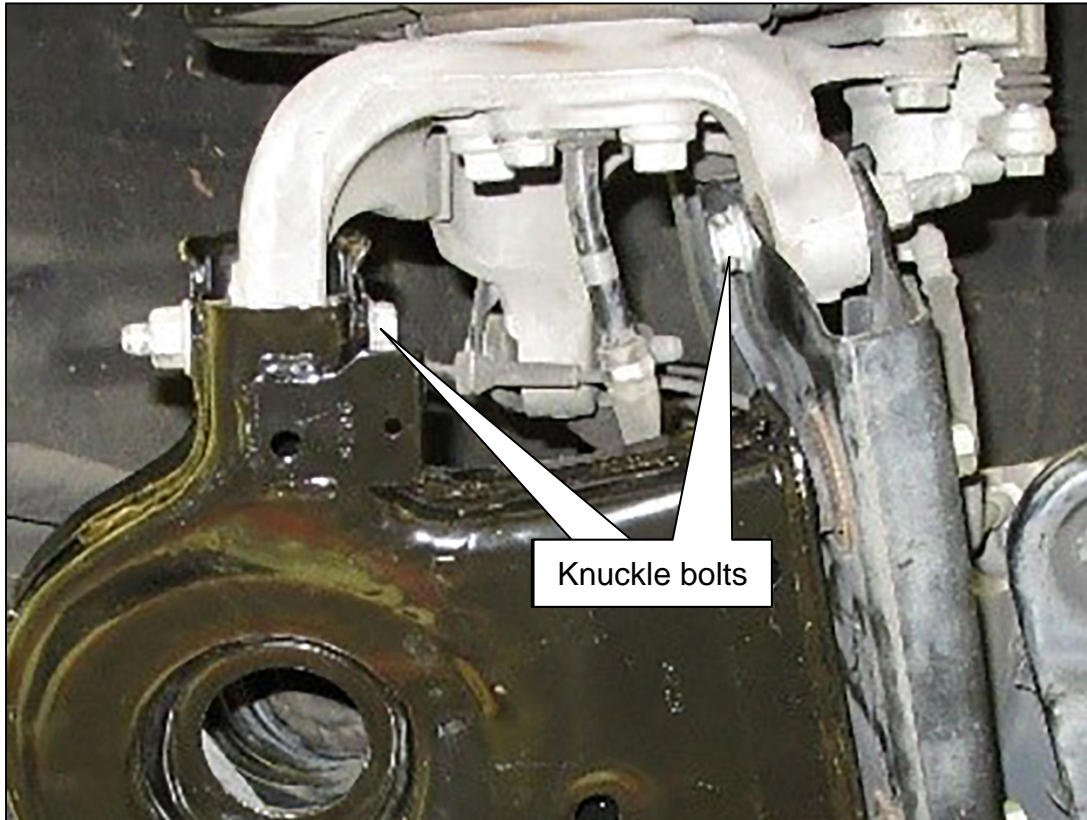
Figure 15

16. Remove the 2 remaining knuckle bolts, and then remove the rear lower link from the vehicle.

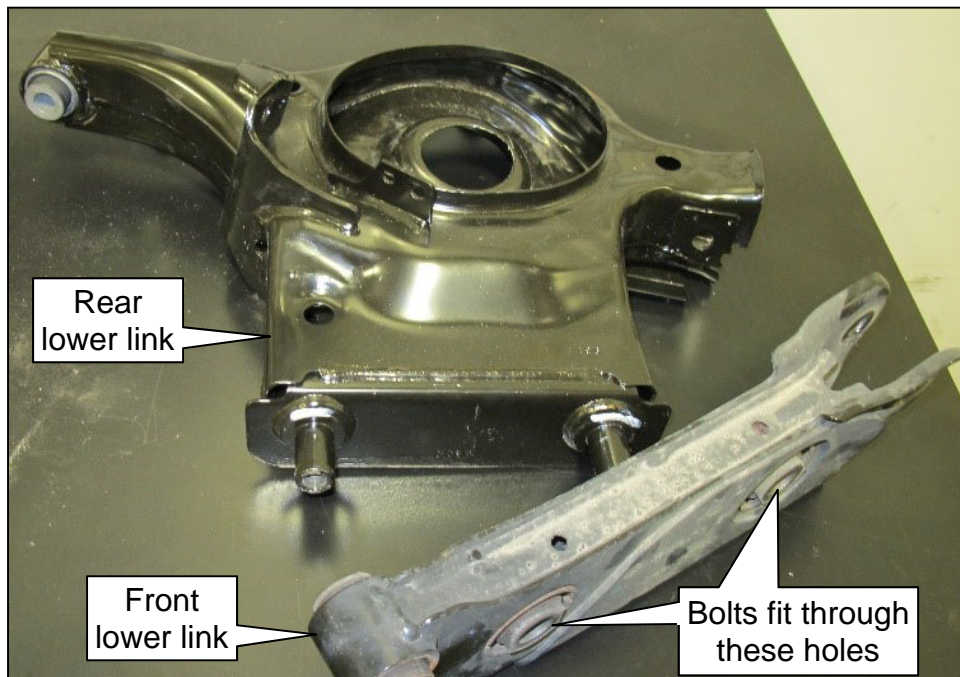
Figure 16

17. Remove the 2 bolts, and then remove the front lower link from the rear lower link.

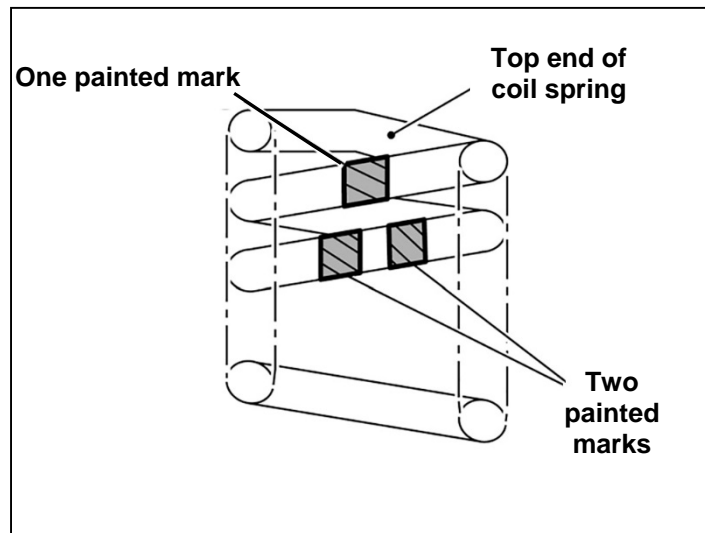
Figure 17

- Nut-to-knuckle bolt torque: 118 N•m (12 kg-m, **87 ft-lbs**)
- When installing the coil spring (still compressed):
 - a. Make sure the orientation of the coil spring is as shown in Figure 17: A single painted mark is above the two painted marks.

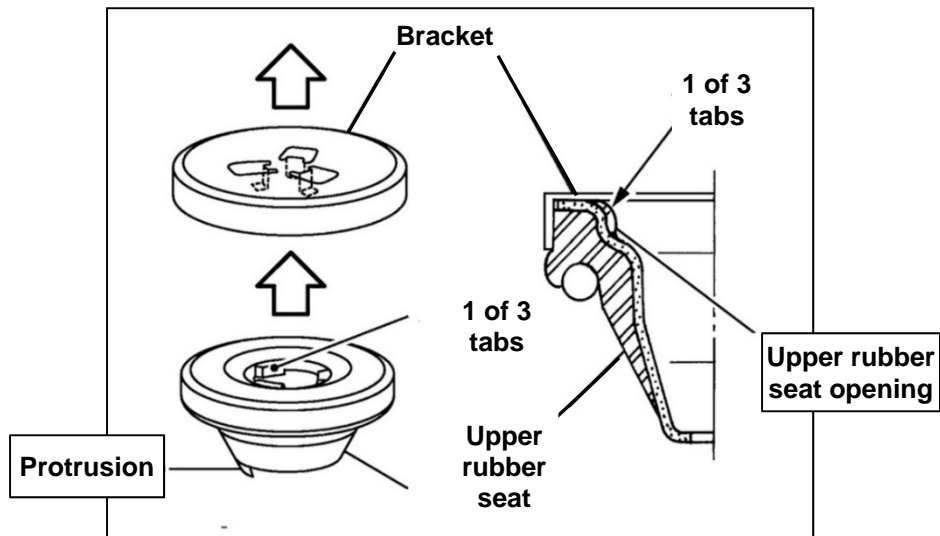
Figure 18

- b. Make sure the upper rubber seat is secured to the bracket, which is secured to the vehicle.
- Make sure the protrusion is aligned, facing into the vehicle.

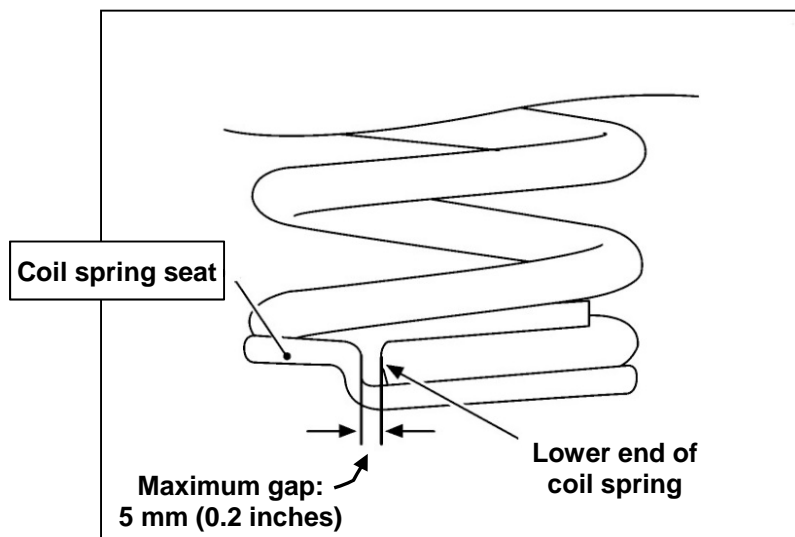
Figure 19

- c. Align the coil spring by placing its lower end as shown in Figure 19.
