Mercedes-Benz

Campaign No. 2021050004, May, 2021

SUBJECT: **Model 907 Sprinter, Model Year 2019**
Update Incorrect VIN

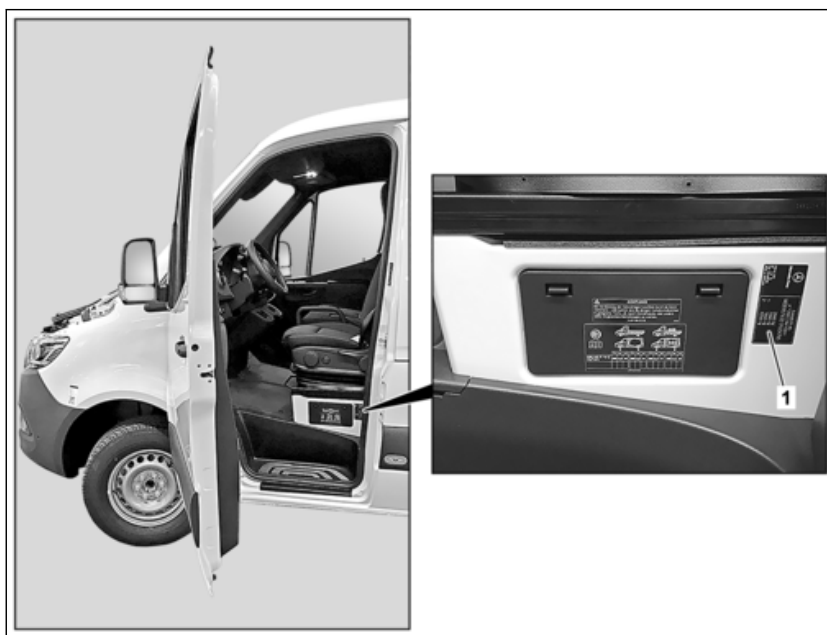
D60.00-A054-06

1 *Information label*

For authorized Mercedes-Benz service partners, only the entry in the Extended VEGA Application (EVA) system, in the "Current" tab, is decisive. An additional test of the affected vehicles in the workshop information system (WIS) or vehicle list is thereby not necessary.	
	Replace		
2	Replace information label (1).

Bonding surface must be absolutely dry and free of dust and grease. This prevents any adhesion problems.

Incorrect vehicle identification number: WDZPF0ED6KT016360 Correct vehicle identification number: W1Z40FHYXKT016360 Cleaner	BR00.45-Z-1025-04A

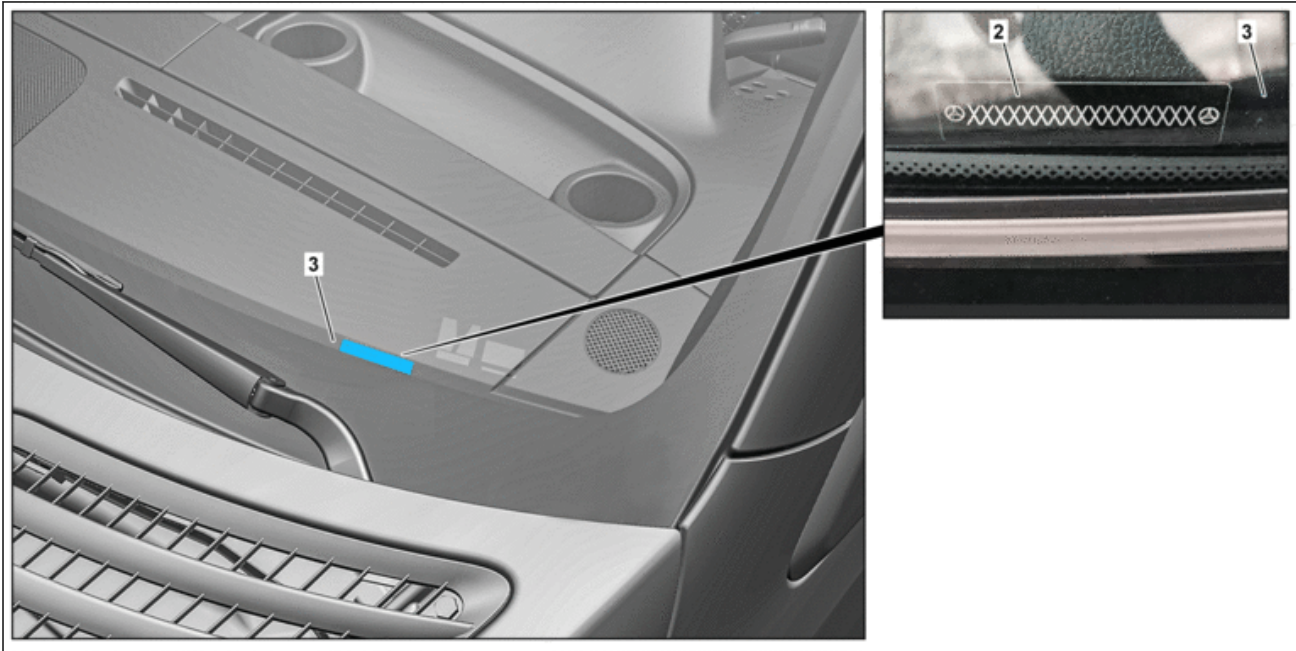
D60.00-A055-79

2 Information label

3 Instrument panel

3	Replace information label (2).

Bonding surface must be absolutely dry and free of dust and grease. This prevents any adhesion problems.

Incorrect vehicle identification number: WDZPF0ED6KT016360 Correct vehicle identification number: W1Z40FHYXKT016360

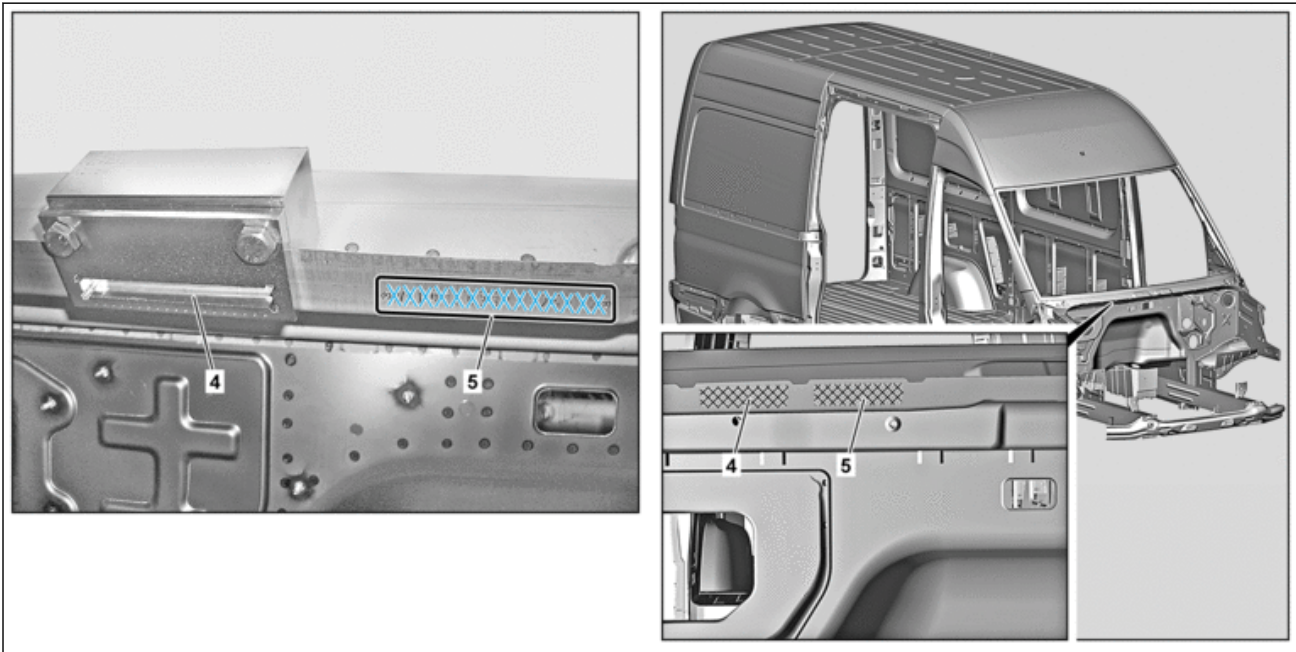
D60.00-A056-79

4 Reserve field for vehicle identification number

5 Standard field for vehicle identification number

Remove ventilation box.		AR83.10-D-0010TS
5	Remove engine compartment seal in area of reserve field (4).		
	Punch in VIN		
6

Stamp correct vehicle identification number into reserve field (4).	<p>

Cross out incorrect vehicle identification number in standard field (5).</p> <p>

Incorrect vehicle identification number: WDZPF0ED6KT016360</p> <p>Correct vehicle identification number: W1Z40FHYXKT016360</p> <p>
