June 2021  
SF627A

## Subject: FCCC XCM Right-Hand Steering Column Stalk

**Models Affected: Specific Model Year 2021 Freightliner Custom Chassis XCM model chassis, manufactured July 20, 2020, through November 7, 2020.**

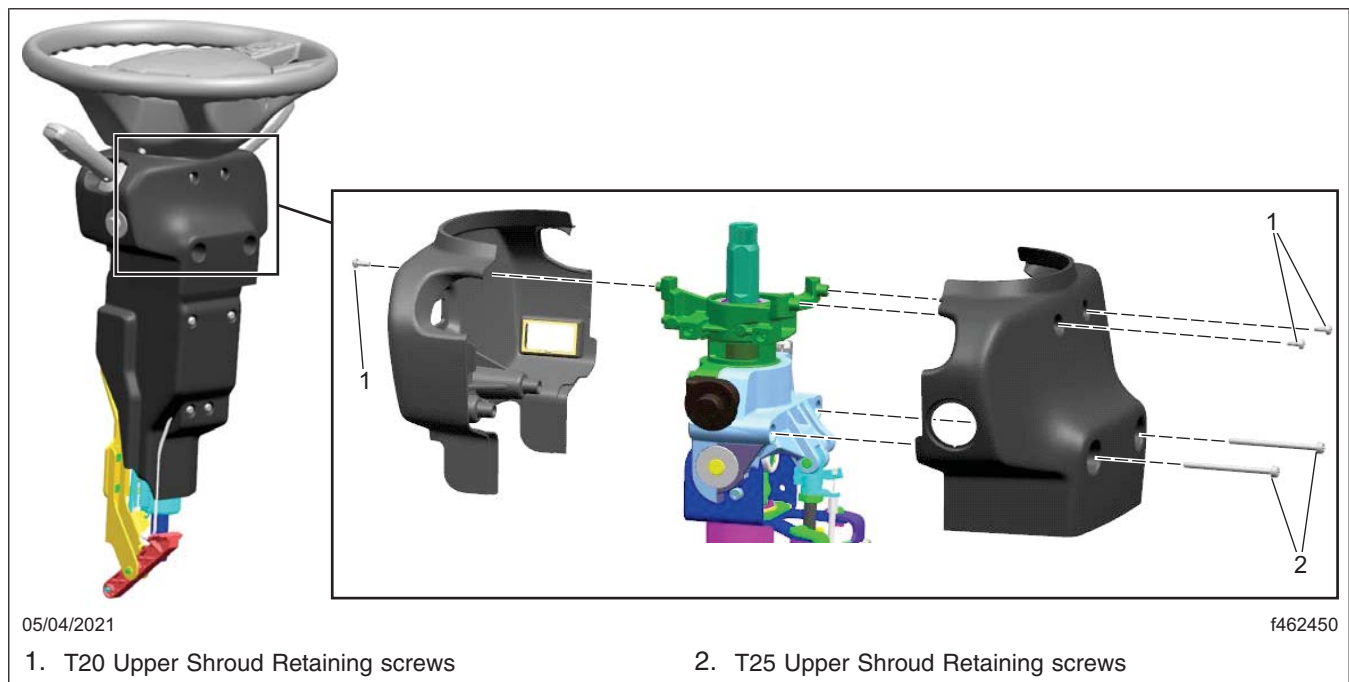
**Fig. 1, Detaching the Steering Column Shroud**

2. Remove the three T20 and two T25 Torx® head screws that attach the steering column shrouds to the steering column, and then separate them enough to gain access to the fasteners that attach the shifter lever to the steering column. See [Fig. 1](#). Retain the screws for reuse.

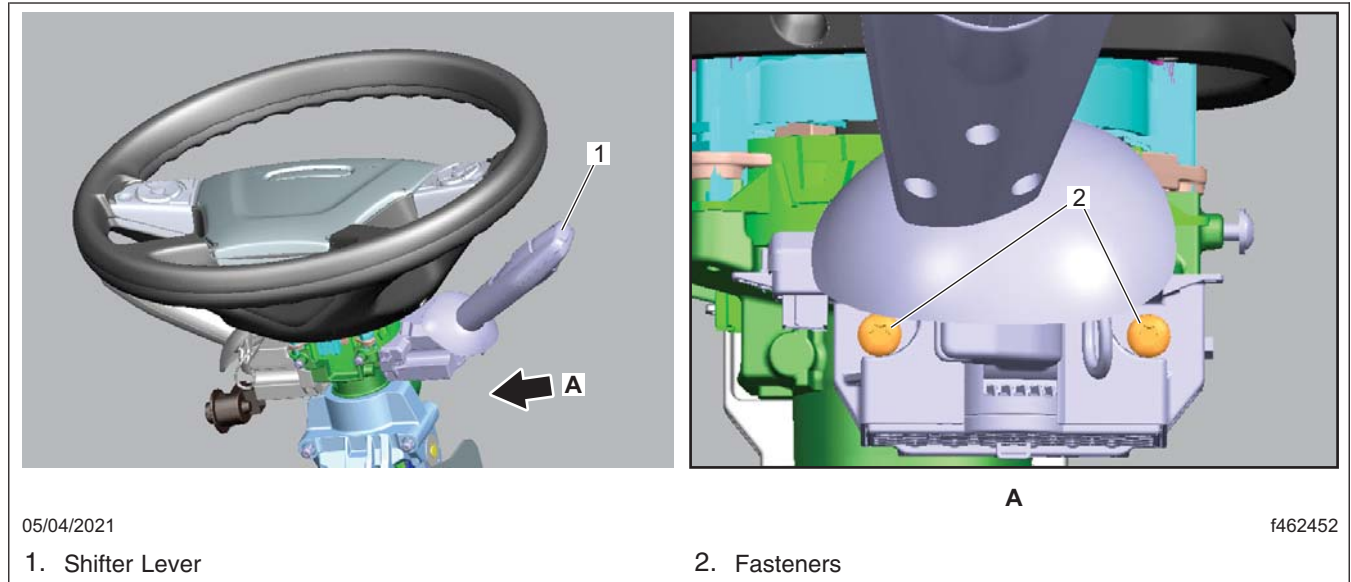
**Fig. 2, Shifter Lever Attachment**

4. Remove the two fasteners that attach the shifter lever to the steering column, and then remove the shifter lever. See **Fig. 2**. Retain the fasteners for reuse, and discard the shifter lever.

5. See **Fig. 3** and **Fig. 4** for incorrect and correct engine brake switches respectively. Position a new single stage VGT engine brake stalk switch, and then install the two T25 screws that attach the shifter lever to the steering column. See **Fig. 2**. Tighten the screws 2.1 to 2.5 lbf-ft (2.84 to 3.38 N-m)

6. Connect the shifter lever electrical connector, and then secure the connector wire harness using cable ties.
7. Position both the upper column shrouds on the steering column, and install the fasteners as per sequence below. See **Fig. 2**.
  - 7.1 Install the three T20 Torx head screws, but do not tighten at this time.
  - 7.2 Install the two T25 Torx head screws. Tighten the screws 2.1 to 2.5 lbf-ft (2.84 to 3.38 N-m)
  - 7.3 Tighten the three T20 Torx head screws 0.8 lbf-ft (1.1 N-m).

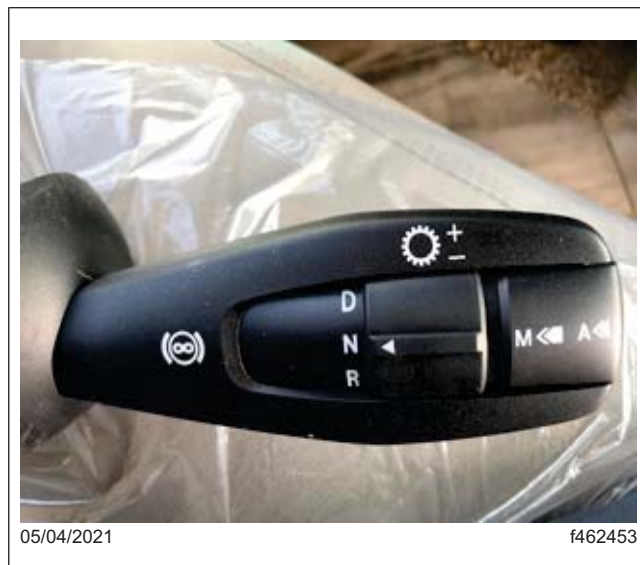
**Fig. 3, Incorrect Switch (06-87751-005)**

Our records indicate that an incorrect three-stage engine brake switch was installed on the right-hand column stalk of your vehicle.

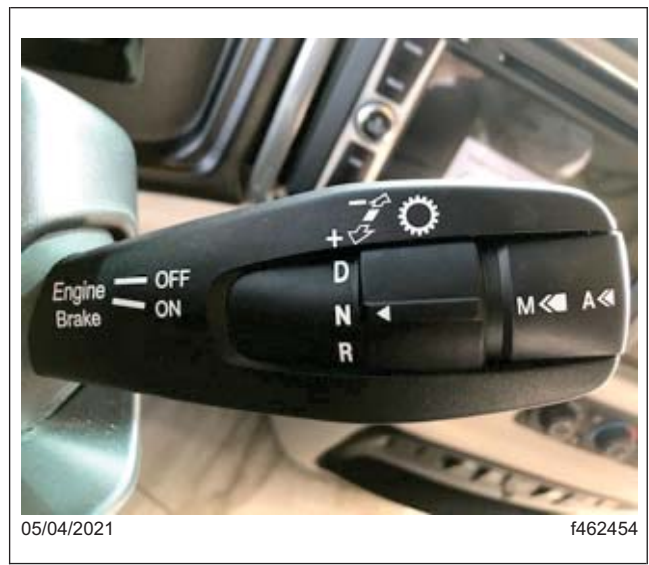
**Fig. 4, Correct Switch (06-87751-006)**

The steering column stalk will be replaced with a stalk that has a single-stage engine brake switch applicable to a Cummins VGT (Variable Geometry Turbo).
